# The archaeological site of Selib 2 in the Dongola Reach: remarks on the 2019 season

**Abstract:** The paper discusses recent fieldwork at the Meroitic settlement site of Selib 2, a town located on the west bank of the Nile between the Third and Fourth Cataracts, investigated by the Banganarti/Selib Polish Archaeological Mission since 2010. The fieldwork was concentrated on uncovering the earliest occupation strata from the 1st/2nd centuries CE. Two mud-brick buildings were fully excavated, along with contemporaneous occupational horizons, yielding, among others, unique bell-shaped decorated vessels, a copper plate, and a female clay figurine. Storage jars used as ovens and cooking places were present in all phases and can be considered as a characteristic furnishing of the explored households. Moreover, an archaeological reconnaissance extended the boundaries of the settlement eastward, providing new data for studies of the settlement plan and its various stages of development.

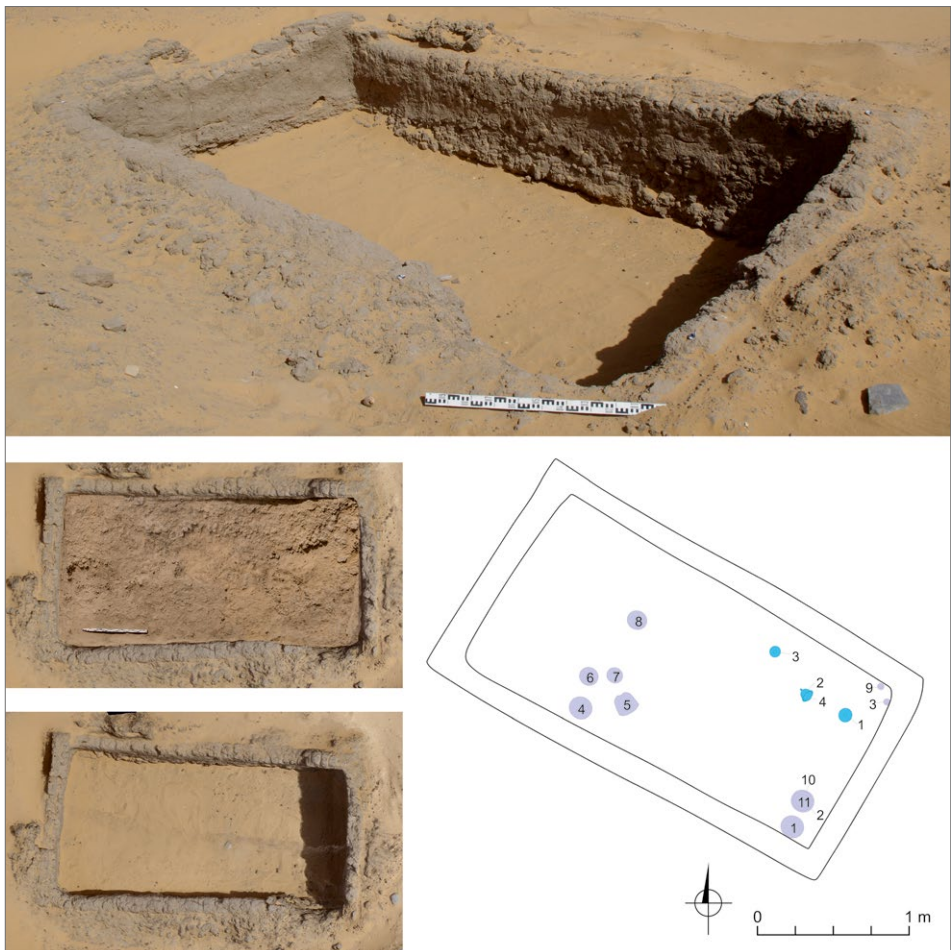
Fig. 2. Building S2/12/2019: top, the building after exploration; center left, view after cleaning the mud-brick rubble; bottom left, view of the collapsed wall; bottom right, plan showing pottery clusters (IKSiO PAN | photos, drawing, editing R. Hajduga)

The building was a small rectangular structure, 4.50 m by 2.50 m, made entirely of mud brick [Fig. 2]. The walls were

preserved to a height of approximately 0.90–1.00 m. The entrance was located in the southeastern corner. The bondwork

was concealed under a well preserved coat of mud plaster, but based on the thickness of the walls (18 cm), a header bond should be assumed.

A thick layer (approximately 0.60 m) of mud-brick rubble covered the western, southern and eastern parts of the unit [see *Fig. 2* bottom left]. It turned out to be the upper part of a wall (S2/10), which had collapsed inside and sealed the occupational fill on the floor, composed of sand and ash (S2/12). This layer yielded five ceramic vessels, three bell-shaped, which is a form previously unparalleled at Selib [see *Fig. 2* bottom right]. The function of these bells, with the cups decorated with painted red stripes on a white slip surface [see below, *Fig. 12*],

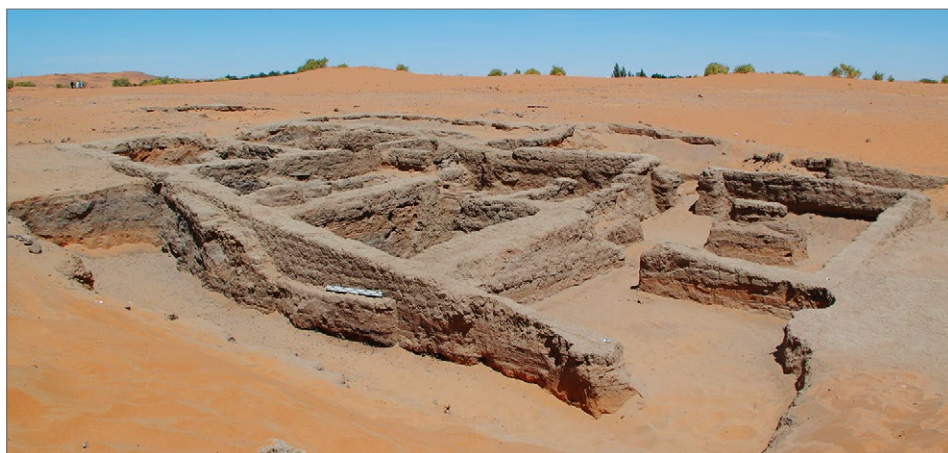
Fig. 3. Building S2/13/2019: general view from the south (IKSiO PAN | photo R. Hajduga)

Surface clearing of the selected site brought to light the full outline of mud-brick architecture in this part of the settlement. Thus, the first goal was achieved, adding new substance to the general plan of Selib 2 [*Figs 3, 4*].

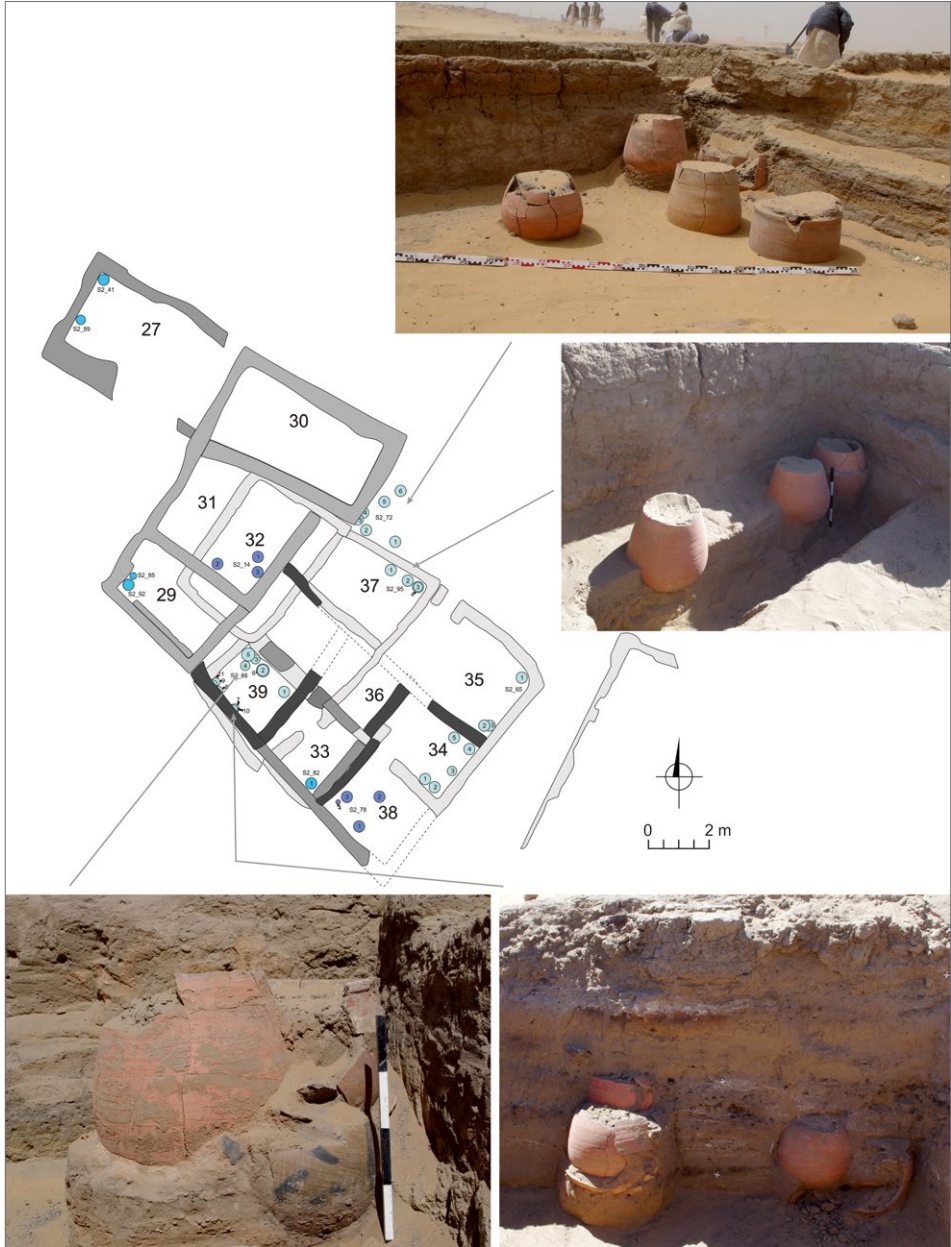
Fig. 6. Building S2/13/2019: storage jars acting as cooking places inside the rooms, divided by phases (IKSiO PAN | photos, drawing, editing R. Hajduga)

The storage jars found in this phase in Room 35, but also 37 and 39, were sometimes reused as open pot ovens, especially

those found in Room 39 [Fig. 6]. They were placed in the sand upside down, the upturned base cut intentionally to

be used for cooking. Eleven vessels of this kind formed two groups inside Room 39, which had a partition wall dividing it into two parts: six vessels were lined up along the partition wall and another five were located next to the south wall of the building (S2/14). Other vessels, presumably for cooking, were associated with cooking places, placed above the ovens or inside them. The cooking places were filled with ash and charcoal, as well as pieces of Doum palm fruit. The pot content was sampled for radiocarbon dating and biological residue analyses.

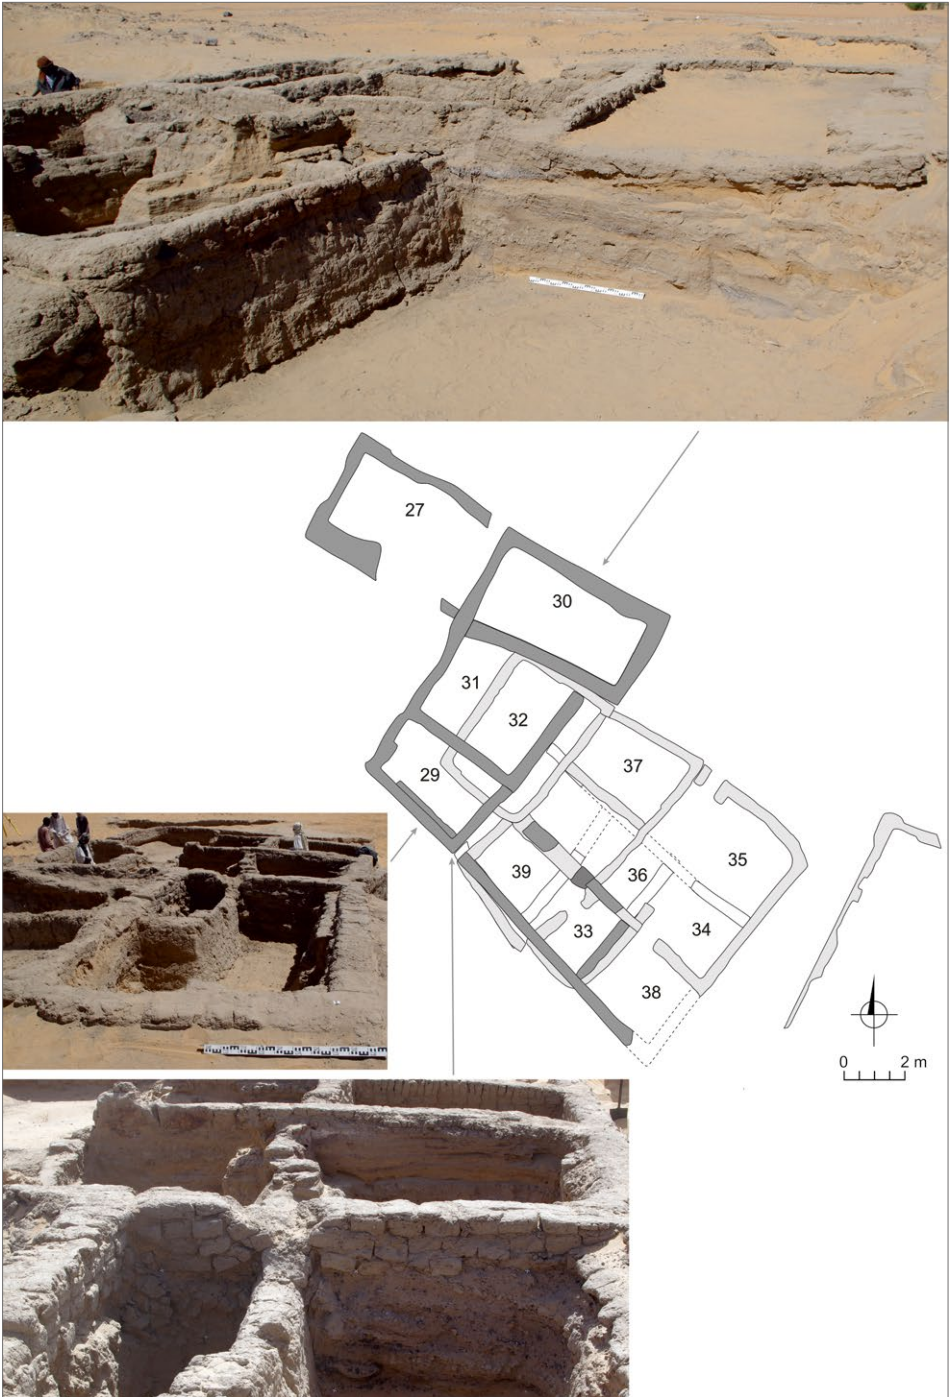
Fig. 7. Building S2/13/2019: phase 2 (IKSiO PAN | photos, drawing, editing R. Hajduga)

In the second phase, the building was reconstructed and the floor surfaces inside the house were levelled, mainly inside Rooms 31, 29 and 39 [*Fig. 7*]. Rooms 31 and 29 (walls S2/18, S2/9 and part of S2/113) were built on old foundations and levelled mud-brick rubble of the earlier phase. The same construction techniques were used in the construction of the new walls. A foundation course one-brick thick was added to reinforce the south wall of Room 29 (S2/113).

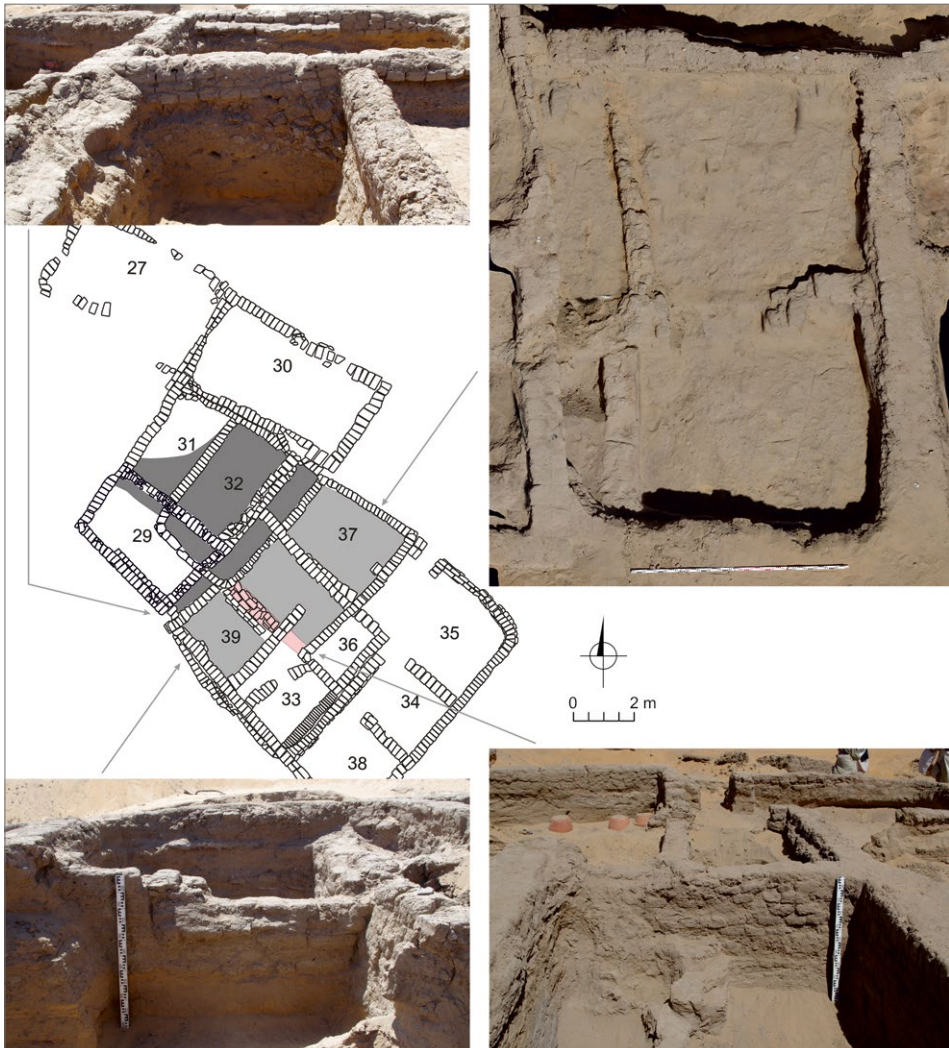
Fig. 8. Building S2/13/2019: mud walking surface (IKSiO PAN | photos, drawing, editing R. Hajduga)

A compact layer of mud formed a walking surface throughout Rooms 32, 37, 39, and part of 33 [*Fig. 8*]. This floor concealed the jars used as ovens in the earlier phase. Evidently, the kitchens inside this house had ceased to function.

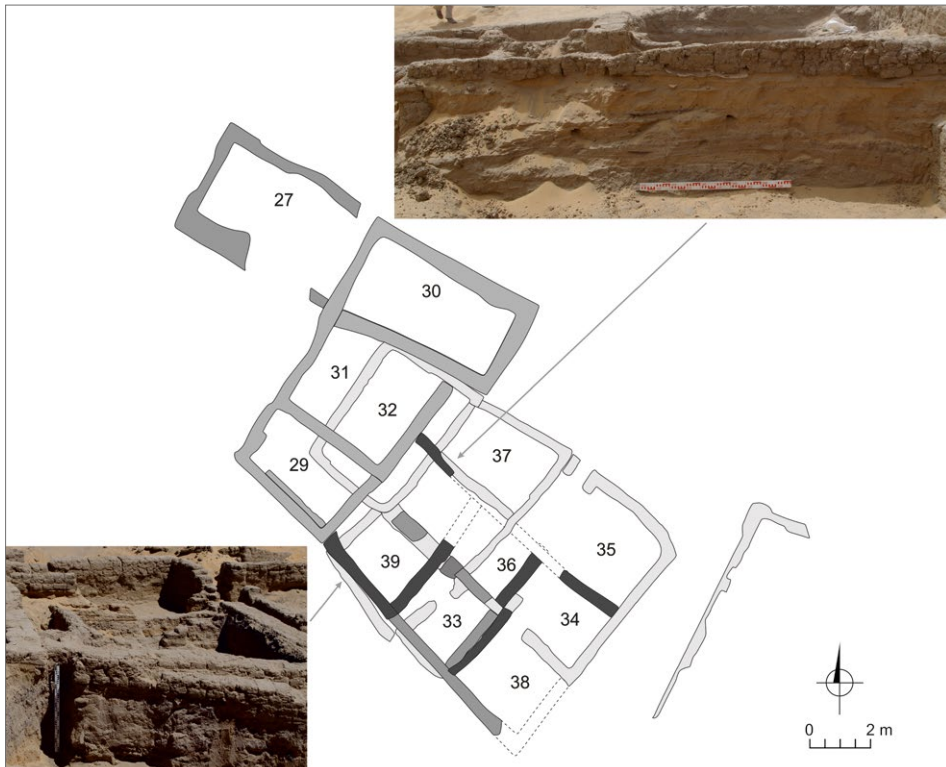
Fig. 10. Building S2/13/2019: phase 3 (IKSiO PAN | photos, drawing, editing R. Hajduga)

During the third phase, the building was enlarged with new units being added to the original structure [Fig. 10]. A platform was installed in the southwestern corner of Room 29, partly overlapping the mastaba against the south wall [Fig. 9]. This platform was placed on layers of ash and sand from the earlier occupational phases, and a storage jar was sunk into it. A bronze plate was found beneath it [see below, Fig. 15].

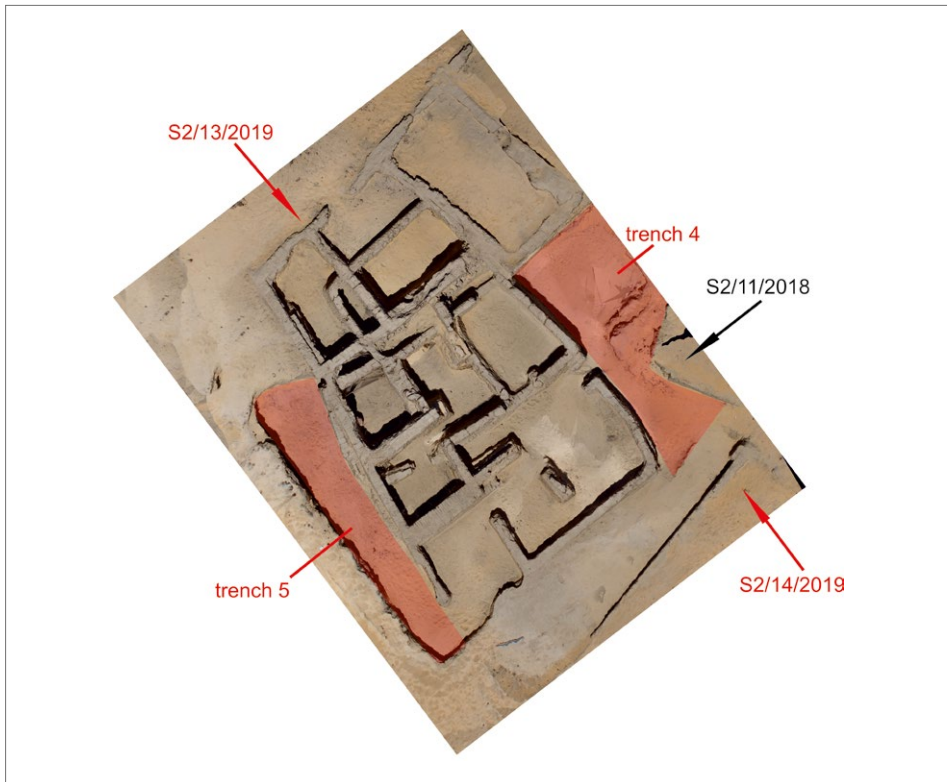
Fig. 11. Building S2/13/2019: location of trenches outside the building (IKSiO PAN | photo and rendering R. Hajduga; geodetic measurements R. Łopaciuk)

Trenches outside house S2/13/19 were aimed at establishing the occupational sequence in these areas [Fig. 11]. Jars used as furnaces were located outside the building in Trench 4 opened north-east of the building. These jars appear to continue to the southwestern corner of house S2/11/18, thus confirming that the two households existed contemporaneously in Phase 1. The food-producing function of these installations was evident, indicating that cooking was an activity carried out also between the houses, perhaps in a common cooking space.

An accumulation of occupation layers was revealed in Trench 5, located south of the building [see Fig. 11]. These layers corresponded to layers of ash, charcoal and potsherds, associated with the first phase of occupation of S2/13/2019, both inside and outside Room 39. They could be considered as waste from the kitchen facilities operating in the southern part of Room 39, presumably reflecting pe-

Another mud-brick structure, S2/14/2019, was observed south of the excavated trench [see Fig. 11]. It will be investigated in a future season of fieldwork.

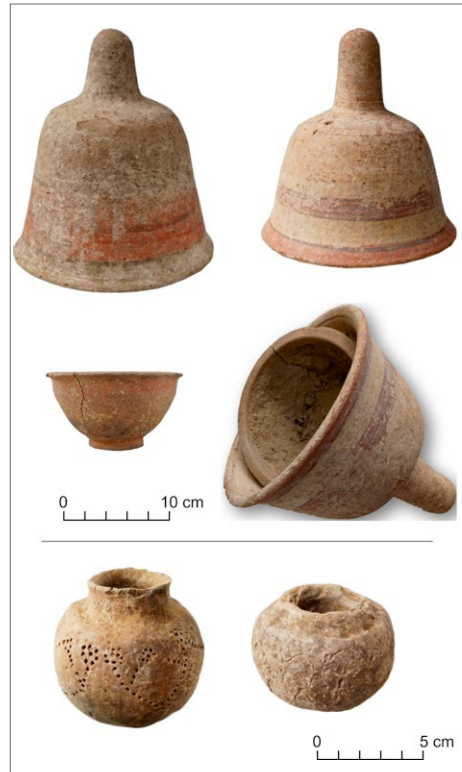
Fig. 12. Bell-shaped vessels and handmade jars with combed and cut decoration (IKSiO PAN | photos P. Terendy)

The bell-shaped vessels from the storeroom S2/12/2019 are unparalleled not just in the Selib 2 material. These vessels were wheel-made, finely decorated on the outside, with red stripes on a white ground, and with an oblong knob handle on top [Fig. 12]. The inside was roughly worked, as if they had been a lid of sorts. A small cup/bowl was found inside one of them, seemingly supporting this notion. There were also two small handmade vessels, a few centimeters high, covered with a typical cut and combed decoration.

were fired in a reduction atmosphere, imparting a fine black color on the surface, frequently slipped and polished on the outside, frequently also decorated with comb impressions, rocker stamps and incisions. Fine wheel-made pottery

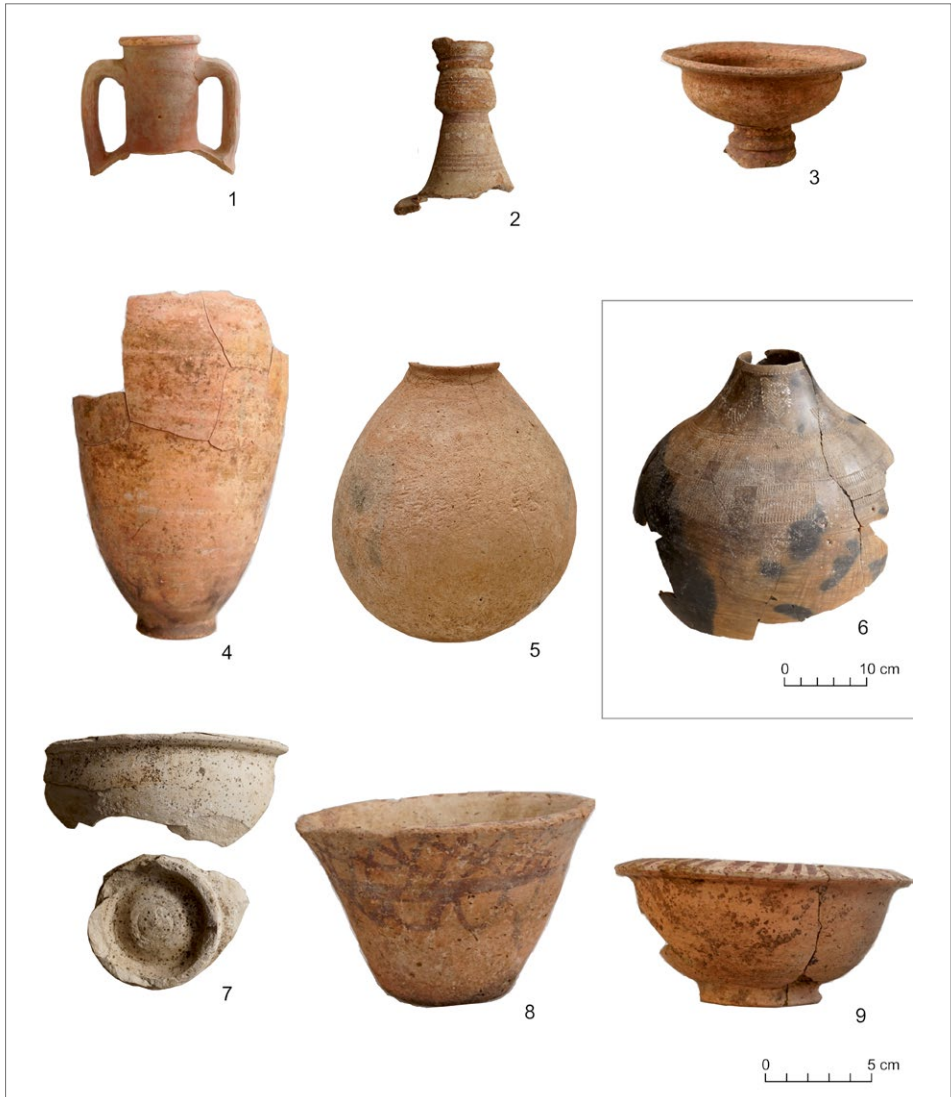
Fig. 13. Wheel-made and handmade pottery from Selib 2: 1, 4 – Aswan imports; 2, 3 – coarse ware; 5 – handmade vessel; 6 – handmade, burnished vessel; 7 – fine ware; 8, 9 – middle ware (IKSiO PAN | photos P. Terendy)

ers. Finer vessels, like cups, beakers and bowls, were made of kaolinitic clay with walls barely 5 mm thick, possibly used for consumption or fine goods [Fig. 13].

Among the transport containers were two examples of amphorae, probably imported from Aswan [see Fig. 13:1, 4].

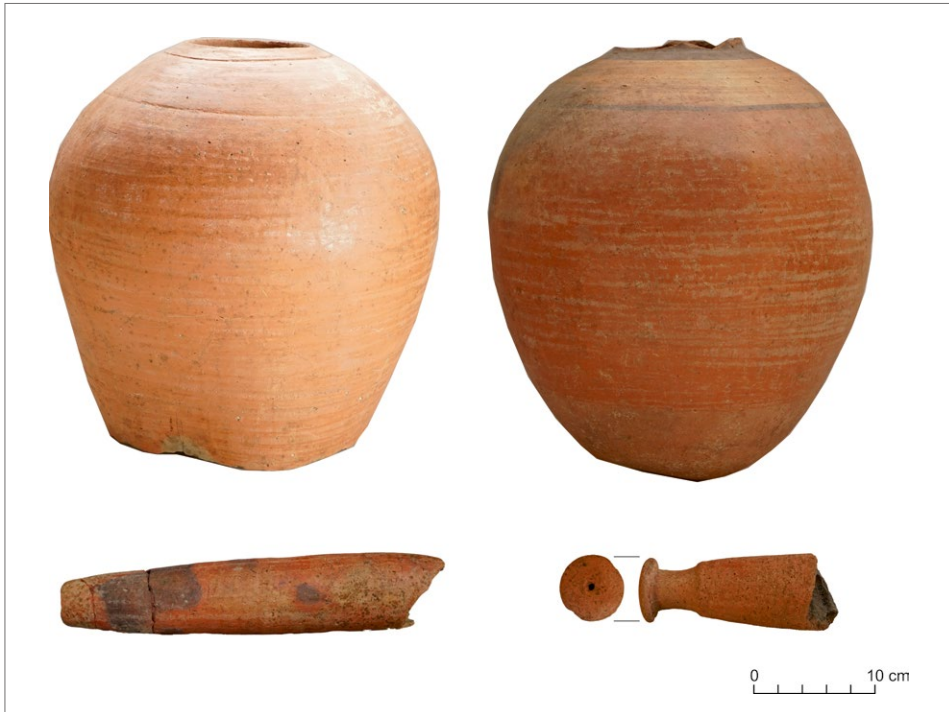
Fig. 14. Typical Meroitic jars from Selib 2 (IKSiO PAN | photos P. Terendy)

Storage vessels dominated the assemblage. Big jars, up to 50 cm high, were installed in the kitchens and other rooms, serving as ovens [Fig. 14; see above]. Different shapes and production techniques are represented among these typical Meroitic products. At Hamadab, in horizon D (Meroitic level), large ceramic furnaces had been dug into the sand layers (Wolf, Nowotnick, and Wöß 2014: 104–120). Likewise, in Selib, most of the oven pots were placed upside

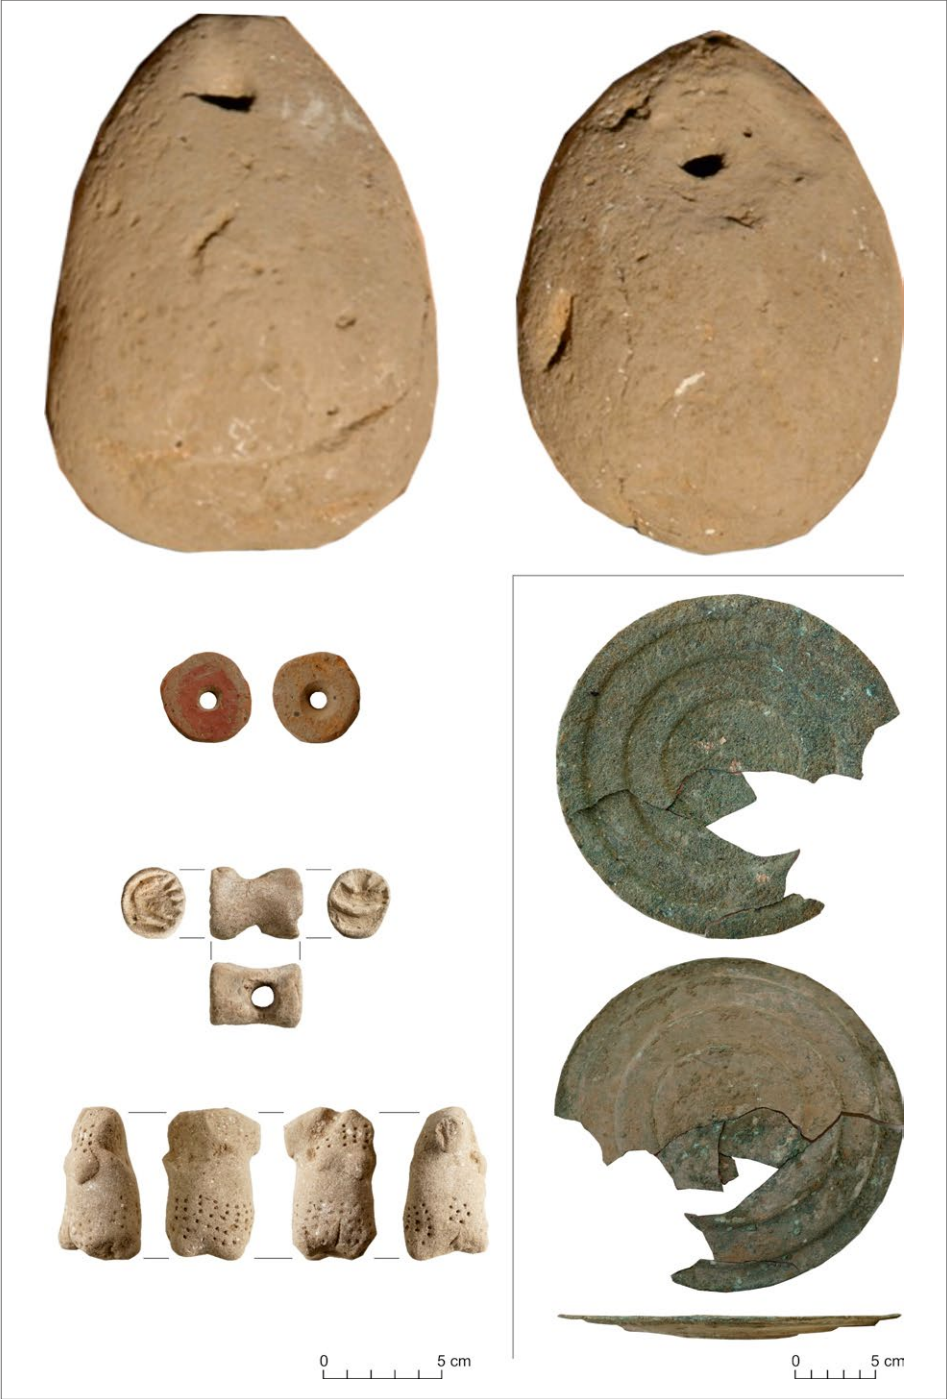
Fig. 15. Small finds: top, loom weights; center left, spindle whorls and clay seal; bottom left, clay female figurine; bottom right, bronze plate (IKSiO PAN | photos P. Terendy)

Finds included loom weights and spindle whorls, indicating the domestic character of the studied households. There was also a bronze plate decorated with concentric rings; it constituted the first find of a metal vessel from Selib 2. A clay seal, less than 3 cm long, has images incised on both sides, possibly a plant or animal motif. The image is schematic but it seems to recall a bronze seal ring with an image of an elephant collected from the surface by the nearby villagers (Hajduga 2013: 292) [Fig. 15].

A schematic anthropomorphic figurine made of coarse clay was found in S2/13/2019 [see *Fig. 15*]. Both arms and the head are missing. The figure has a stippled decoration, made with a sharp tool like a bone pin or spindle. The dots are arranged in groups in semblance of jewellery, clothing or a body tattoo. It was apparently intended to represent a female. The rough craftsmanship indicates that it was rather a common object.

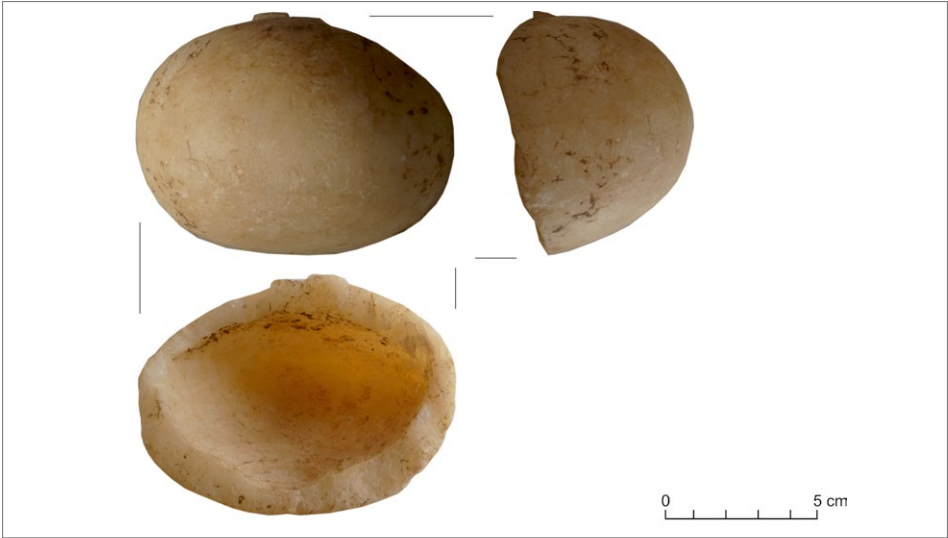
Fig. 16. Alabaster bottle (IKSiO PAN | photos P. Terendy)

A set of stone grinders, pounders and querns was also collected, mostly from the layer of mud-brick rubble in the storeroom S2/12/2019. The finds included an alabaster bottle, hand-turned on a lathe. Since it is the first find of its kind from Selib 2, it is likely that it was brought to the site as a container for some luxury contents, such as fragrances or oils.
