Some new earthquake-related evidence from Marina el-Alamein in Egypt

Keywords: Marina el-Alamein, seismic events, stone wall construction techniques, bathhouse, latrine

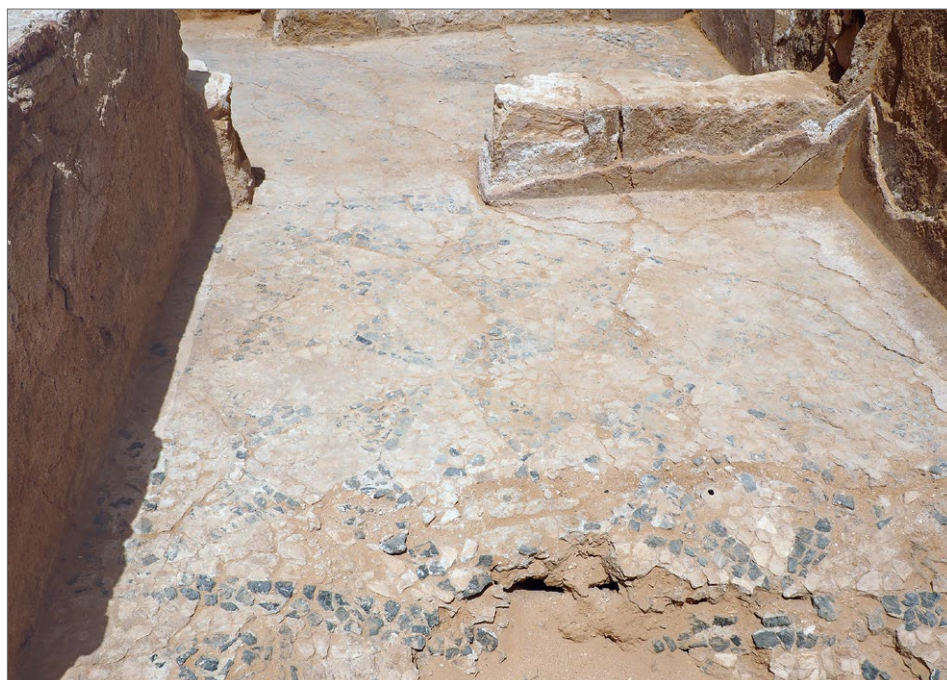
Fig. 1. Cracked walls and mosaic floor in the H.39 bathhouse, view from the east (PCMA UW | photo K. Jakubiak)

by Polish archaeologists excavating the site of Marina el-Alamein (Medeksza 2000; Daszewski 2002; Zych, Obluski, and Wicenciak 2008; I. Zych, personal communication). The recent season of the PCMA UW archaeological project at Marina el-Alamein, in October 2020, continuing the excavation of buildings from the 1st through 4th centuries AD in the northwestern part of the site, already close to the unpreserved harbor, has added some new earthquake-related evidence. Previously recognized traces take on the form of cracked wall substance and a badly damaged hypocaust chamber in the bath installed in House H.39. Effectively, seismic shock would have resulted in, first, a “squeezing” of the wall structure and then a release that

caused cracking as well as floor decomposition [Fig. 1; for the location of H.39 see Fig. 2]. Evidence of a similar nature is recognized in the ruins of nearby House H.1, located east of H.39. The crack noted in H.39 appears to have run east, damaging the southern part of House H.1. Indeed, the tension was such that the southern fragments of the building were displaced and moved about half a meter down toward the south [for the location of H.1 see Fig. 2 inset].

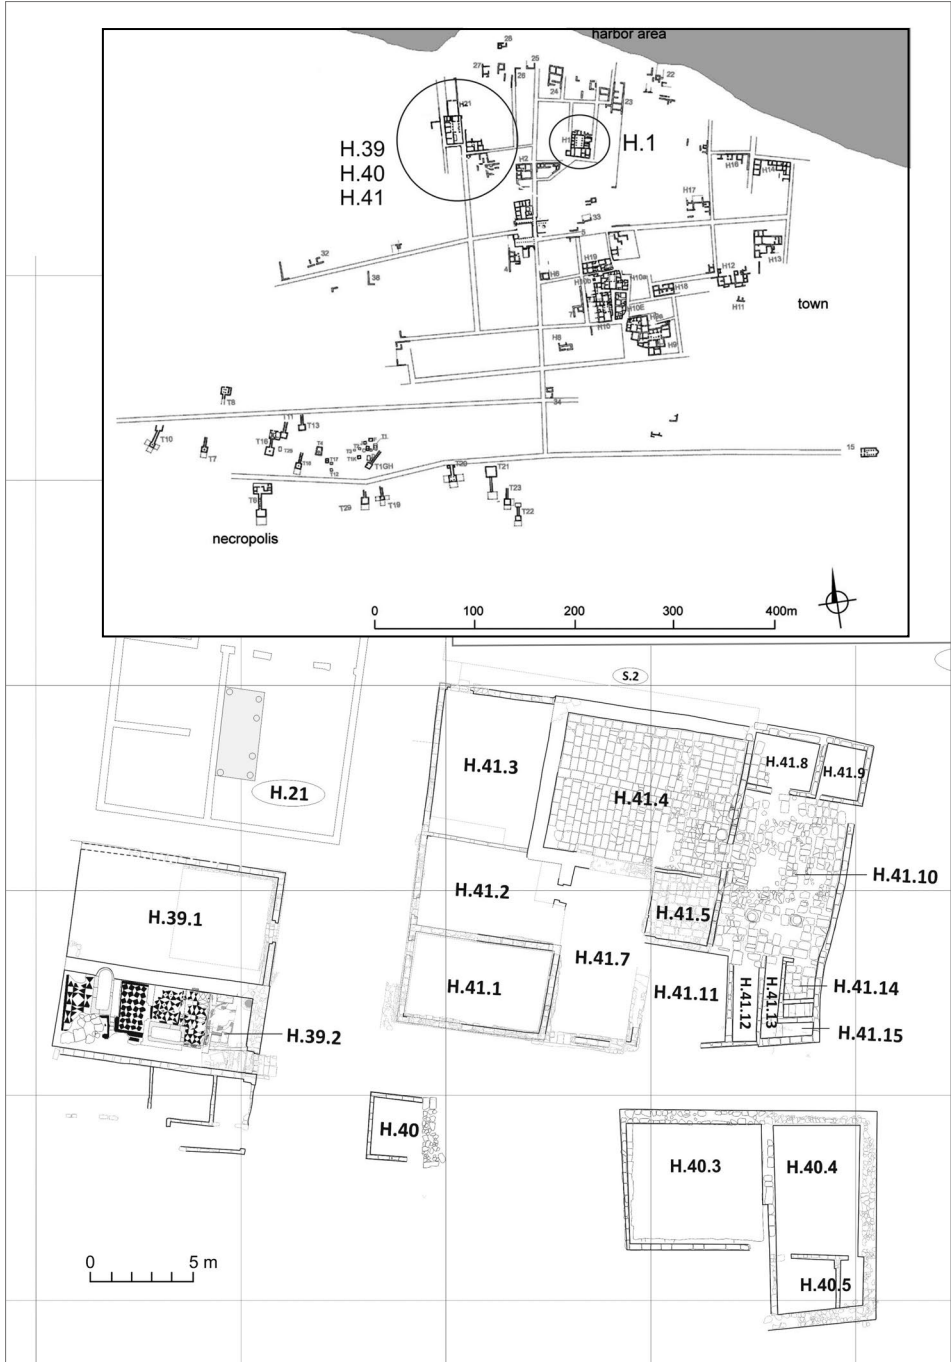
Fig. 2. Structures H.39 and H.40 in the northwestern part of the town; top, plan of the site of Marina el-Alamein, circled location of complexes discussed in the text (PCMA UW | drawing S. Maślak, M. Iskra; site plan after Czerter and Bąkowska-Czerter 2020: Fig. 1)

In 2020, the team explored the northern part of H.39, contextualizing the bathhouse discovered on this spot in earlier seasons (Jakubiak 2018; 2019). More work was done also on the ruins located south of H.41, that is, structure H.40 [see Fig. 2].

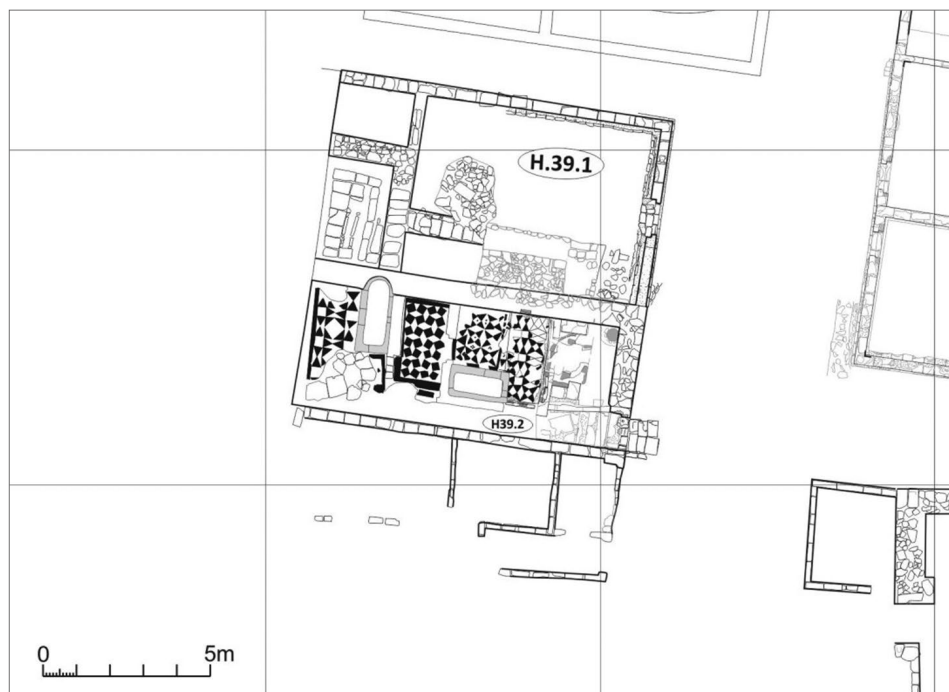
Fig. 3. Structure H.39 (PCMA UW | drawing S. Maślak, M. Iskra, O. Puzkarewicz)

The first structure built north of the bathhouse was a stone platform that was added against the north wall of the bath [Fig. 4]. The purpose of this platform is not clear. A deep latrine operated in conjunction with the bath in the western part of the building. It was contemporaneous with the platform, occupying a corner next to the north wall of the bathhouse, but not bonded with it. It was rectangular in plan, with seats and a channel system ensuring the supply of clean water on the one hand and the discharge of sewage on the other. The sewage channel ran east under the latrine wall and alongside the platform [Fig. 3]. A cistern, or rather a waste collector, was discovered in the central part of the excavated area

[see *Figs 3; 4*]. Compared to other water cisterns excavated throughout the town (e.g., H.1, H.21, H.40 in the northern and northwestern part, H.9 and H.10 in the southeastern part; see Daszewski 2011; Jakubiak 2016; Bąkowska-Czerner and Czerner 2019), the recently discovered structure is not as elaborate and well finished, but it resembles closely the water or waste collector from the next-door bathhouse. The localization of the two structures close to one another and their specific construction leads to the conclusion that they were part of a sewage system and had been used as collectors for waste water. It is also likely that the installations could have been part of a drainage system in the street or open space that lined the western façade of

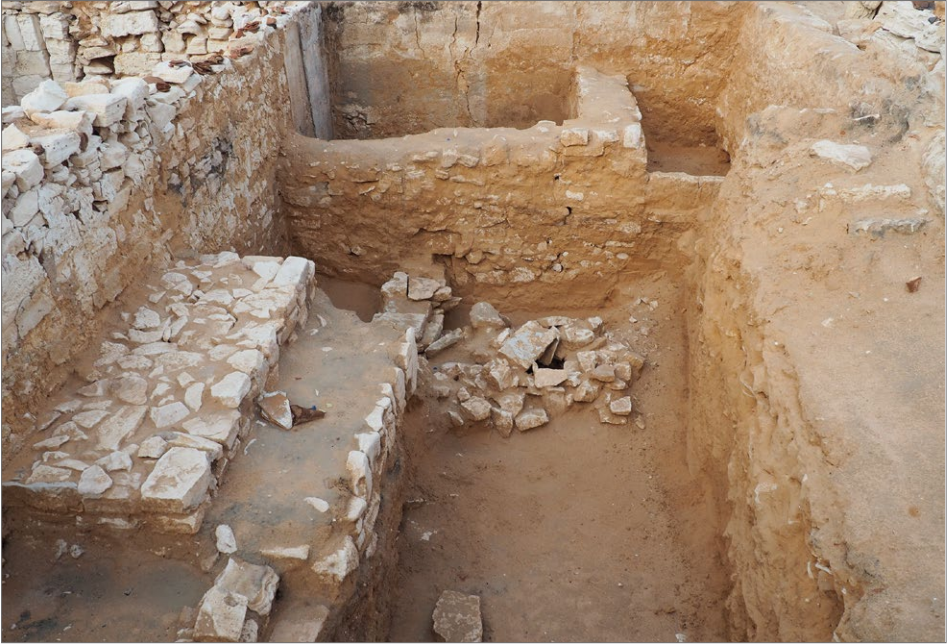
Fig. 4. H.39, northern part, viewed from the east (PCMA UW | photo O. Puzskarewicz)

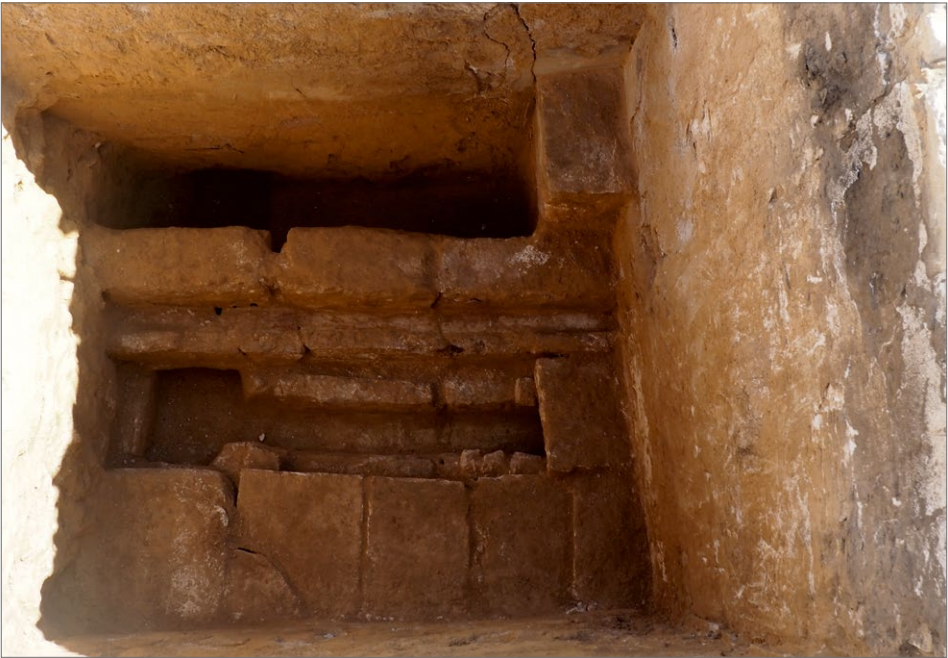
Fig. 5. Latrine in building H.39 (the bath facility is behind the wall on the right) (PCMA UW | photo O. Puzskarewicz)

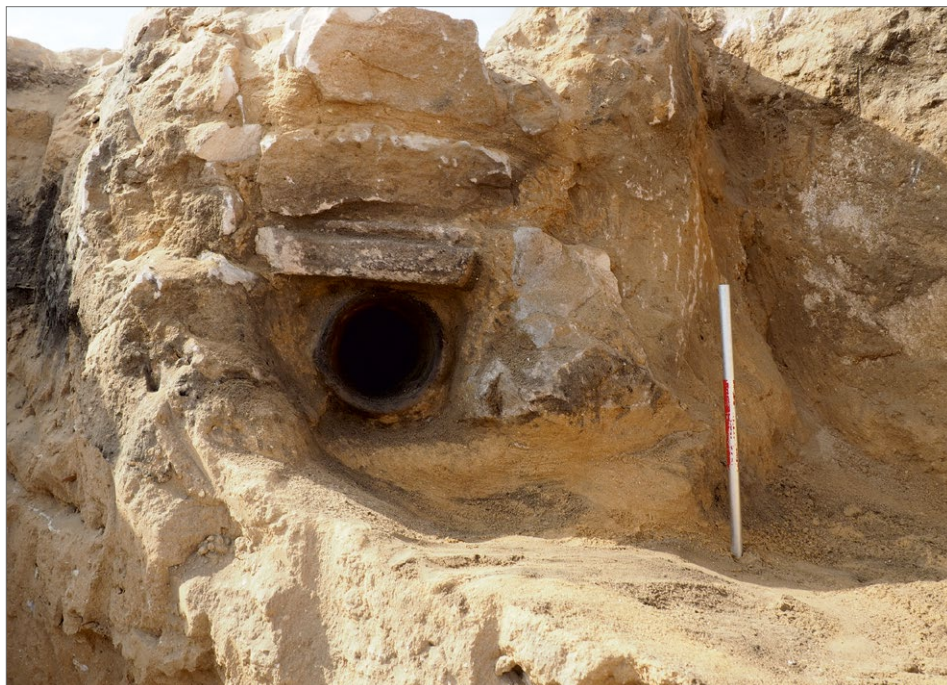
Fig. 6. *Tannur* situated in the southwestern corner of the northern unit in H.39, external view of the air hole (PCMA UW | photo O. Puszkarewicz)

The function of this enclosed space attached to the northern façade of the structure that had once been a bathhouse has not been established. A small oven (*tannur*) was located in the southwestern corner of the unit. It was constructed of sherds of a Dressel 7 type amphora made locally in the Mareotis region (Peacock and Williams 1991: 117–119) [Fig. 6].

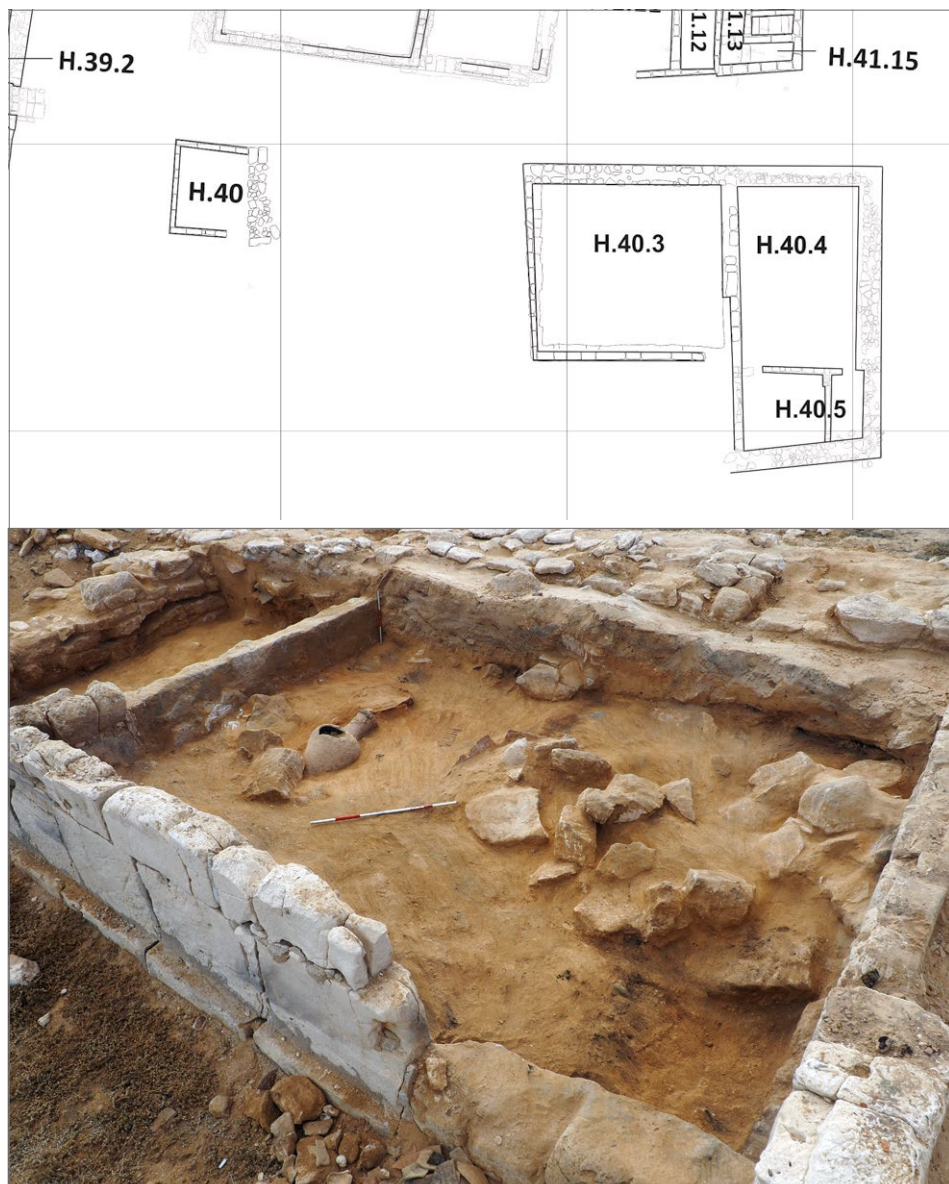
Fig. 7. Unit H.40.5, viewed from the northwest (PCMA UW | photo M. Iskra)

Southeast of the bath structure is a building, H.40, two rooms of which were partly cleared previously (Jakubiak 2018). A trench was now opened along the southern side of a street running in an east–west direction, uncovering three additional chambers [Fig. 7]. The chamber located in the southeastern corner of the building is rectangular in layout; it was used presumably as a latrine as attested by a partly preserved sewage canal discharging into a street passing

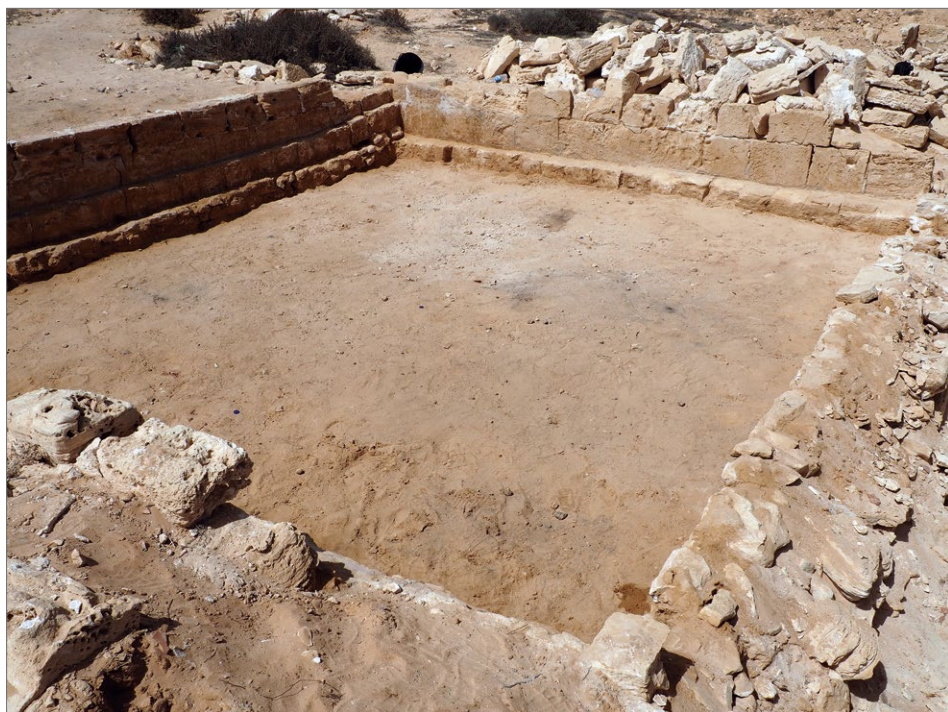
Fig. 9. Unit H.40.3, viewed from the northwest; note the solid ashlar bondwork of the walls in the background and the irregular stone masonry of the wall at right and bottom (PCMA UW | photo K. Jakubiak)

A detailed analysis of wall construction techniques contributes to the discussion of earthquake-related issues at Marina el-Alamein. Part of building H.40 was built of regular, almost standardized ashlar, the rest—at least at the foundation and substructure level—of irregular blocks of stone and boulders [Fig. 9]. The latter are of rather poor quality limestone and it cannot be excluded that they constitute waste from the dressing of stone blocks (which could have been partly quarried from the underground tombs in the necropolis south of the town; see Popławski 2021). Suffice it to say that pre-

cise building from such material is difficult at best. Moreover, an architectural analysis of the wall structure reveals two building phases, corresponding perhaps to the two occupational phases discussed above. A part of the building is constructed of regular ashlar and this part of the structure seems to be earlier in date than the rough walls of irregular stones. No interbonding has been noted between the ashlar walls and the rough-shod walls; the latter appear to have been attached to the better-built walls. Whether this is due to a time lapse between the two kinds of wall structure (with all the consequences for the building chronology) or some practical reasons, it is difficult to specu-

one is entitled to speculate that the case of H.40 illustrates the application of some kind of anti-seismic technical solutions. The combination of an ashlar bond with masonry walls of irregular stones could have been accidental to some extent (possibly reflecting different phases in town development), but it certainly made the structure more elastic, on the principle of expansion joints in construction. Furthermore, the voids between irregular stones in the wall structure acted effectively as shock absorbers, protecting the building against major damage. This had its consequences for wall thickness: the ashlar walls were thinner than the masonry ones, the latter being so wide at the base in order to provide a stable platform for the upper parts of the walls.
