# Two houses from the Third Intermediate Period settlement at Tell el-Retaba: a case study of activity-area analysis

**Abstract:** A Third Intermediate Period settlement continued to be excavated by a Polish–Slovak archaeological team working in Area 9 in Tell el-Retaba in 2019. Two houses, {1095} and {3111}, have been studied in detail, applying an activity-area analysis to determine the main occupation activities of the inhabitants in successive phases. The analysis is based on the archaeological assemblage recorded from these features, including small finds, pottery, and installations.

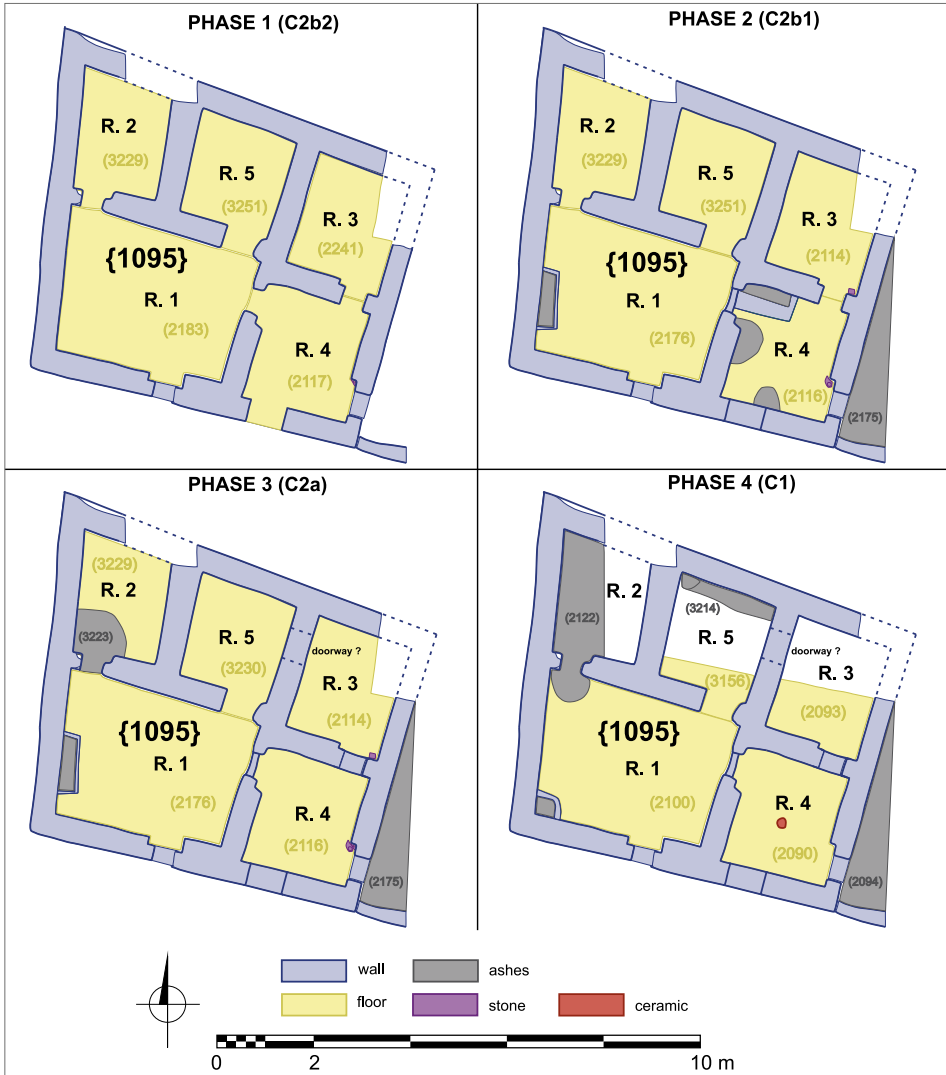
Fig. 1. The phasing of House {1095} (University of Warsaw Tell el-Retaba Project | drawing Ł. Jarmużek)

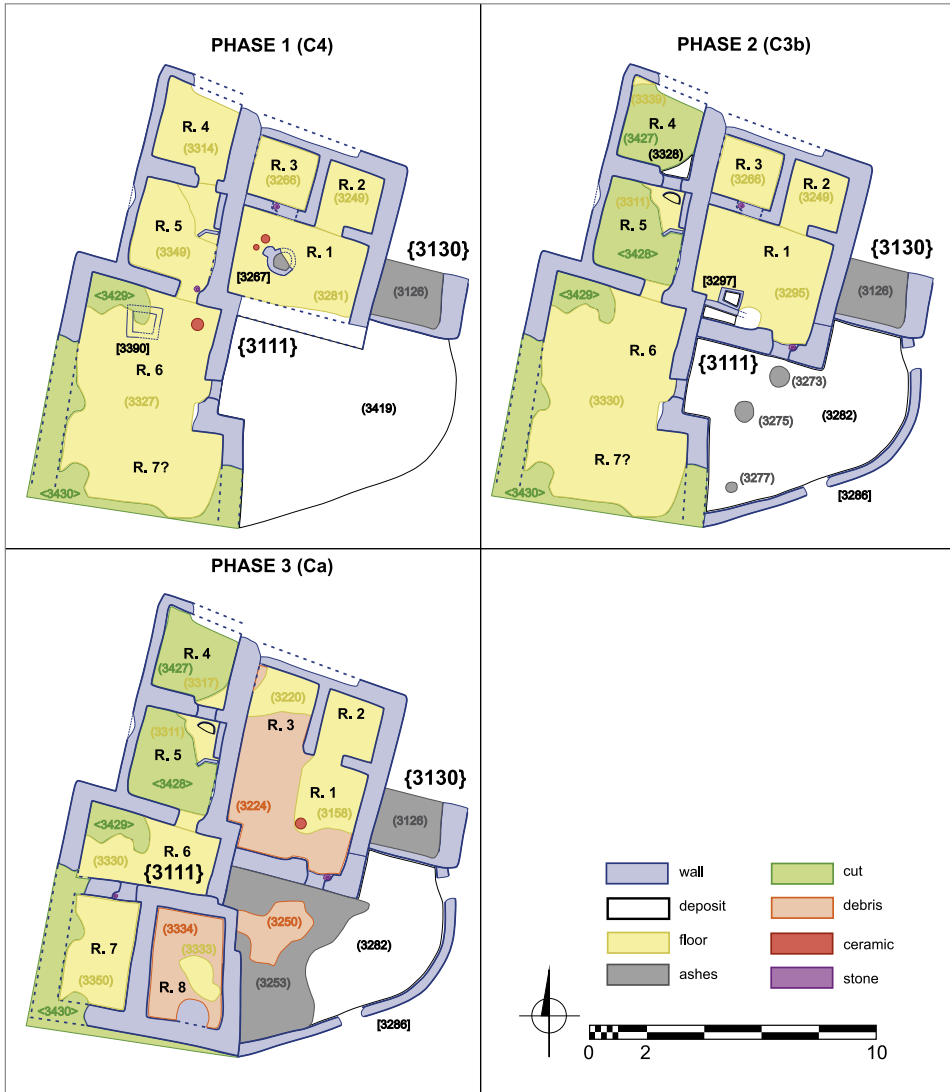
Fig. 3. The phasing of House {3111} (University of Warsaw Tell el-Retaba Project | drawing Ł. Jarmużek)

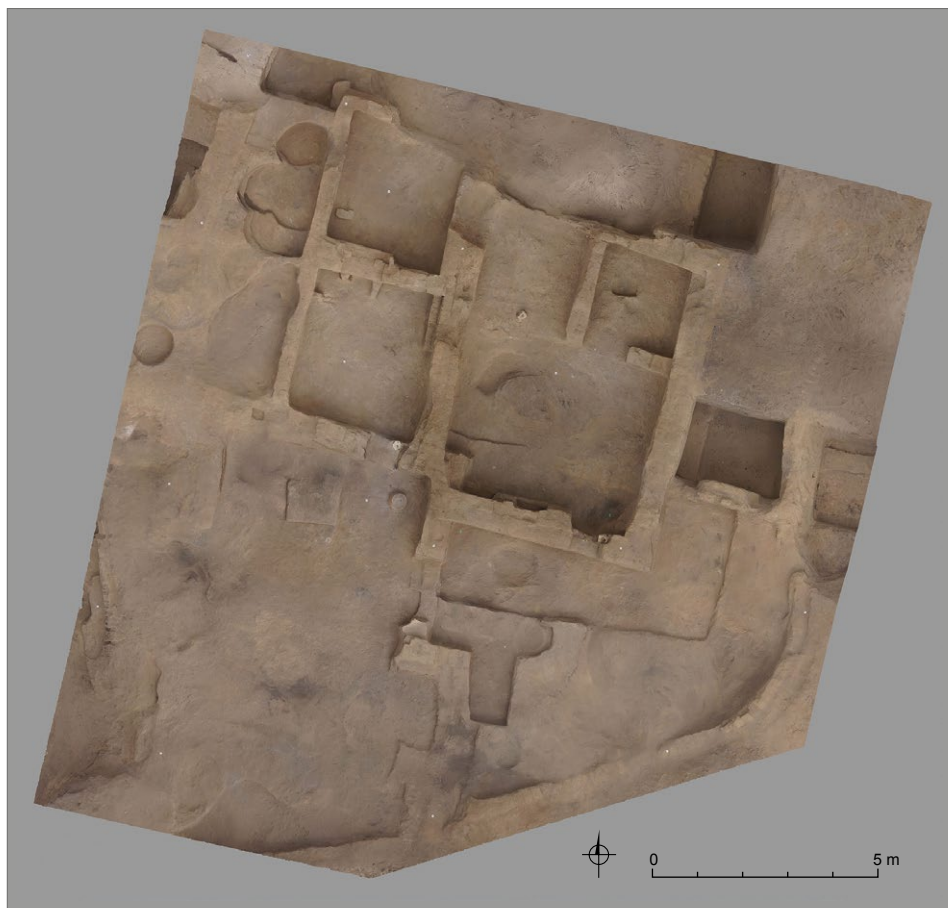
Fig. 4. House {3111} after exploration (University of Warsaw Tell el-Retaba Project | orthophoto Ł. Jarmużek)

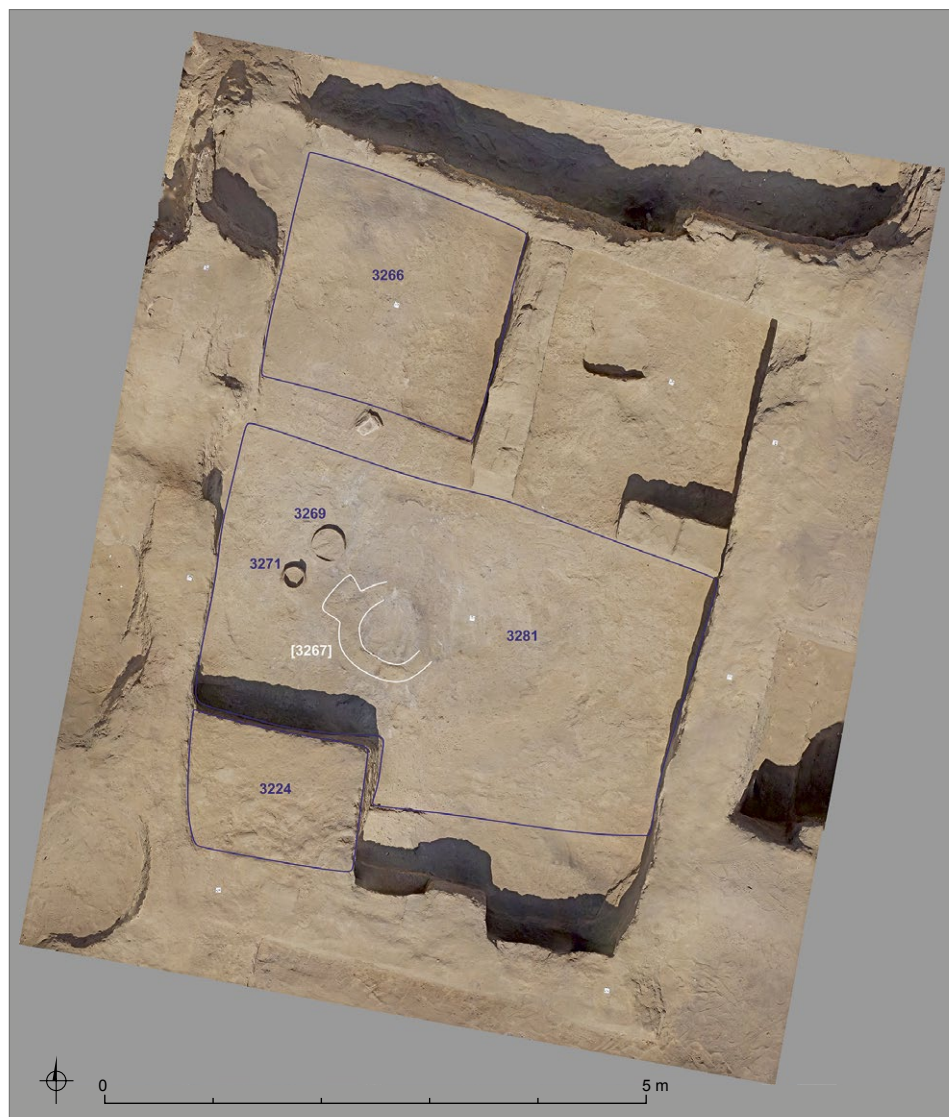
Fig. 5. House {3111}: Rooms 1, 2 and 3 from Phase 1 (University of Warsaw Tell el-Retaba Project | orthophoto Ł. Jarmużek)

A thin, whitish-grey floor (3281) was found in Room 1. A circular fireplace [3267] lined with mud bricks, situated

roughly in the middle of the room, was one of three features on the floor surface. At least one mud brick abutted the west wall of the fireplace, forming a small platform. The space between the walls was filled with a layer of ash (3268). Pottery vessels (3269, 3271), *in situ*, were found in two cir-

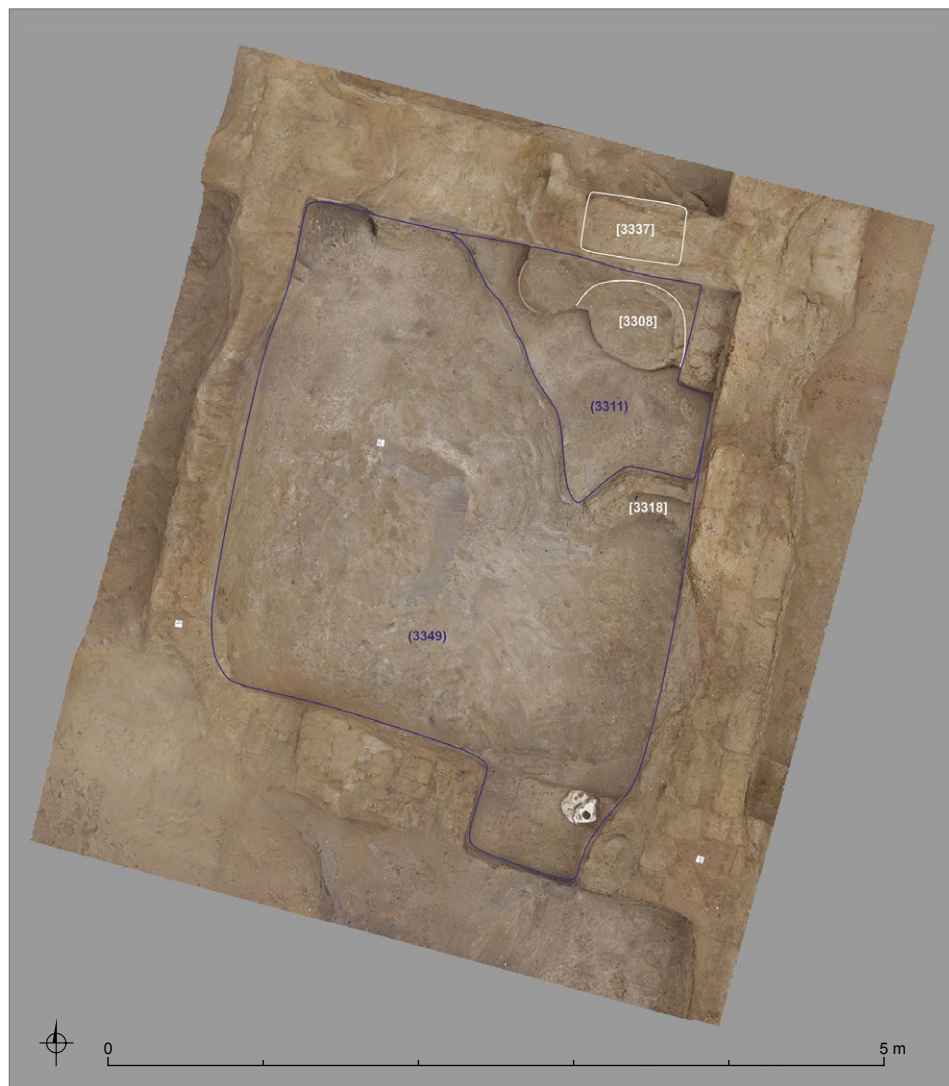
Fig. 6. House {3111}: Room 5 from phase 2 (University of Warsaw Tell el-Retaba Project | orthophoto Ł. Jarmużek)

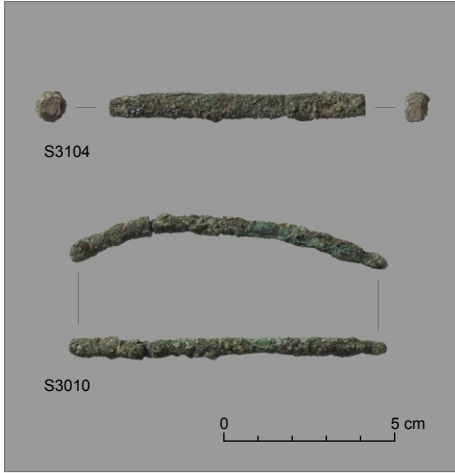
Fig. 12. Examples of needles from Room 1 in House {1095} (University of Warsaw Tell el-Retaba Project | photo S. Rzepka)

The distribution and number of objects connected with craftwork activities is also similar in all phases. Artifacts are connected mostly with spinning/weaving [Fig. 12]; they are attested particularly in Room 1. The possibility of cloth making in House {1095} is also confirmed by pottery finds (see below, § 4.1.3). However, no traces were found which could be related to weaving installations, such as a loom, for instance. The Craftwork category includes objects connected with abrasive/smoothing activities. It comprises whetstones, which can be connected with the production of bone or wooden objects

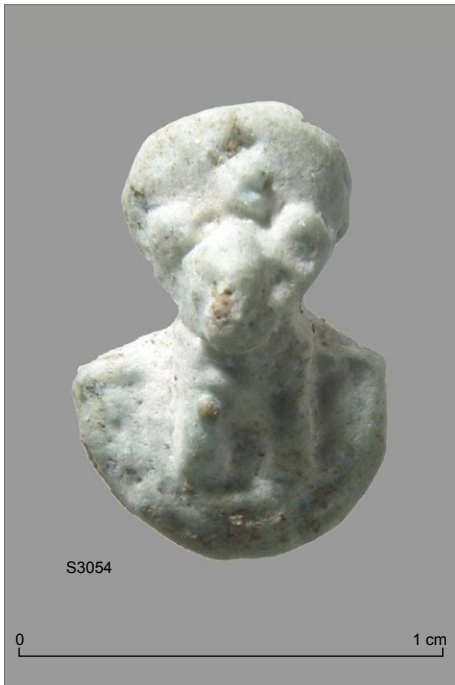
Fig. 13. Amulets from Room 1 in House {1095}: above, S3054 (University of Warsaw Tell el-Retaba Project | photos S. Rzepka)

Objects connected with religious activity were found only in Phase 1. These include three faience amulets from Room 1, one poorly preserved (S3046), but two in a complete state. One is in the form of a bust with the head of a lion- or cat-headed goddess, with the uraeus and sun disk (S3054) [Fig. 13 above]. The other is in the form of a standing figure of a cat-headed goddess (S3108) [Fig. 13 right]. The pendants represent most probably Bastet or Sakhmet (Andrews 1994: 33; Rzepka et al. 2017: 60).

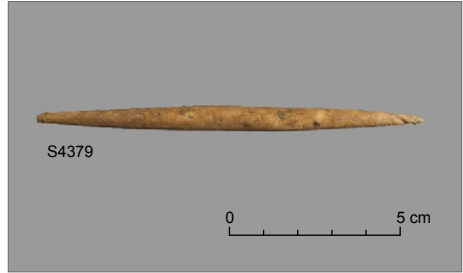
Fig. 14. Spinning tool from Room 6 in House {3111} (University of Warsaw Tell el-Retaba Project | photo M. Reklajtis)

and installations. It could have also been a small-scale production. Use-wear traces on the bone pin (S4379) from Phase 2 in Room 6 indicates either spinning activi-

ties, textile weaving or netting production [Fig. 14]. A relatively large number of net sinkers makes the latter idea more probable.

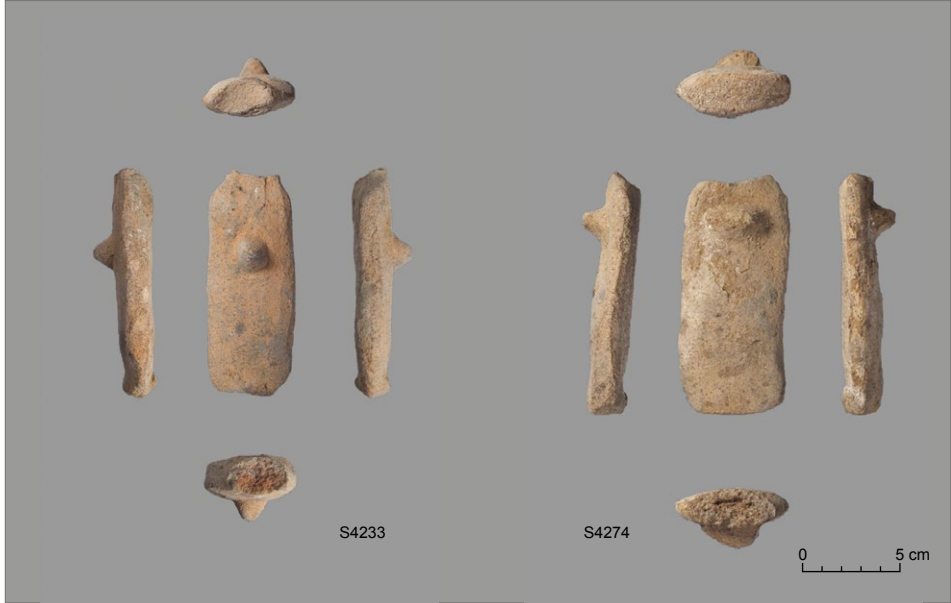
Fig. 15. Clay figurines from House {3111}: left, S4233, right, S4274 (University of Warsaw Tell el-Retaba Project | photos M. Reklajtis, processing A. Ryś)

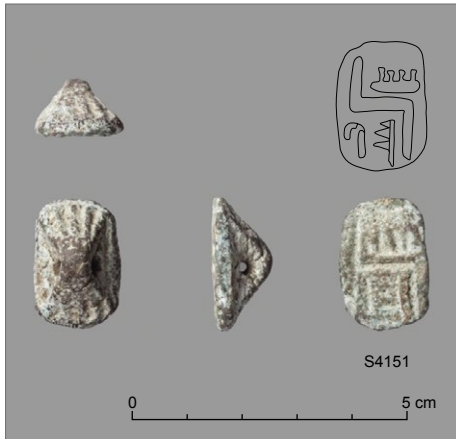
Fig. 16. Faience stamp seal S4151 from Room 1 in House {3111} (University of Warsaw Tell el-Retaba Project | photos, M. Reklajtis, processing A. Ryś, drawing P. Sójka)

Two inscribed objects from House {3111} can be assigned a protective function. The first one is a faience seal (S4151), found in Room 1 of Phase 1 [Fig. 16]. Its bundle-back handle is decorated with an indication of gathered lines. The inscription on the base is quite poorly executed and difficult to read. It may have contained the sign “*mn*”, while the vertical line to the left could be an “*i*”, and the horizontal line underneath could be an “*n*”; thus, the inscription would include the name of Amun. This type of small faience seal inscribed with a god’s name on the underside is also recognized as a protective amulet (Andrews 1999: 54, Fig. 55). The scarab (S4268) was found in Room 6, in a Phase 2 context [Fig. 17]. It is made of blue-glazed faience, has its base decorated with the name Menkheperre; the *kheper* sign is flanked by two *maat* feathers. It is a popular composition on scarabs from the time of the Eighteenth Dynasty to the Late Period, also imbued with protective powers (Andrews 1994: 55).
