# Conservation in Marina el-Alamein in 2017

## (Polish–Egyptian Conservation Mission)

**Abstract:** The conservation program of the Polish–Egyptian Conservation Mission in Marina el-Alamein in 2017 included restoration of wall structures and architectural decoration elements damaged as a result of unfavorable climate conditions (Houses H9/H9a and H21, Rooms 10 and 11 in the Roman baths). Wall paintings exposed to weather conditions *in situ* were treated as part of another conservation project. Minor metal finds were also treated using both chemical and mechanical means in order to identify the objects.

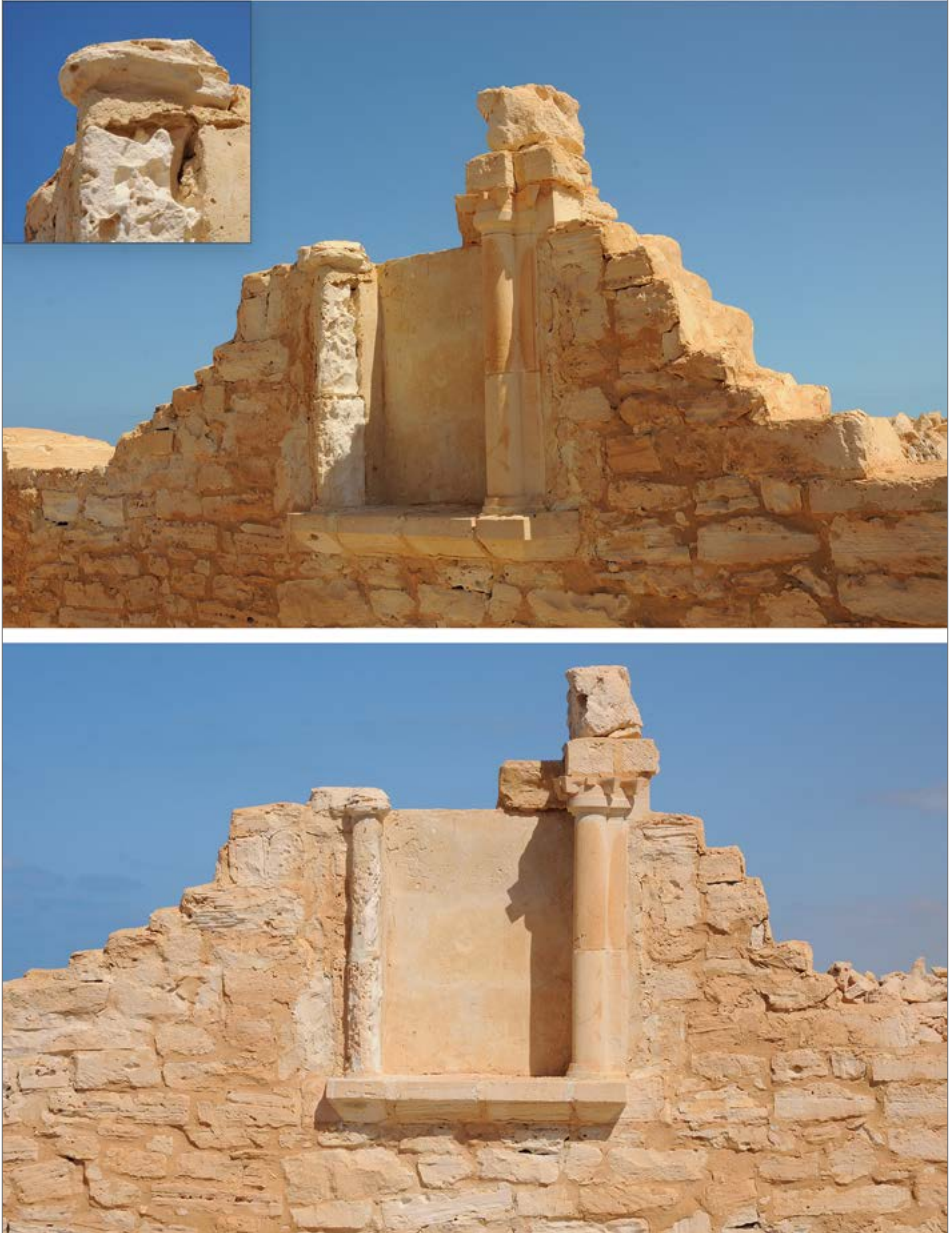
Fig. 1. Small aedicule in House H9: top, before conservation; inset, detail before conservation; bottom, after conservation (Polish–Egyptian Conservation Mission Marina el-Alamein/photos P. Zambrzycki)

In the 2017 season, joints were repaired in a small aedicule in House H9 [Fig. 1], capitals were remounted in the

The joints and losses of stone in the architectural elements in House H9 were filled with a mineral mortar: 3 parts sand to 1 part lime to 0.5 part cement. Mortar with relatively low durability was used, adjusted to the weakened structure of

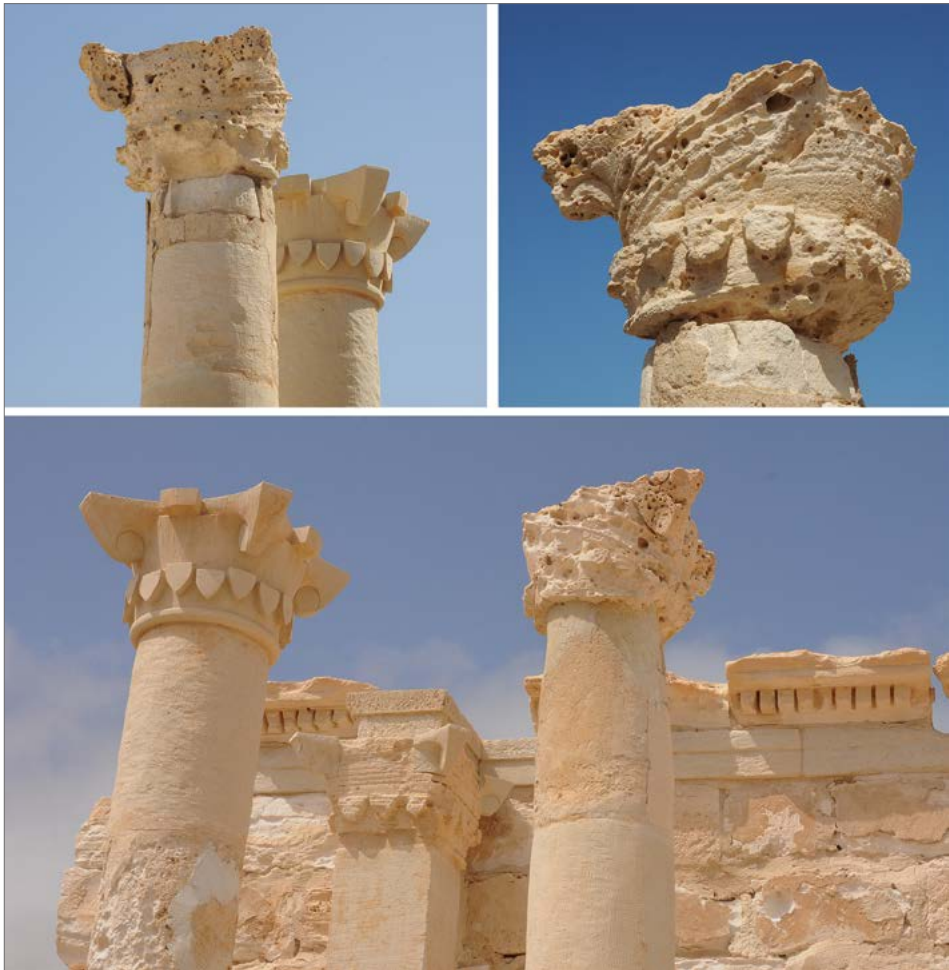
Fig. 2. Capitals of the commemorative monument in House H21: top row, before conservation; bottom, after conservation (Polish–Egyptian Conservation Mission Marina el-Alamein/photos P. Zambrzycki)

commemorative monument in House H21 [Fig. 2], and bands were introduced to protect the edges of ancient plaster in Rooms 10 and 11 of the Roman baths south of the main square [Fig. 3].

tural elements repaired in House H21, a stronger mortar was used, 3 parts sand to 1 part lime to 1 part cement, this in

view of the fact that the previous joint, being made of the weaker mortar, had been washed away, posing the danger

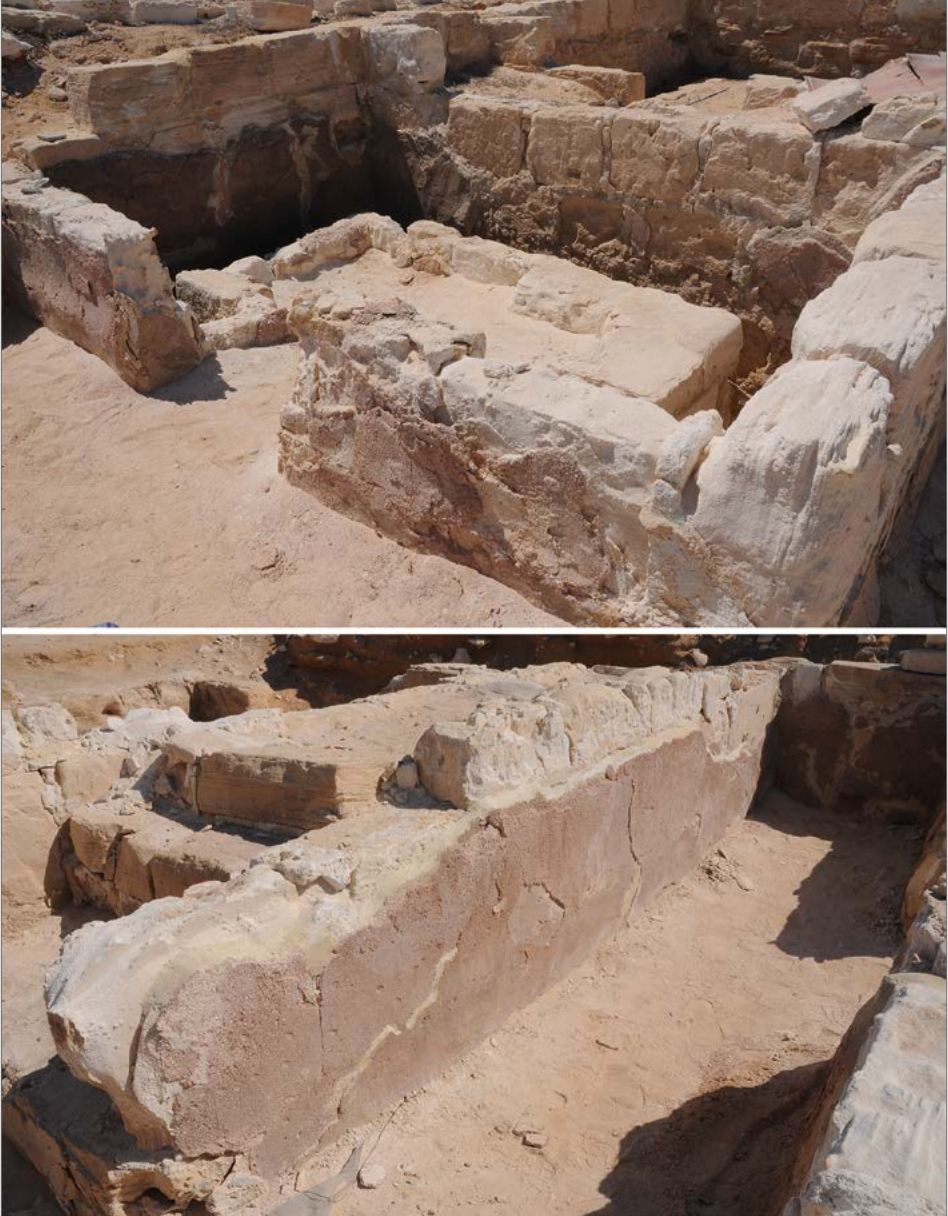
Fig. 3. Bands protecting ancient plaster edges in the Roman baths: top, before reconstruction; bottom, after reconstruction (Polish–Egyptian Conservation Mission Marina el-Alamein/ photos P. Zambrzycki)

the stone. The same mortar was used for the bands to protect the edges of plaster in the Roman baths. As for the architec-

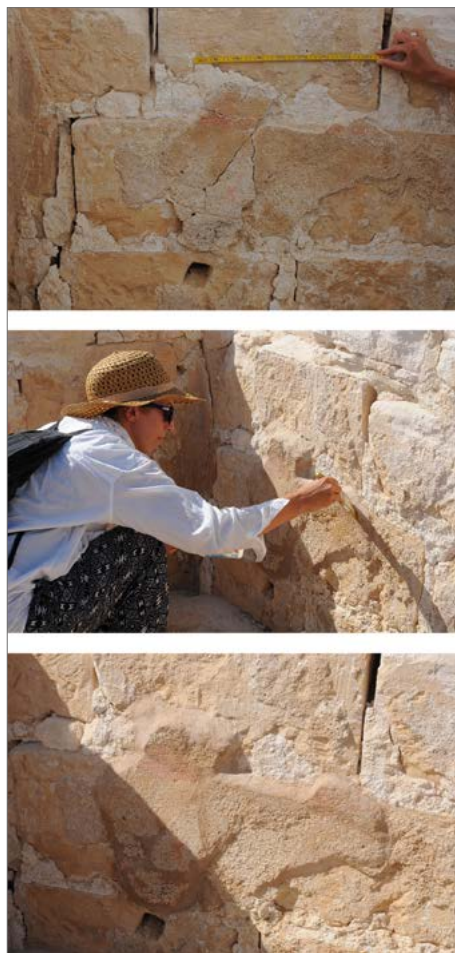
The painting, a fragment of which was discovered on the south wall of the room, decorated probably the whole interior. There was a dado in the bottom part, a frieze consisting of three colors above it, and presumably geometrized panels higher up. The preserved decoration is located a little above the floor level. The lowermost part is painted black, the upper part is in shades of red. The decoration was painted against the background of white plaster laid without any ground directly on the stone surface. The painting layer is characterized by good adhesion to the plaster with high cohesion and hardness. However, larger pockets are created in places where the edges of the plaster, impacted by strongly unfavorable climatic factors, are weakened and partly detached from the wall.

No evidence of salt precipitation was observed on the surface of the painting. The painting was cleaned of loose fragments of plaster and sand. Cracks were not deepened due to the high

Fig. 4. Relics of painting in Room 9 of the Roman baths: top, before conservation; middle, during the consolidation of paint layers; bottom, after conservation (Polish–Egyptian Conservation Mission Marina el-Alamein/ photos P. Zambrzycki)

Conservation of painted wall decoration, another regular team project, concerned painting discovered in Room 9 of the Roman baths. This was conservation of a salvage nature [Fig. 4], and it initiated research aiming to assess the odds of being able to preserve painted wall decoration *in situ*, exposed to the all-year weather conditions prevalent in Marina el-Alamein. The project will be implemented in coming seasons.

adhesion of the mortar to the ground. A lime–sand mortar with carefully chosen strength parameters was used for the bands and for filling cavities and larger cracks. This mortar was composed of lime, fine-grained sand, cement and a small amount of crushed brick sand, 1:3:0.5:0.08 parts respectively. To increase mortar flexibility, a 2% solution of Primal AC 33 in water was added (Chmielewski 2013: 206–207). The addition of crushed brick dust served to enhance the hydrophobic properties (making the mortar waterproof). The conserved surfaces were first moistened with water. A test was made on a part of the painting to see how reinforcing the painting layer with a 2% solution of Primal AC 33 in water, applied to the surface with a soft brush, would work (Jakubowski 2008: 130–131).
