# Ceramic building material from the Roman forts on the Colchis coast: archaeology and archaeoceramological analysis

**Abstract:** The article collects the modest evidence available on the use (and possible production) of ceramic building material by the Roman army in Colchis, using it as a backdrop for presenting the exceptional richness, in quantity as much as diversity, of the finds from Gonio/Apsaros. The signatures on these products add to the value of this assemblage. Part 1 of the article presents documented examples of stamps on bricks, roof tiles and ceramic pipes from the Gonio/Apsaros fort and links them to the construction projects of specific Roman army units in the Cappadocia province. The results of laboratory tests conducted on samples of ceramic products and raw clay from Gonio, presented in Part 2, distinguish between two reference groups for the production of which clay from near the fort was used. However, it has not been possible to indicate the specific deposits of such raw material used by the Roman army.

## PART 1. CERAMIC BUILDING MATERIAL FROM THE ROMAN FORTS IN COLCHIS: ARCHAEOLOGICAL DATA

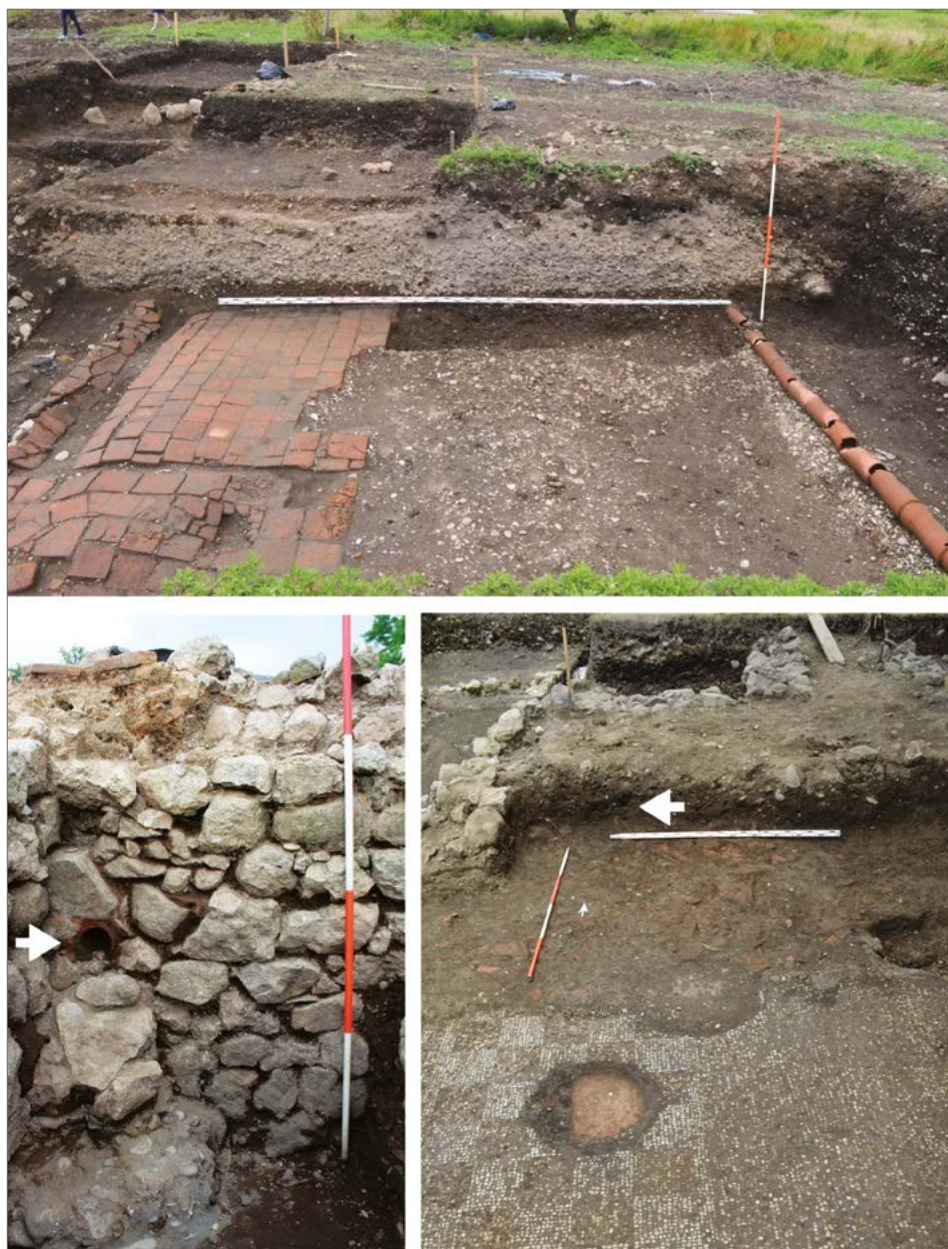
Fig. 5. Baths at Gonio: top, latrine floor (Phase 1) from east and water supply system consisting of ceramic pipes on the street north of the building (Phase 2); bottom left, northern edge of wall W2 viewed from the west, showing ceramic pipe for draining water from the *frigidarium* pool (Phase 1); bottom right, layer of broken roof tiles covering the mosaic floor from Phase 2, during exploration (Gonio/Apsaros Expedition/photos O. Kubrak, A. Trzop-Szczypiorska)

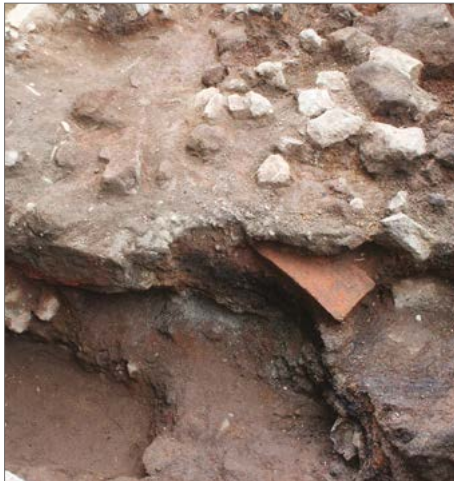
Fig. 6. Backfill of a bathhouse furnace (*praefurnium*) during exploration with a rectangular brick stuck in the layer (Gonio/Apsaros Expedition/ photo A. Trzop-Szczypiorska)

► Rectangular bricks. Only a few specimens have been found fully intact, excavated in the *thermae*. Their dimensions amount to 13–13.8 × 20–21 × 2.5–3 cm, and they come from Phase 2 bathhouse destruction layers (NO 11, Sq. 8). The dimensions of many fragmentary bricks, recognized by their proportions as rectangular, could not be reconstructed. A few broken specimens were found in the ruins of the furnace (*praefurnium*) and in the neighboring hypocaust basement (NO 11, Sqs 36–37). Based on the context, it can be concluded that they had been used to build the hypocaust system in Phase 2 [Fig. 6].

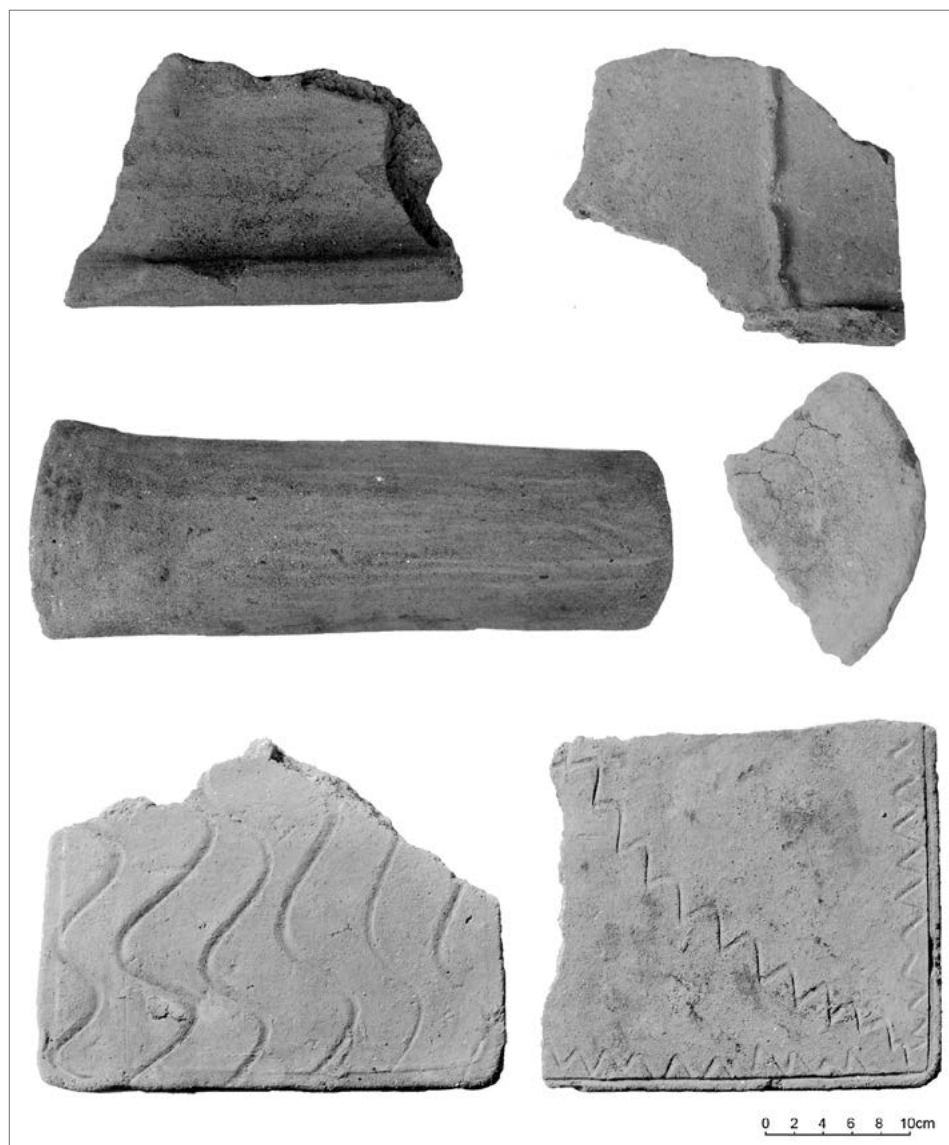
Fig. 7. Examples of fragmentary roof tiles from the bathhouse in Gonio/Apsaros: top row, flat roof tiles (*tegulae*), prominent "ribbing" on the surface of the tile on the right; center left, semicircular roof tile (*imbrex*); center right, round ceramic tile; bottom row, ornamental ceramic tiles (Gonio/Apsaros Expedition/photos O. Kubrak)

► Semicircular roof tiles (*imbrices*). One specimen, preserved intact, came from the ruins of the bathhouse; it was 46 cm long [Fig. 7 center left]. Its surface was decorated with elongated depressions

made by running fingers along the still wet clay surface. Similar traces could be observed on fragments of other specimens of this type.

► Round tiles. Recorded examples were about 27 cm in diameter and 4.5–4.9 cm thick [Fig. 7 center right]. They came from secondary contexts inside the bathhouse and in one case, from a layer preceding the reconstruction of the *thermae*. In the latter case, it may have been part of a pillar (*pilae*) in the hypocaust cellar of Phase 1. However, the only hypocaust examined so far, situat-
