# Dismantling, relocation, and reconstruction of the internal rooms of the Lower Anubis Shrine in the Temple of Hatshepsut at Deir el-Bahari

**Keywords:** Anubis Shrine, non-standard wall constructions, temple expansion, room relocation, reused wall blocks

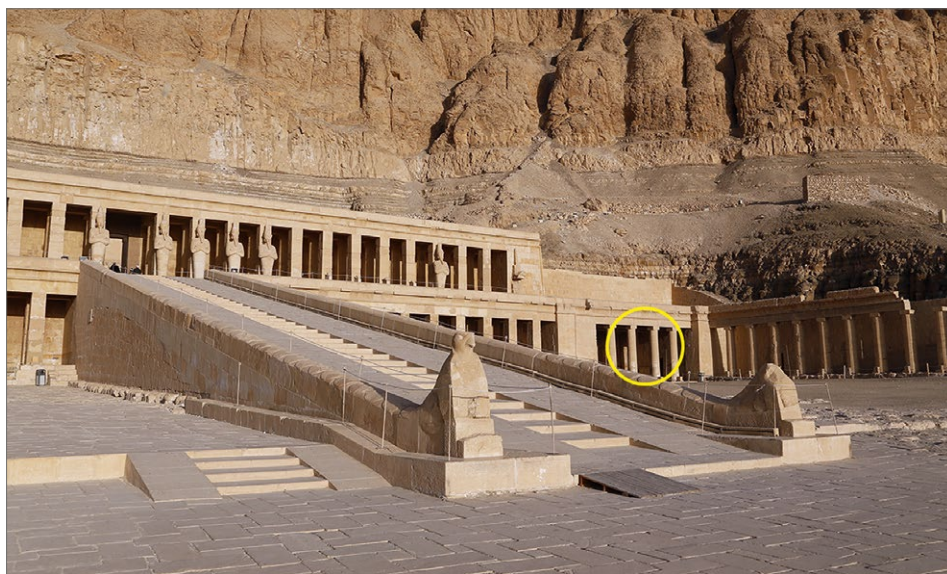
Fig. 1. Location of the Lower Anubis Shrine in the northern part of the Middle Terrace (Photo M. Jawornicki; processing A. Kwaśnica)

The Lower Anubis Shrine is located on the northern edge of the Middle Terrace of the temple. As it stands today, it consists of four rooms: the Hypostyle Hall, Vestibule, Sanctuary, and Niche [*Figs 1, 2*].

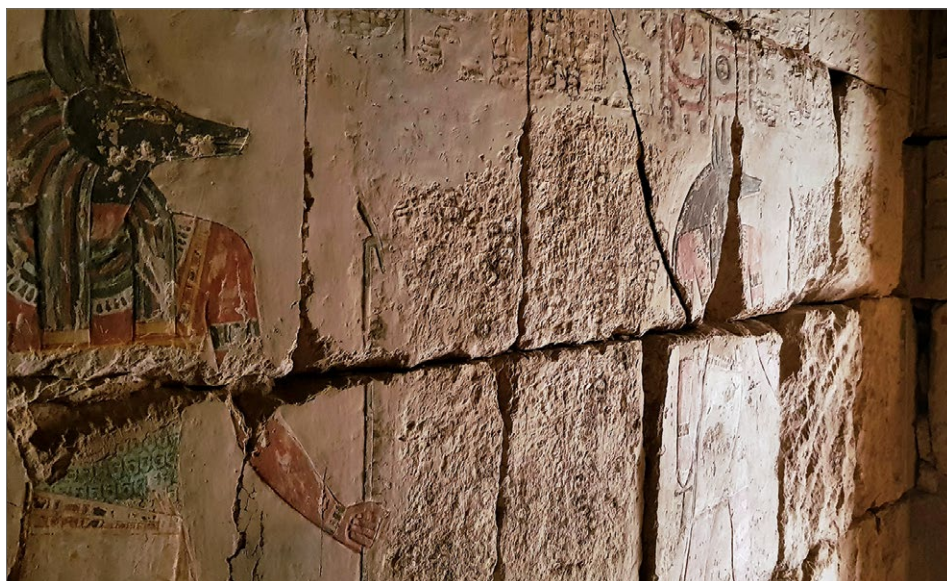
Fig. 4. The eastern wall of the Sanctuary. The wall blocks lack sharp edges, with large gaps at their joints (Photo A. Kwaśnica)

The polychrome reliefs are crisscrossed with cracks and gaps at nearly every joint between the wall blocks [Fig. 4].

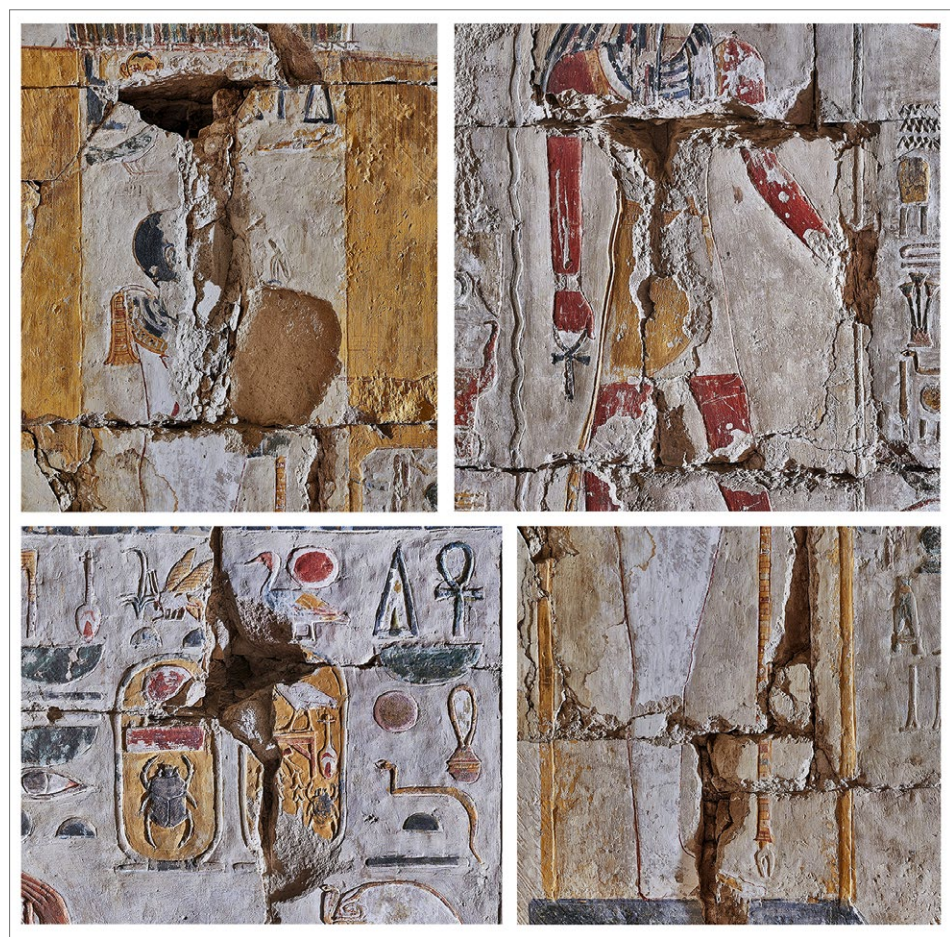
Fig. 5. Eastern wall of the Sanctuary. The large gaps between blocks are filled with crushed stone covered with polychrome plaster (PCMA UW | photo M. Jawornicki)

the wall blocks, and in many places the blocks do not align properly, leaving empty spaces between them. Now that most of the masking plaster has fallen off, the poor condition of the decorated block edges is clearly visible. It gives the impression that the wall blocks were installed without adjusting their side surfaces, and the gaps between them were filled afterward.

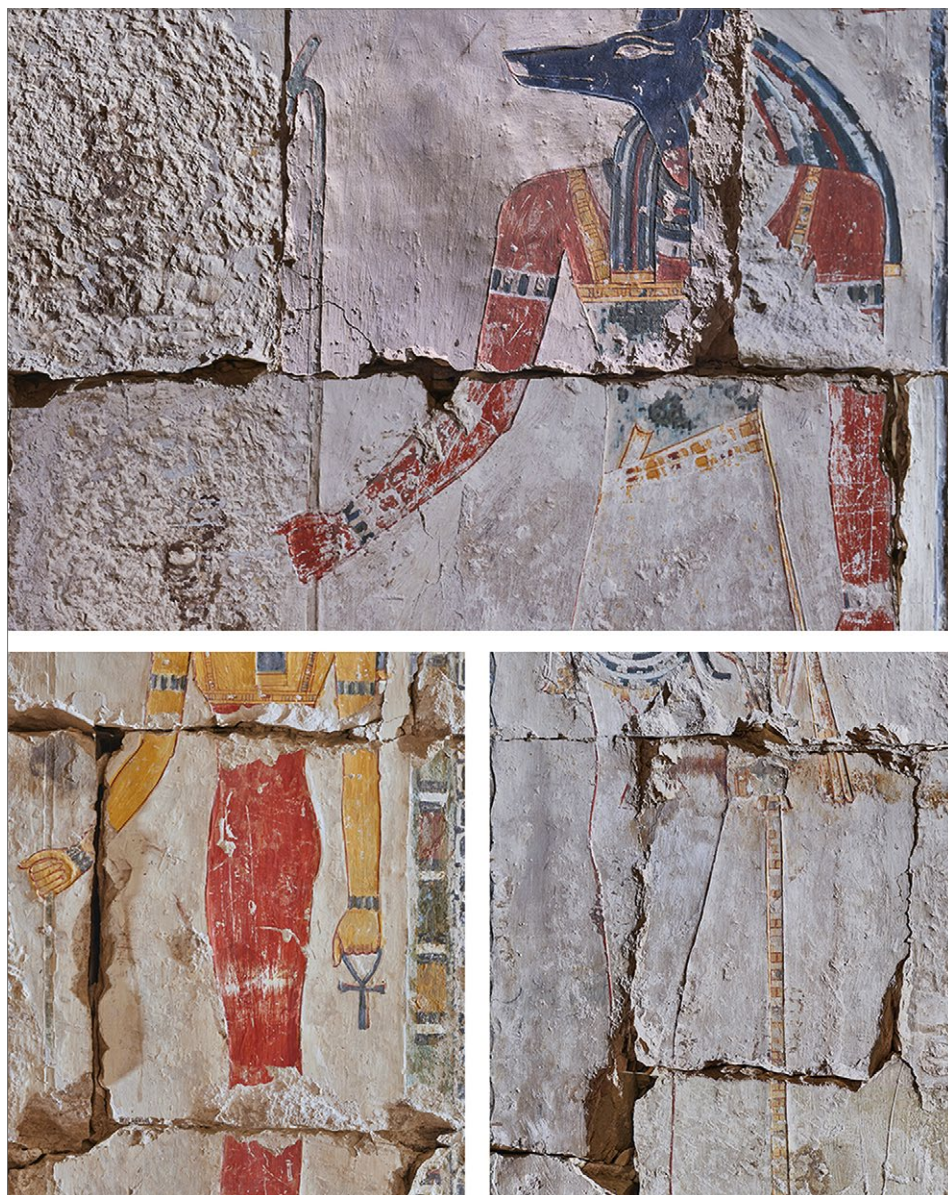
Fig. 8. Wall fragments of the Sanctuary. Marks show where rods (wedges) were inserted between blocks to pry them apart during dismantling. The rods acted as levers, damaging the edges of adjacent blocks (PCMA UW | photo M. Jawornicki)

Traces of the dismantling of the Sanctuary and Niche are preserved on nearly every block, revealing the technique used to disassemble both structures. The blocks were pried apart using crowbars (rods), and wooden wedges were likely driven into the gaps between them [Fig. 8]. This process caused damage not

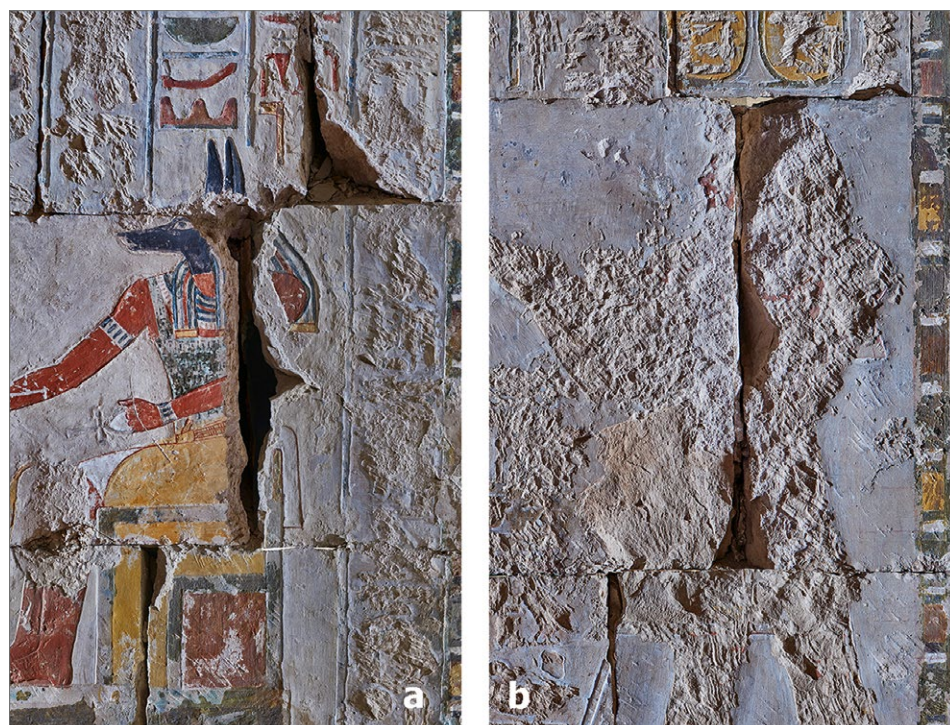
Fig. 10. Damaged walls during dismantling of the Niche: a) southern wall, b) northern wall. Damage on both walls was caused by prying the blocks apart with rods during the wall's disassembly. The marks show they were shifted sideways (to the left) using three rods simultaneously at the top, bottom, and middle. The central lever pressure caused severe damage to the blocks on the right side (PCMA UW | Photo M. Jawornicki)

The dismantling technique can also be observed in the Niche. Based on the damage, it is possible to reconstruct how the blocks were shifted sideways [Fig. 10]. a rod was placed at mid-height

of a block and used as a lever, which simultaneously caused damage to the adjacent block.

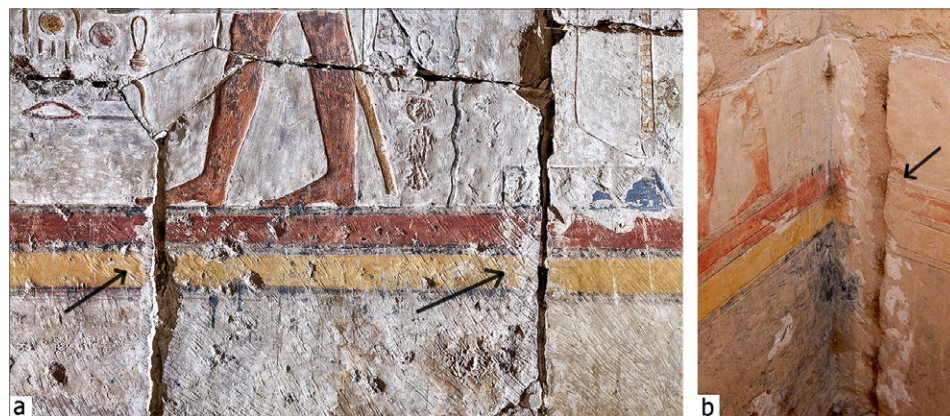
Fig. 12. The outer face of each block was shaved, including the decoration, to align the exterior surfaces of neighboring blocks after reassembly. This method was used in the Sanctuary (a) and in niches transferred to the Vestibule of the Chapel of Hatshepsut (b) (a: PCMA UW | photo M. Jawor-nicki; b: photo and processing A. Kwaśnica)

Other imperfections in the reassembly of the rooms are also visible. On the eastern wall of the Sanctuary, not all blocks formed a flat surface after being repositioned. To compensate, the protruding edge of a block was trimmed, which simultaneously damaged the decoration [Fig. 12]. a similar practice is known from another part of the temple: when the decorated niches were

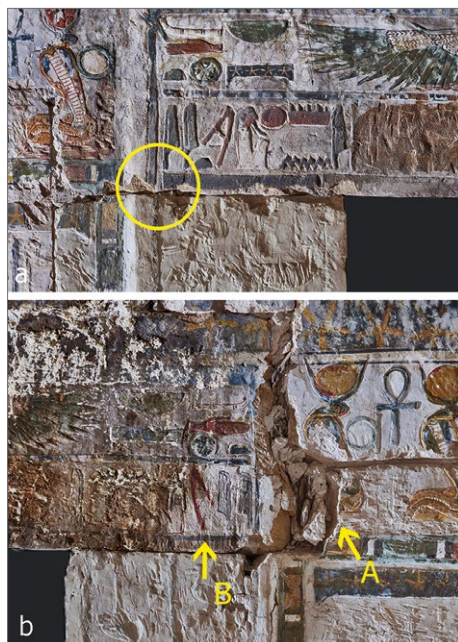
Fig. 14. a) Detail 1. Lintel of the portal in the western wall of the Sanctuary. Note, that the vertical strip does not align properly with the jamb. This part of the lintel preserves original decoration from the time of Hatshepsut. The cobra, the wing of the goddess, texts, and the bands are rendered consistently. The decoration differs on the opposite side of the portal (PCMA UW | photo M. Jawornicki, processing A. Kwaśnica); b) Detail 2. Right side of the portal lintel. The quality of the relief is markedly lower, as it was carved on a previously chipped surface. The most intriguing feature is the connection of the lintel block with the wall. To insert the lintel, a portion of decorated limestone blocks had to be cut out. A – filler material used to compensate for the mismatched edges between the lintel and wall, consisting of limestone rubble and mortar (no longer preserved). B – absence of the *pet* sign; text is only partially painted and lacks relief (Photo M. Jawornicki, graphic A. Kwaśnica)

This is confirmed by several inconsistencies in the lintel's decoration. The vertical bands do not align with their continuations on the jamb blocks below, on either side of the portal [Fig. 14:a]. Additionally, some of the hieroglyphs on the lintel are only painted, whereas the texts on the limestone walls were carved in raised relief. Furthermore, the *pet* band is missing from the lower right side of the lintel, although it is present in the symmetrical position on the left [Fig. 14:b].

The missing plaster on the right side of the lintel reveals how it was installed. The sandstone block was not evenly cut, resulting in an uneven surface. It was not well-fitted to the existing wall blocks, so to position it correctly, the decorated limestone block had to be trimmed. This was very roughly done, and the resulting gap was filled with limestone rubble and plastered over [Fig. 14]. This disrupted the wall decoration, which was likely recreated on the plaster.

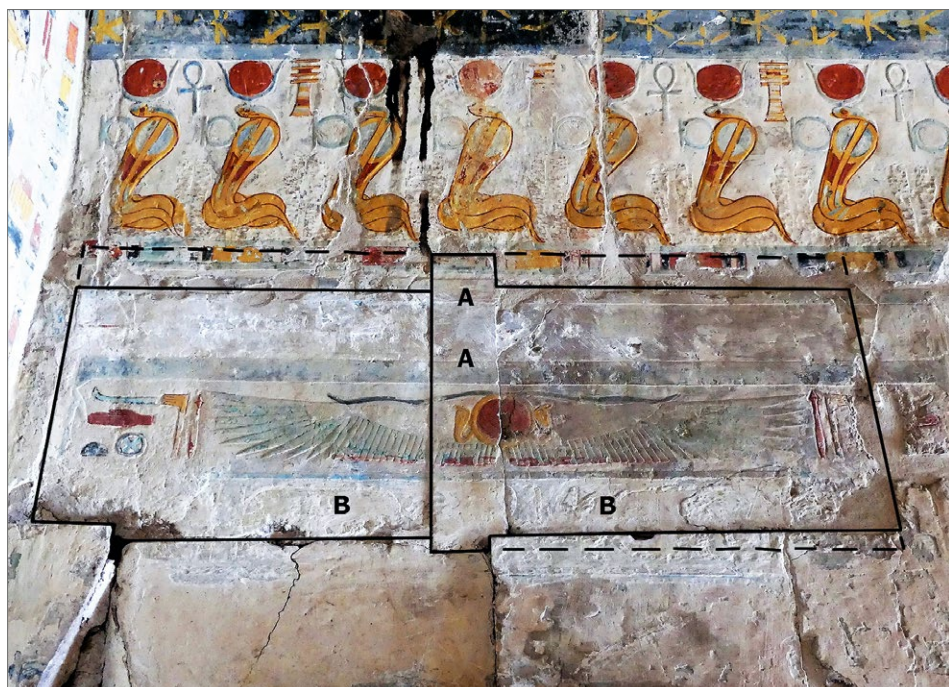
Fig. 18. Lintel of the portal leading to the Sanctuary. Two reused decorated blocks inserted into the wall. Dashed lines indicate the original block shapes. A – indicates *pet* stripes; two *pet* stripes with a gap between them form a decorative element not seen elsewhere in the temple. Originally, this must have been the lower level of the scene above. B – indicates remnants of hieroglyphic text added after the decoration above (Photo and graphic A. Kwaśnica)

Further deviations from traditional building methods can be observed in the portal leading from the Vestibule to the Sanctuary. The portal does not have a traditional lintel in the form of a single large block resting on the jambs. Instead, it consists of two layers of individual blocks meeting above the entrance [see Fig. 17:b]. These two lintel layers form a construction method not seen elsewhere in Egyptian architecture. The irregular shapes of the lower layer of lintel blocks resulted from the need to compensate for the incline of the construction ramp [see Fig. 17:b]. The second lintel layer consists of three blocks, with the central block presenting a complete contradiction to the standard lintel construction. This narrow, central block is much taller than the two side blocks, cutting into both the layer below and the layer above — a clear construction anomaly [Figs 17:b, 18]. Traditional construction principles would call for a single large stone beam over the entrance, especially since the jambs are only 0.70 m apart.

The large block in the lower layer of the northern wall of the Vestibule is a remnant of the previously existing wall. It was used as a stable component of the ramp required to rebuild the Sanctuary and Niche. The construction work carried out here is characterized by extremely poor quality and a failure to adhere to traditional Egyptian construction standards. This is confirmed by the design of the lintel, which completely deviates from the norms used in portal construction.
