Research and conservation work on the Northern Colonnade at the Temple of Hatshepsut at Deir el-Bahari

Abstract: This article is a summary presentation of the meticulous research, conservation, and construction efforts undertaken on the Northern Colonnade on the Middle Terrace of the Temple of Hatshepsut. Over the past 150 years, the Temple's archaeological and conservation missions have contributed invaluable research, enriching our understanding of its historical context. A significant portion of this work, often overlooked, remains unpublished and is only documented in field notes or typescripts, the sole testament to the thoroughness and dedication of these endeavors. This article draws on these unpublished reports, as well as on the results of the authors' own fieldwork focused on the analysis of the construction techniques of the Northern Colonnade and the state of preservation of this part of the Temple.

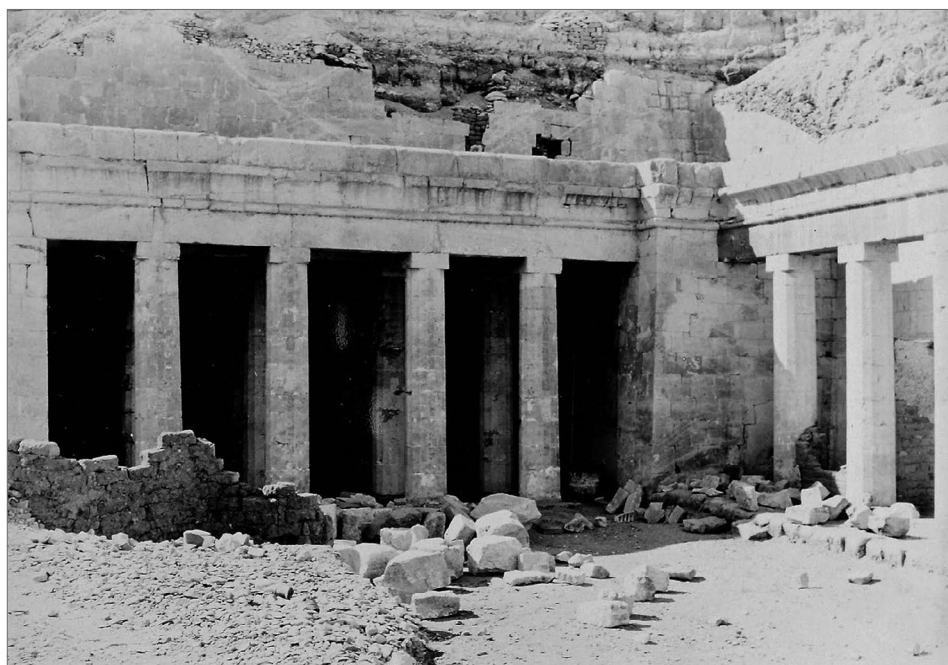
Fig. 6. Middle Terrace, view of the Anubis Chapel Vestibule and a section of the Northern Colonnade with visible remains of brick structures (Egypt Exploration Society DB-HAT.NEG.C.27 <https://www.flickr.com/photos/egyptexplorationsociety/albums/72157661494672977/with/38099658095>) (Accessed 20.01.2025)

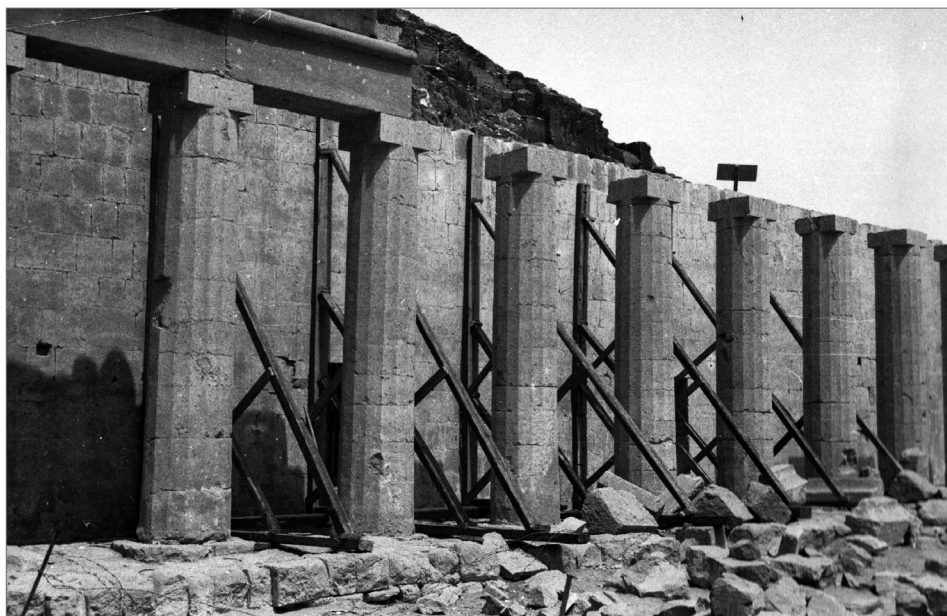
Fig. 7. Northern Colonnade, *ad hoc* timber scaffolding supporting the leaning wall (After Wysocki 1987: Fig. 9)

the wall was supported by a wooden scaffolding at the point of the largest bulge [Fig. 7]. Analyses conducted to determine the causes of the displacement and devise protective measures revealed that the bulging of the wall resulted from the weathering of the surrounding Esna slate (clay rock). Centuries of exposure led to weathering and expansion of the rock slope, causing the stone wall structure to shift. The blocks of the wall were bonded with a small amount of weak lime-gypsum mortar. Considering the historical authenticity of the leaning wall and the exceptionally good state of preservation

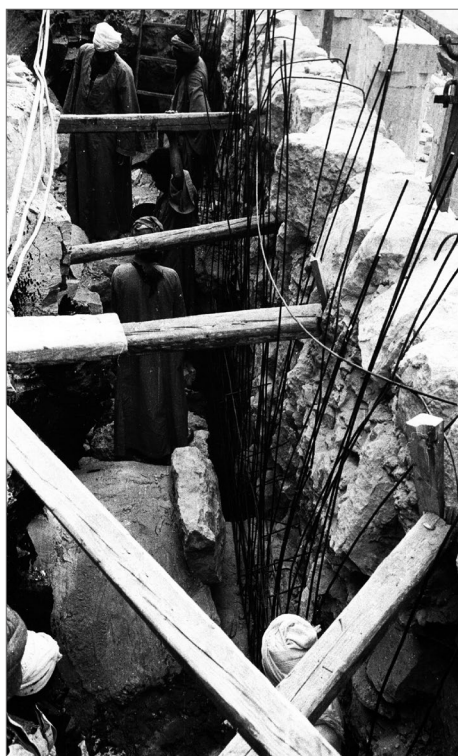
Fig. 9. Construction work behind the Northern Colonnade wall, installation of the reinforced concrete faceplate (Bielenia 1988: Fig. 5)

Work on Trench 3 followed similar methods to those used in the earlier trenches excavated during the same season. The trench was excavated to a depth of 5.6 m, and a test pit beneath the original wall revealed its shallow foundation at a depth of 0.25 m. After cleaning the excavated surface, the exposed rock was waterproofed using liquid bitumen applied in three successive layers. Once the waterproofing had dried, the faceplate-reinforced concrete structure was installed at the back of the ancient wall [Fig. 9].

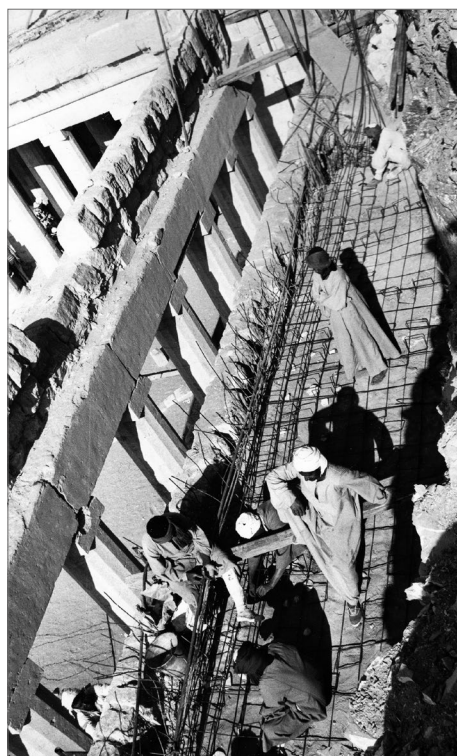
Fig. 10. Construction work installing the horizontal reinforced concrete slab at the back of the north wall of the Middle Terrace portico (Połozanin 1988: Fig. 8)

above the slab was filled with stone chips in cement mortar, and another reinforced concrete slab was installed as capping [Fig. 10]. It extended 0.4 m below the top of the ancient wall and was shaped like a trough.
