The archaeological and architectural context of the mosaic floor in the Roman fort of Apsaros (Gonio, Georgia)

Abstract: Since 2012, a joint Polish-Georgian expedition has been conducting research at the Roman Fort of Apsaros (Gonio, Georgia). The most important discovery made during this project is a mosaic floor decorated with geometric motifs. The room with the mosaic is part of an architectural complex dating to the second half of the 1st century and first half of the 2nd century AD. During this period, the building underwent changes in both form and function. Initially, it served as a granary. Later, a garrison bathhouse was erected on the same site. The final reconstruction resulted in a residence that included, among other features, private baths and an atrium. The floors of at least two rooms were decorated with mosaics. The residence is dated to the reign of Hadrian, and its construction may have been linked to the stay at Apsaros of Flavius Arrianus, governor of the province of Cappadocia.

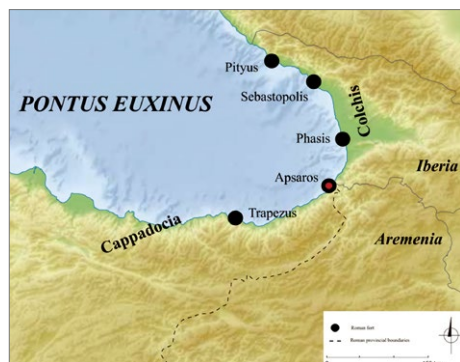
Fig. 1. Territories around the Black Sea showing the location of Apsaros and other forts (1st–3rd century AD) (Drawing N. Lockley)

The first to mention the fort at Apsaros [Fig. 1] is Pliny the Elder (Plin. *HN* 6.12.4 and 6.13.11). Besides this fort on the coast of Colchis, he also mentioned the fort at Sebastopolis. These same two forts are marked on the eastern coast of Pontus on the *Tabula Peutingeriana*. Thus, ancient sources confirm the Roman military presence at the mouth of the Chorokhi (Akampsis) River in the second half of the 1st century AD (see also Joseph. *BJ* 2.366–367). It seems probable that the Roman army may have arrived in this area as early as during Nero's reign, in connection with the expedition he planned to Caucasian Albania (Tac. *Hist.* 1.6; cf. Mitford 2018: 58).

(Dunbabin 1999: 280–281). In the Black Sea region, only one other comparable example has been identified. In all probability, the same technique was employed in the military *thermae* at the fort located at the Ay-Todor Cape (near Yalta in Crimea) [see Fig. 1]. Unfortunately, the documentation from the excavations conducted there over 100 years ago has not been preserved. We have only brief descriptions and limited excavation results published in early reports (Rostovcev 1900; 1902; D'ákov 1930). Among these, D'ákov (1930: 26) noted fragments of a mosaic made from cut beach pebbles (*galka* in Russian).

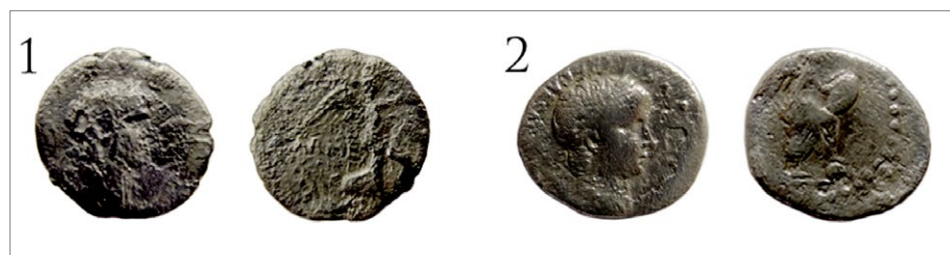
Fig. 4. Two hemidrachmas minted in Caesarea in Cappadocia under Nero, found in a buttress of the *horreum* (After Jaworski, Karasiewicz-Szczypiorski, and Mamuladze 2021: Fig. 4)

the case of the *horreum* at Apsaros, it was possible to establish that it comprised two identical storehouses sharing a central bearing wall. The granary measured 19.60 m in length and 14 m in width. The entrance to the western storehouse was located on the southern side, near the southwestern corner. Not far from this spot, two hemidrachmas were discovered within the construction of one of the buttresses. These coins had been minted in Caesarea in Cappadocia during the reign of Nero, probably in AD 59 (Sydenham 1978: 40, fn. 80), [Fig. 4:1–2]. They commemorate the victory of Corbulo over Armenia in the war against the Parthians. The discovery of both coins in the same location suggests they were intentionally deposited. The first coin (Inv. No. 515/15; see [Fig. 4:1]) depicts Nike facing right, with the inscription ARME- [NIA C] (Sydenham 1978: 40, No. 81; RPC I, 3644), while the second (Inv. No. 517/15) shows Nike also facing right, writing on a shield (Sydenham 1978: 41, No. 83; RPC I, 3646; see [Fig. 4:2]). According to Piotr Jaworski, the coins probably constituted a foundation deposit placed there during the construction of the building. The use of coins bearing the image of a ruler

later condemned to *damnatio memoriae* allows us to confidently conclude that the building must have been founded during the issuer's lifetime — i.e., before AD 68 (Jaworski 2021: 127; Jaworski, Karasiewicz-Szczypiorski, and Mamuladze 2021: 295). During the excavation of this structure, a broken beaker was also found in a cut beneath the foundation, near its southern wall. Made of yellowish-green glass, it belongs to the category of so-called “victory beakers” — cylindrical vessels with concave walls and relief decoration in two registers. So far, this type has been identified at only a few sites. The form and decoration style indicate production in Syro-Palestinian workshops during the 1st century AD (Dusenbery 1971: 13, Fig. 6). Due to its archaeological context, the beaker from Apsaros enables a more precise dating of this type of vessel to the mid-1st century (oral communication from M. Wagner, University of Warsaw). Archaeological research has also uncovered evidence for the destruction of the Phase 1 building, including fragments of roof tiles. On this basis, it can be assumed that the structure was completed and remained in use for some time.

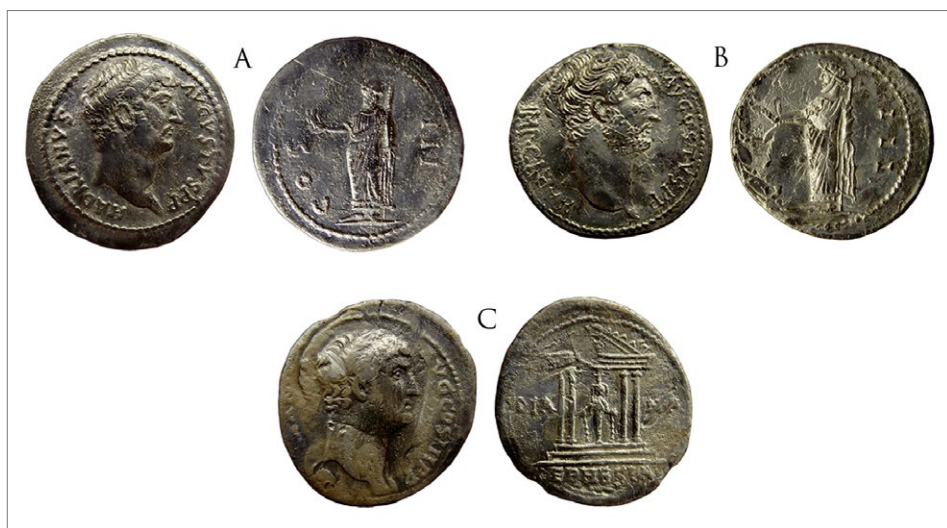
Fig. 7. Three cistophoric tetradrachmas of Hadrian minted in the province of Asia (After Jaworski, Karasiewicz-Szczypiorski, and Mamuladze 2021: Fig. 6)

clay in their higher parts. Exceptionally rare silver coins were found within this clay layer [Fig. 7]. These include three cistophoric tetradrachmas of Hadrian, minted in the province of Asia, probably between AD 128 and 130 (Metcalf 1980: 123; RPC III.1, 165). Two were minted in Laodicea ([Fig. 7:A–B] RPC III, 1399), and the third in Ephesus ([Fig. 7:C]; RPC III, 1332). Cistophori are rarely found outside the province of Asia (Metcalf 1980: 73–74), and the discovery of three specimens in a single archaeological context strongly supports, following the recent findings of Piotr Jaworski (2021: 131), the interpretation of this find as a foundation deposit associated with the transformation of the *thermae* into a commander's residence. Without a doubt, this is an exceptional discovery. It is therefore worth considering the possible circumstances under which Hadrian's cistophori arrived at Apsaros.

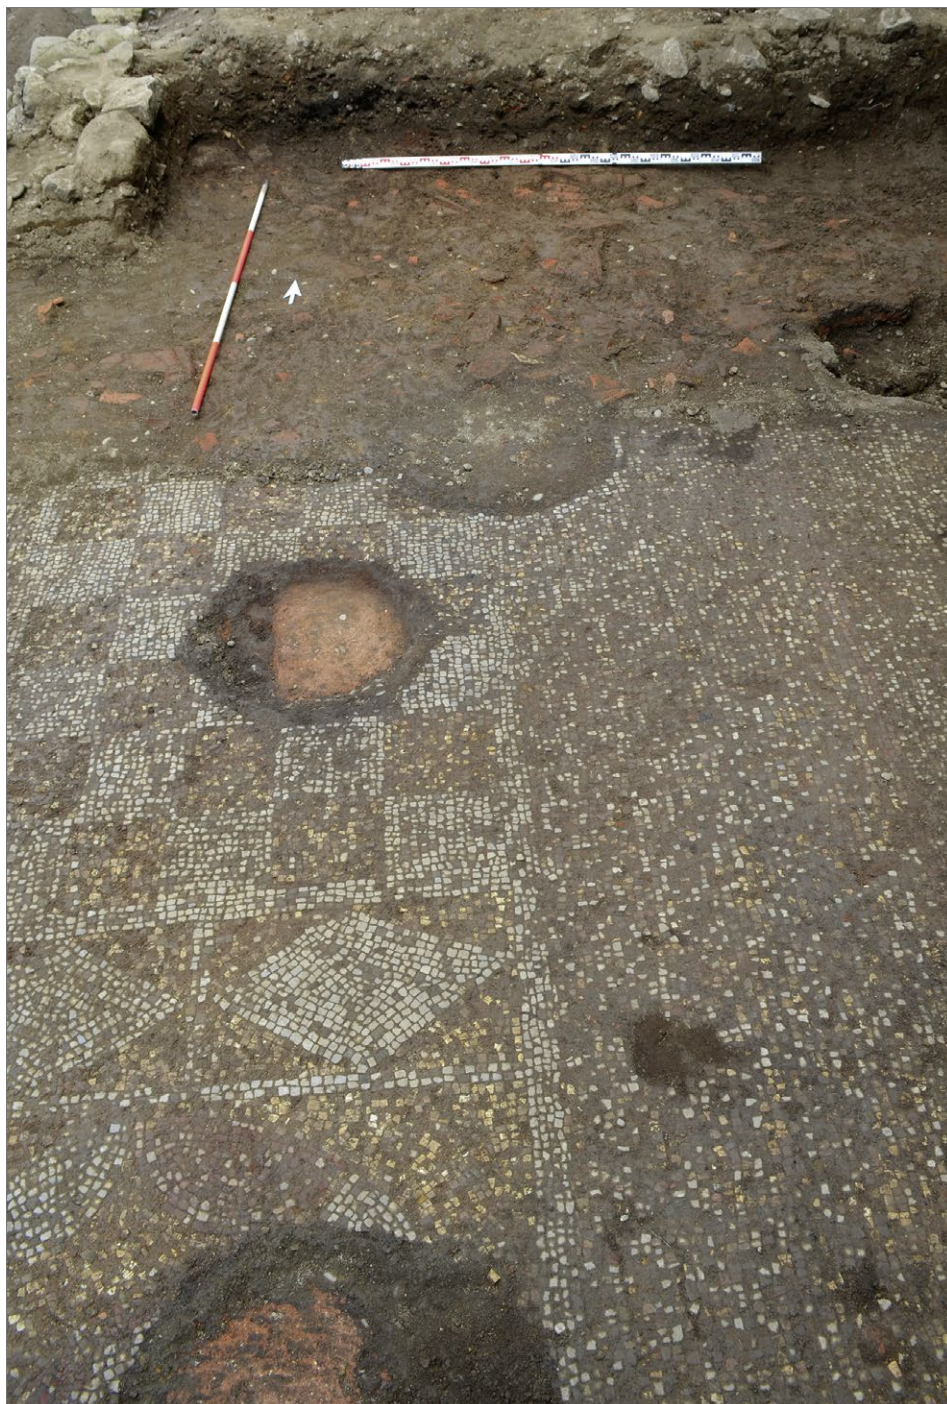
Fig. 8. Apsaros fort (Gonio). Layer of broken roof tiles covering the mosaic floor (Phase 3) during excavation (Photos O. Kubrak and A. Trzop-Szczypiorska)

Another important stratigraphic observation is the accumulation of a layer of broken tiles on the mosaic floor [Fig. 8]. A similar layer was observed in several other places, primarily south of the room with the mosaic.¹ The collapsed roof — evidenced by the backfill of roof tiles on the floor of Room No. 4 — was never cleared. New construction on this spot did not occur until the Late Roman period. A sparse collection of small artifacts was found directly beneath the layer of roof tiles, resting on the floor. The context allows these finds to be considered especially important for dating the destruc-

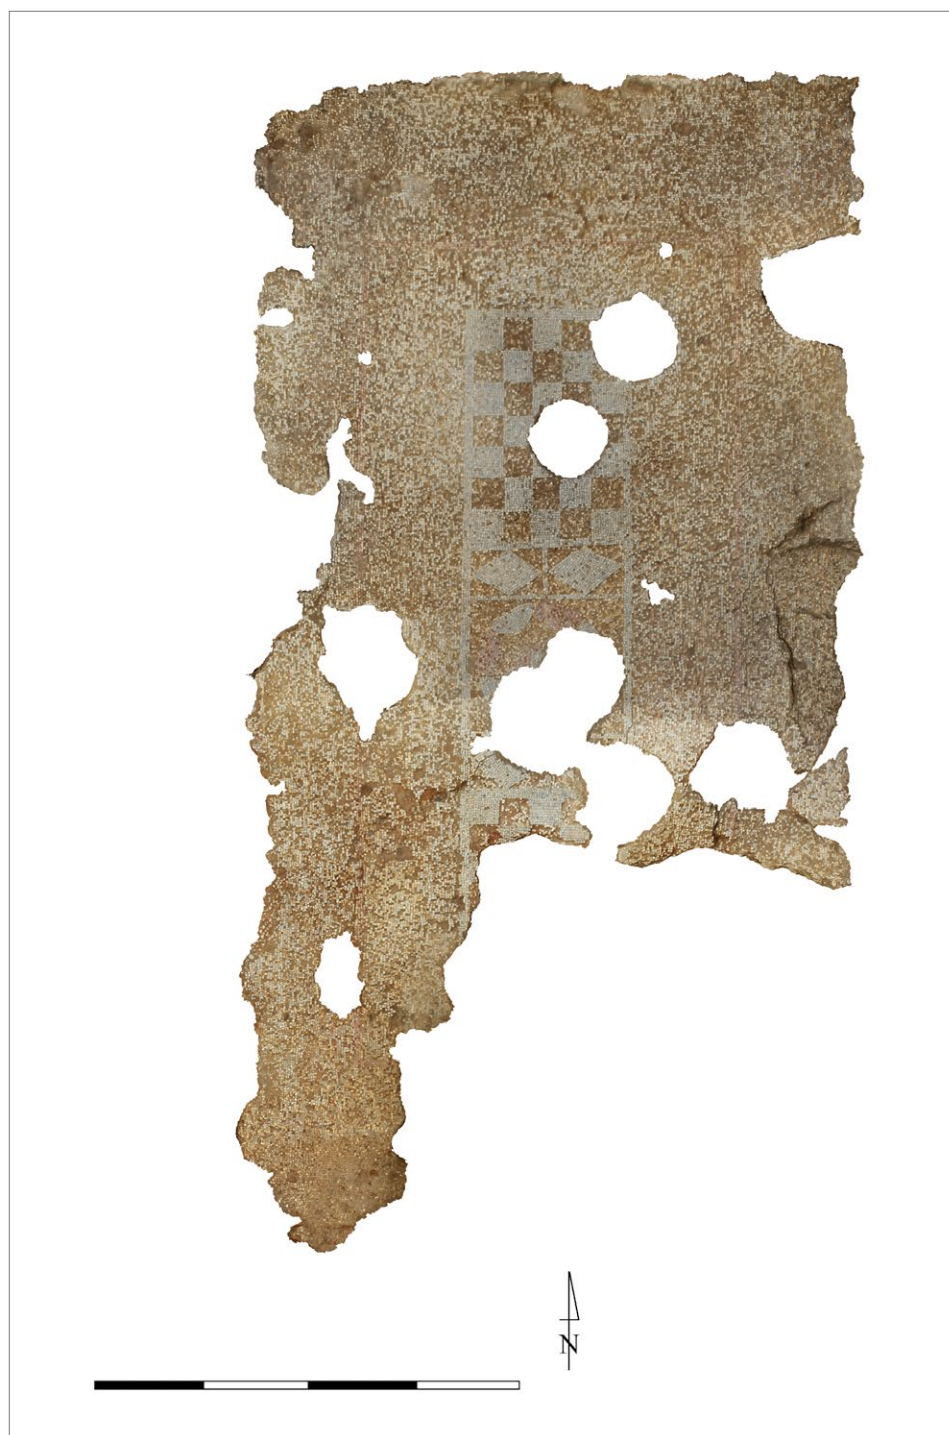
Fig. 11. Apsaros fort (Gonio). Mosaic floor (Photos K. Nowicki; digitizing M. Bura and J. Janowski)

The mosaic from Room No. 4 is decorated with a simple geometric pattern [Figs 11, 12]. It is located in the central part of the floor, creating the illusion of a carpet. A patterned strip, measuring 7.5 m × 1.7 m, was laid along the longer axis of the room (N–S). However, due to the room's layout, it was not possible to view the entire composition from the main entrance, i.e., from the atrium.

Three decorative motifs can be distinguished on the panel, arranged symmetrically across five fields: a checkerboard pattern at both ends, a motif of two diamonds flanking the central emblem, and the central motif itself, composed of half-circles arranged side by side to form a circular shape. Within this circle there is another, also made of half-circles, the center of which is filled with blue mosaic stones. A simple border in the form of a narrow band of blue tesserae surrounds the entire carpet-like panel, dividing it

into geometric units. While light-colored tesserae fill the background of the central motif, red-pink tesserae were also used to articulate specific pattern elements. Each checkerboard section consists of five equal squares on the east–west axis and seven similar squares on the north–south axis. The entire design is enclosed by a surrounding border.

The checkerboard and diamond motifs are symmetrically arranged around the central field with a concentric garland design, together forming a so-called “carpet panel”. A narrow band of red-pink tesserae outlines the panel, positioned about 1.5 m from the longer sides and approximately 0.5 m from the shorter sides. The area between the central panel and the red border, as well as the space between the border and the walls, is filled with the multicolored background tesserae, predominantly in shades of white and yellow.

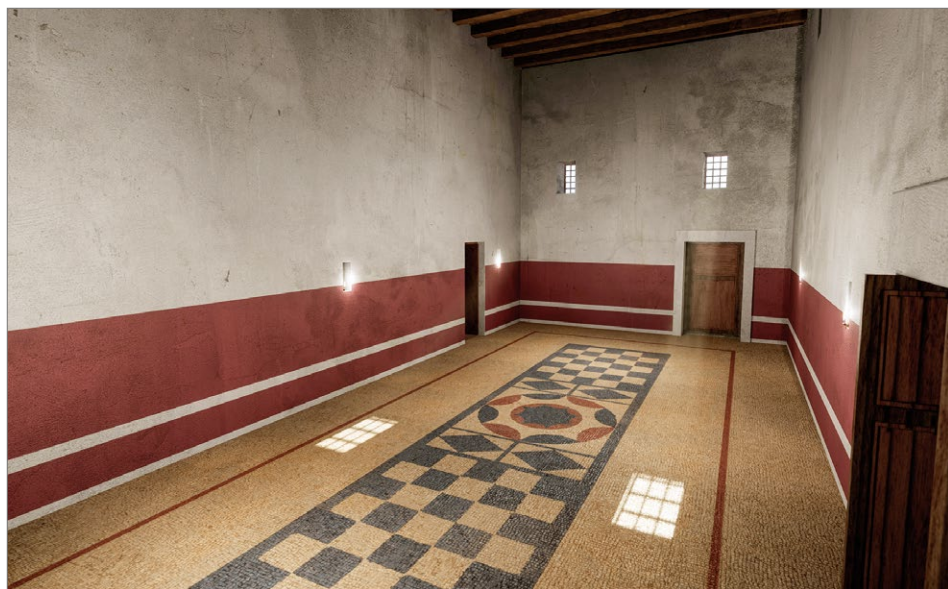
Fig. 12. Mosaic reconstruction and visualization (R. Karasiewicz-Szczypiorski and M. Osiadacz)
