# The East Bath: a Greek bath at Krokodilopolis (Kiman Faris)

**Abstract:** The East Bath at Kiman Faris is one of four collective Greek baths uncovered during rescue excavations in the 1960s at the archaeological site of Kiman Faris in Fayoum City. Since its discovery, several photographs with brief comments have been published, but the bath has not yet been fully documented or mapped. The present study aims to provide a comprehensive description of the archaeological remains of the building, a plan of the discovered architectural elements, and a discussion of the building materials, floors, and the use of space within the structure. The goal is to enhance understanding of the East Bath's significance as an integral part of the cultural and architectural history of the ancient city of Krokodilopolis and of Ptolemaic Egypt in general.

Polish Archaeology in the Mediterranean 34.1 | Mahmoud 2025: 465–496

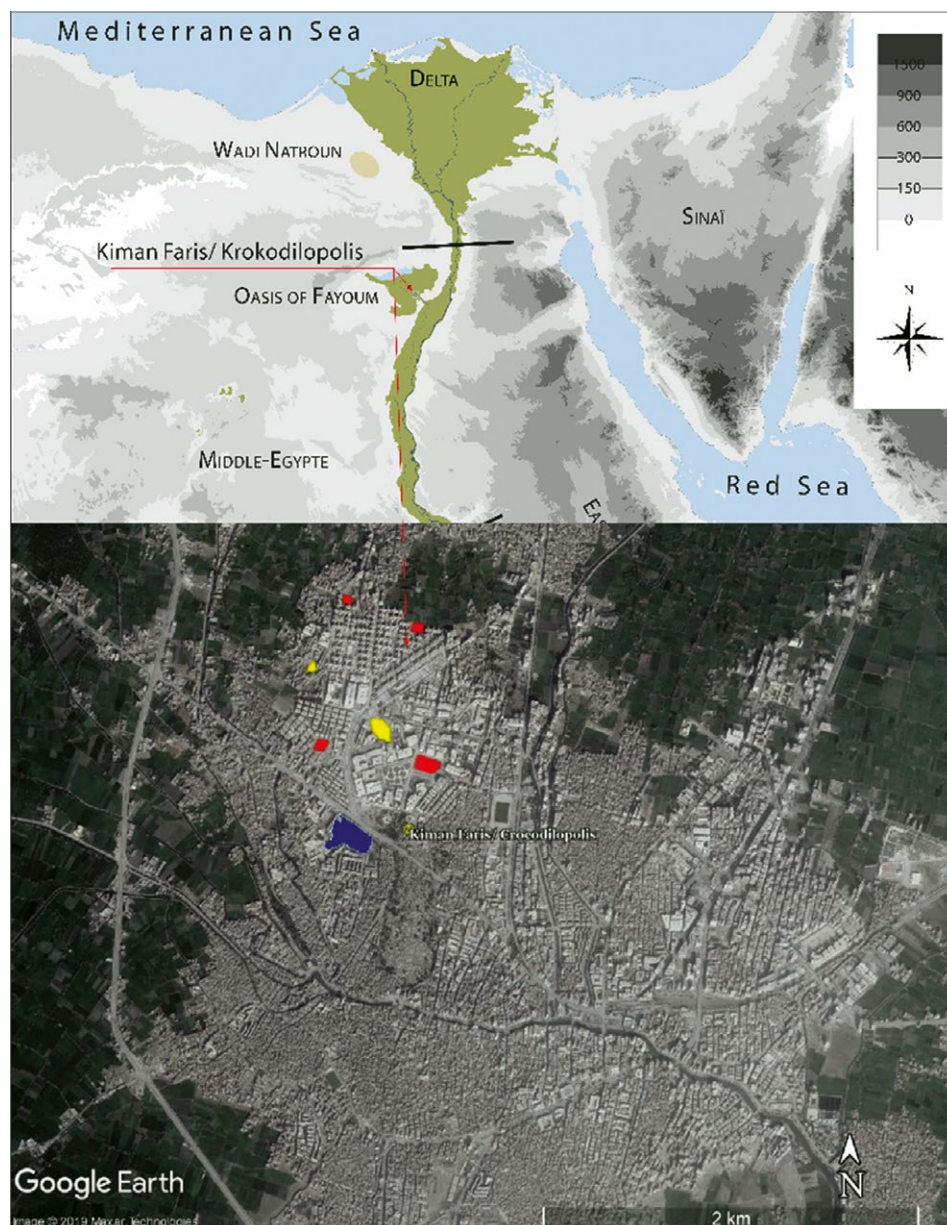
Fig. 1. Position of the East Bath within the area of Ptolemy's temple, one of the remaining parts of Kiman Faris (Google Earth image edited by Y. Mahmoud)

Kiman Faris is the location of “Shedet/Šdt”, the regional capital of the Fayoum from the Old Kingdom onward [Fig. 1]. The sacred name was “Per Sobek,” which means “House of Sobek” (Petrie 1889: 1; Derda 2006: 3; Hewison 2008: 18). This name was translated into Greek as “Krokodilon Polis/Κροκοδύλων πόλις”. The metropolis was given names after members of the Ptolemaic royal house, such as Ptolemais Euergetis (Πτολεμαῖς Εὐεργέτις), Arsinoiton Polis (Ἀρσινόιτων πόλις), and Arsinoe (Ἀρσινόη) (Davoli 1998: 149; Hewison 2008: 19; *TM Geo* 327).

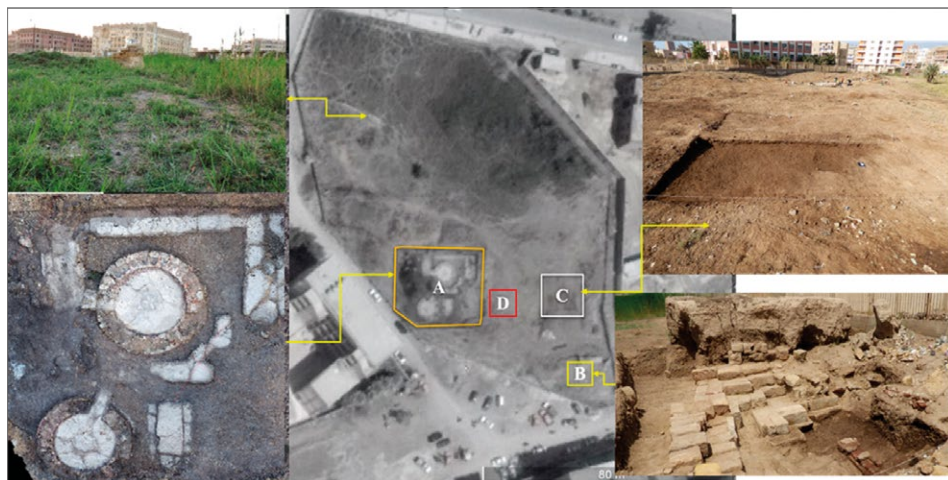
Fig. 2. Aerial view of the “Ptolemy’s temple” area of Kiman Faris. A–D are four trenches excavated by Fayoum University, each accompanied by a photograph of its results. A: the East Bath; B: the basement of a large building; C–D: trenches revealing mixed materials from previous excavations (Photo and processing Y. Mahmoud)

The East Bath is located in Ptolemy’s temple area, one of the few remaining parts of the ruins under the authority of the Ministry of Tourism and Antiquities [Fig. 2]. The area is bordered on the north, west, and south by streets that separate it from governmental buildings and educational facilities, while on the east it is bounded by governmental buildings. The bath itself is situated in the southwest of the site, adjacent to its western boundary. About 50 m north of the bath, there

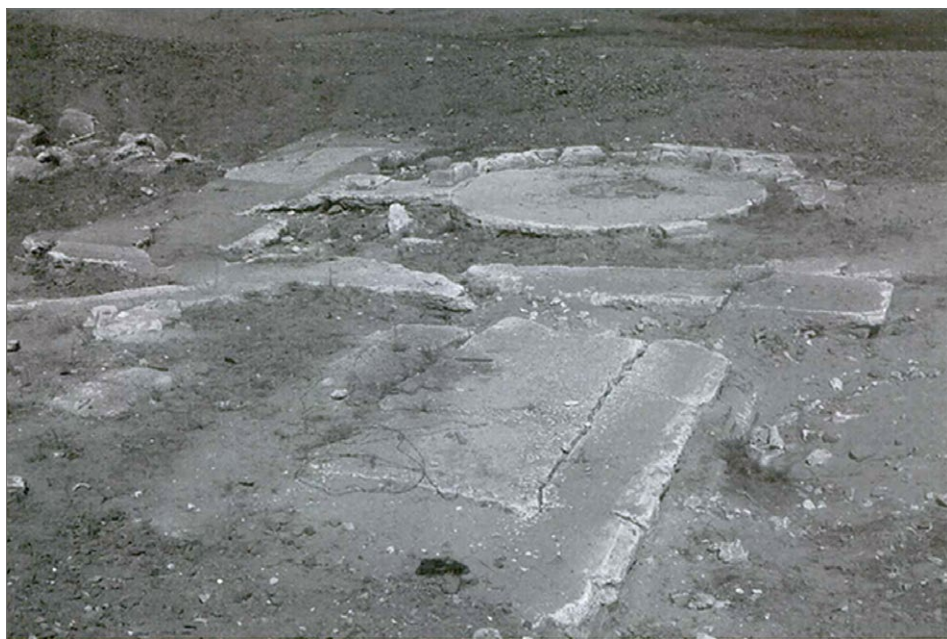
Fig. 4. Remains of the Hellenistic bath in the 1990s, view to the north (Photo P. Davoli, after Davoli 1998: Fig. 67)

In the late 1990s, Paola Davoli briefly commented on the bath and published a general photograph of the building [Fig. 4] (Davoli 1998: 149, Fig. 67; Davoli and Ahmed 2006: 85). However, in her 2006 paper with Nahla Ahmed, the baths were not mentioned among the remaining archaeological features visible on the surface. Bérangère Redon and Thibaud Fournet also referred to the bath in their study of the Greek baths in Egypt (Fournet and Redon 2017b: Cat. No. 19). Additionally, a mention of the bath mosaics

Room 7 is located on the southern side of Corridor 5 and has retained most of its floor [see *Figs 4, 6*], although it shows large cracks and some small missing sections. Based on the remaining floor de-

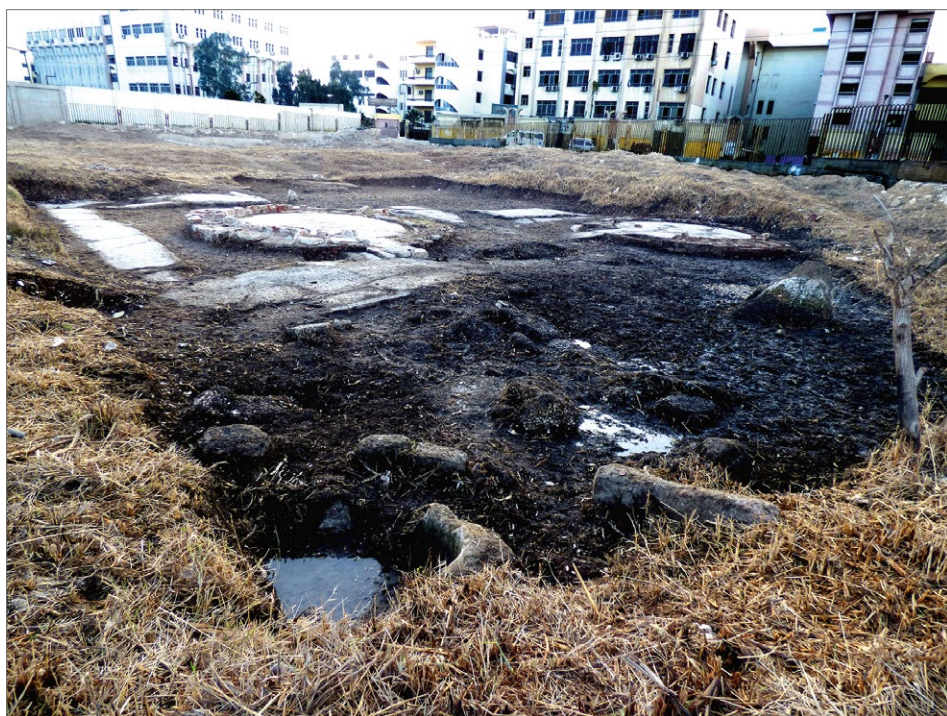
Fig. 5. The East Bath at the end of the 2016–2017 Fayoum University excavations (Photo Y. Mahmoud)

of the bath (Rooms 8–9) due to the high groundwater level. Additionally, after removing the weeds and surface mud, it was discovered that the floor of the area had been severely damaged, despite appearing to be in good condition in earlier photographs [Fig. 5].

grass and reeds, but no archaeological features were uncovered. Excavations did not descend lower than 10 cm due to the high water table. However, scattered slag remnants were observed in debris from previous excavations to the west and southwest of the bath [see *Fig. 5*].

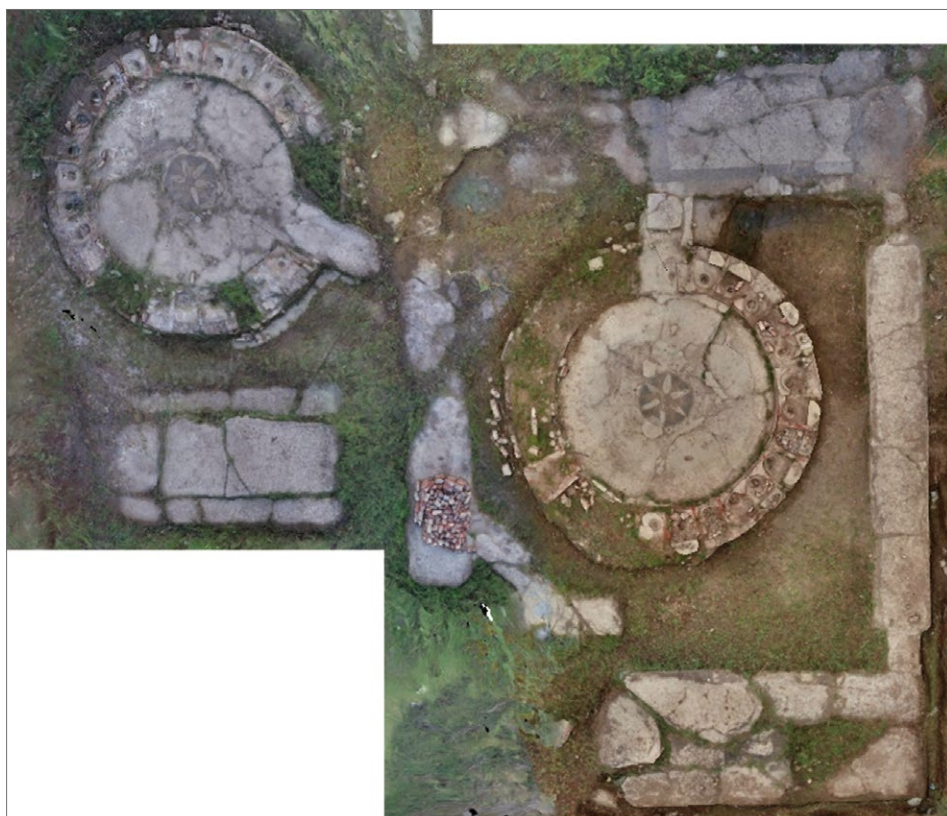
Fig. 6. Orthophotomosaic of the East Bath at the end of the 2016–2017 Fayoum University excavations (Photo and processing Y. Mahmoud)

hip-bathtubs, and the floors of three rectangular rooms (2, 7, 8). Only Room 8 contained remains of two immersion bathing tubes. No traces of walls remained [Figs 6–7].

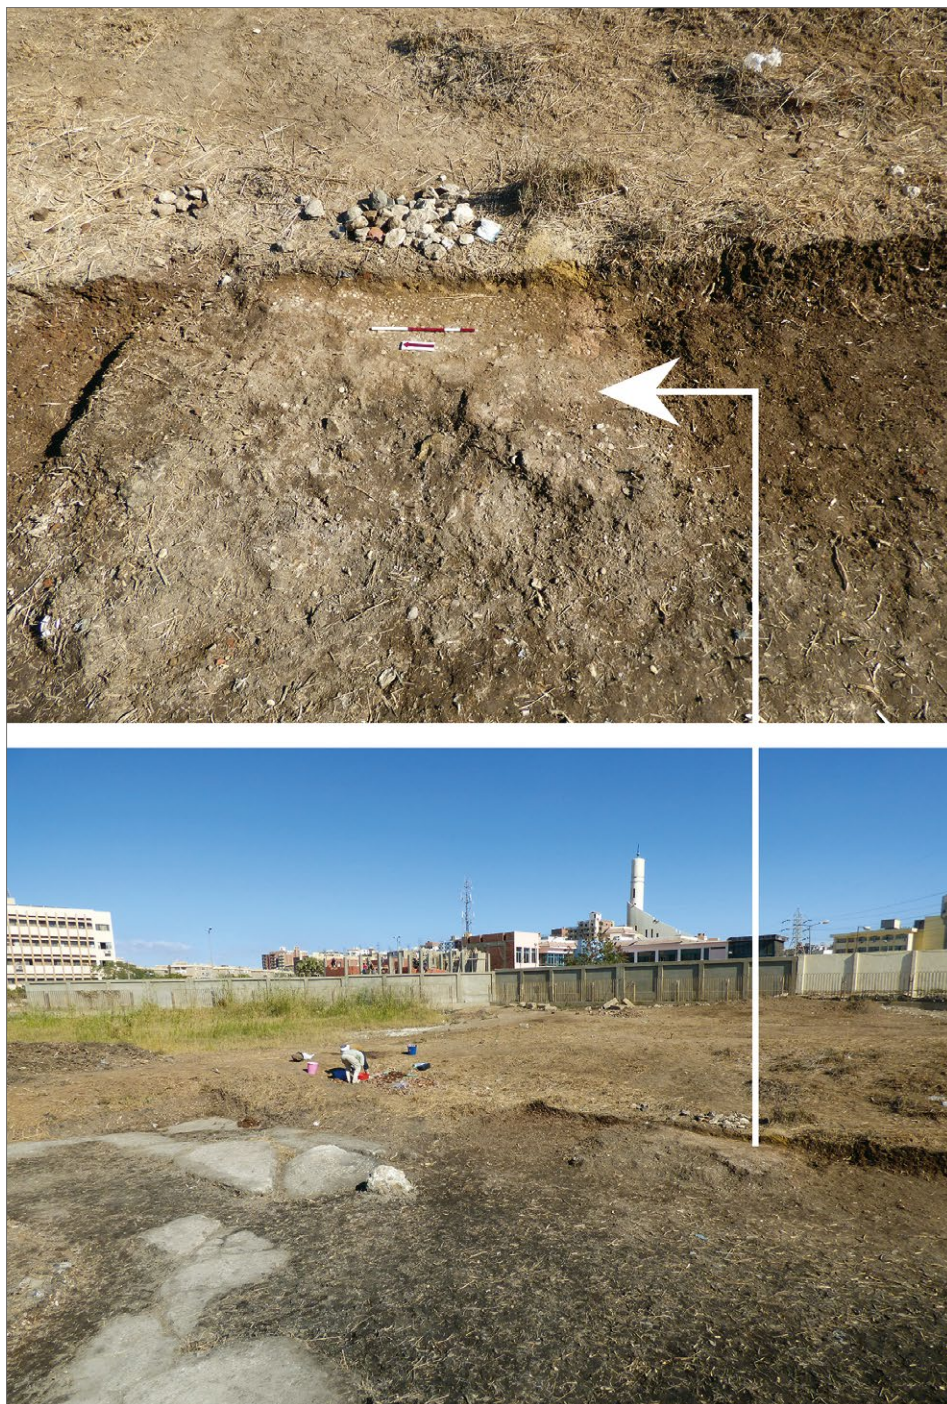
Fig. 10. A portion of the floor of Corridor 1 was uncovered to the southeast of the corner of the floor of Room 2 (Photo and processing Y. Mahmoud)

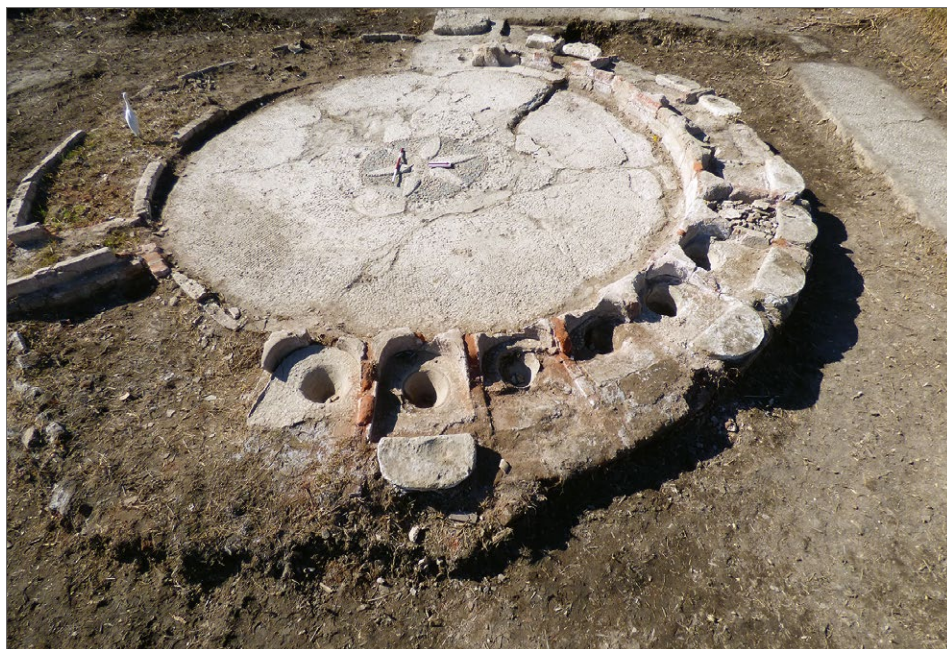
Fig. 11. *Tholos* Room 10, viewed from the east (Photo Y. Mahmoud)

piece had a width equal to the maximum width of the basin, measuring about 0.55 to 0.60 m, and occupied a space of 0.30 to 0.33 m from the rear part of the basin. The hip-bathtubs were constructed of red bricks measuring 0.24 m × 0.12 m × 0.07 m. The extension of the rear wall of the basins revealed that the wall foundations extended to three courses below the floor level, approximately 36–40 cm deep [see Figs 3, 11].

the missing southern extension of the hip-bathtubs [see *Fig. 11*]. It also appears that the restoration department carried out repairs on parts of the bath's flooring, particularly in Room 1, where white cement mortar mixed with sand was used to fill cracks and gaps. Additionally, black cement mortar was applied to parts of the exterior of the hip-bathtubs and spread across the surrounding floor area — likely as a protective measure or to prevent plant growth.

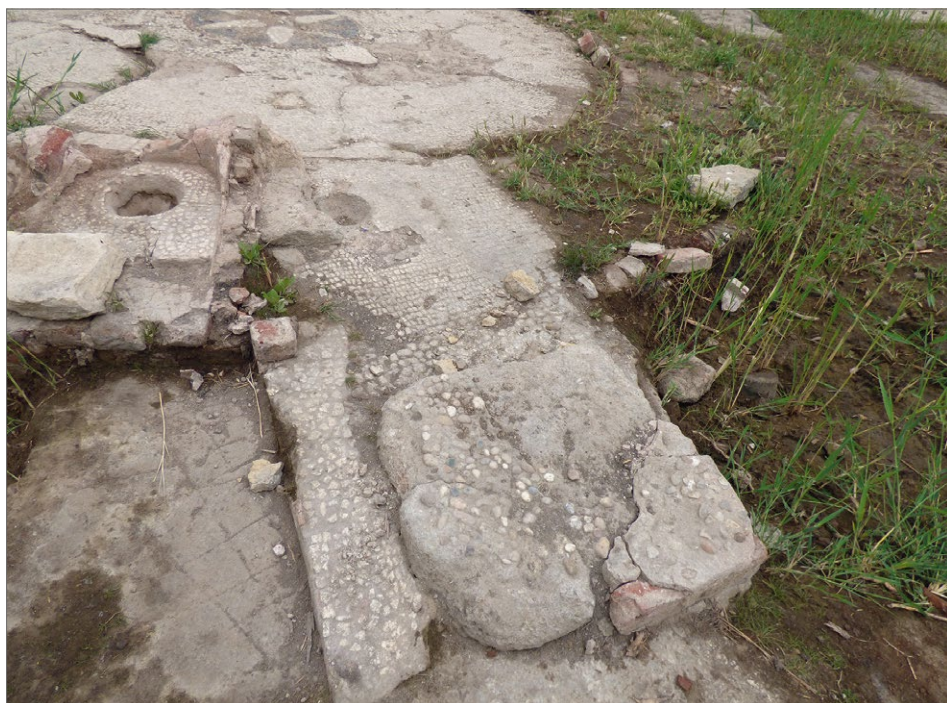
Fig. 12. Entrance to tholos Room 10 (Photo Y. Mahmoud)

low the level of the first hip-bathtub on the northern side of the entrance [Fig. 12]. These findings suggest that the *tholos* underwent two phases of construction. Based on this, two hypotheses can be proposed: the first is that the entrance was originally narrower and was widened by removing one of the hip-bathtubs, meaning that the room originally contained 26 hip-bathtubs. The second hypothesis is that the entrance was not originally located here, and the room was modified to have its entrance from the west. The second hypothesis seems more likely, as the entrance floor is already narrow. If it had originally been narrower by the width of a full hip-bathtub, it would have been too narrow to allow anyone to pass through. During the first phase, the original entrance to *tholos* Room 10 might have been toward the south, opening into Corridor 5 [see Fig. 8], similar to the North Bath at Kiman Faris, with which the East Bath shares many characteristics (Fournet and Redon 2017b: 412).

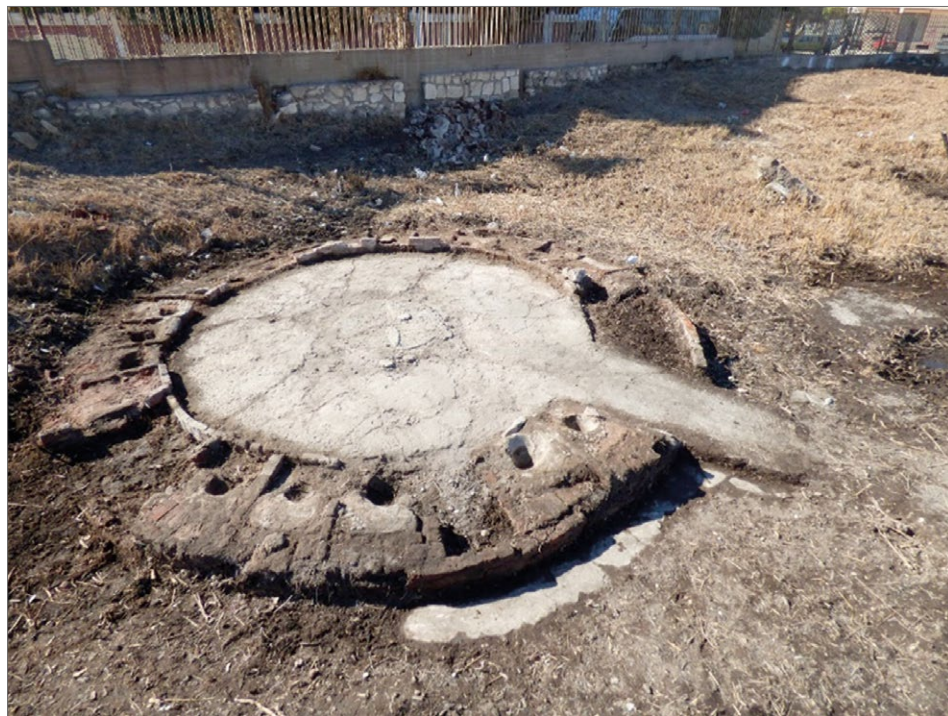
Fig. 13. *Tholos* Room 11, viewed from the east (Photo Y. Mahmoud)

ing entrance leads from the corridor into the room. This elevation difference might be due to ground disturbances caused by dredging activities and a rising water table, which lowered the level of Corridor 5. This is evident in the steep slope of Corridor 4's floor from north to south, although there may have originally been a planned elevation difference, as the entrance from the corridor to the room appears to have been intentionally sloped [Fig. 13, see Fig. 3].

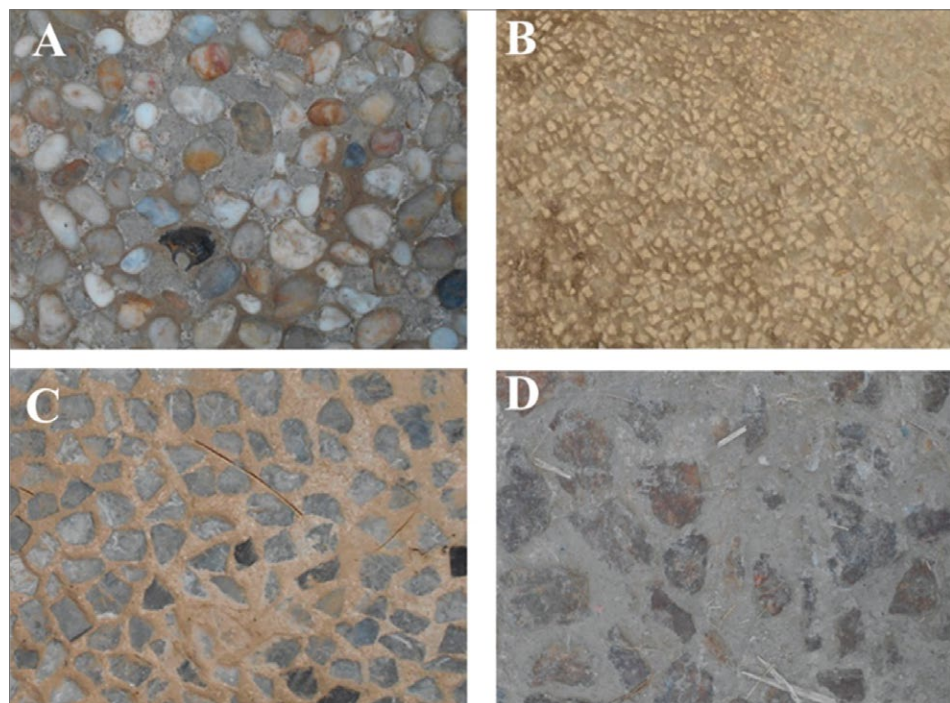
Fig. 14. A – pebble fill of mortar floors in Corridors 1, 2, 3, and 7; B–D – limestone chip flooring in the rectangular frieze in Corridors 4, 5, 6, 12 and Rooms 8, 10, and 11 (Photos Y. Mahmoud)

1. Mortar floors [Fig. 14]: mortar floors consist of a surface layer made of mortar spread across the floor, into which aggregate is embedded to enhance its strength — though the aggregate is not meant to be visible. This surface layer is typically very thin, often just a few centimeters thick and sometimes even less than 1 cm, in contrast to the thicker sub-floor layers beneath it (Guimier-Sorbets and Redon 2017: 140).

stone chips arranged in a central pattern [see *Fig. 14:B*]. These floors were designed with a slope from the center toward a small drainage channel that runs parallel to the hip-bathtubs positioned along the edge of the mosaic floor. Despite suffering significant damage due to rising groundwater and soil subsidence—which resulted in the floors breaking into several sections with differing heights, directions, and slopes—it can be confirmed that the overall slope of the *tholoi* floors leads toward their entrances.

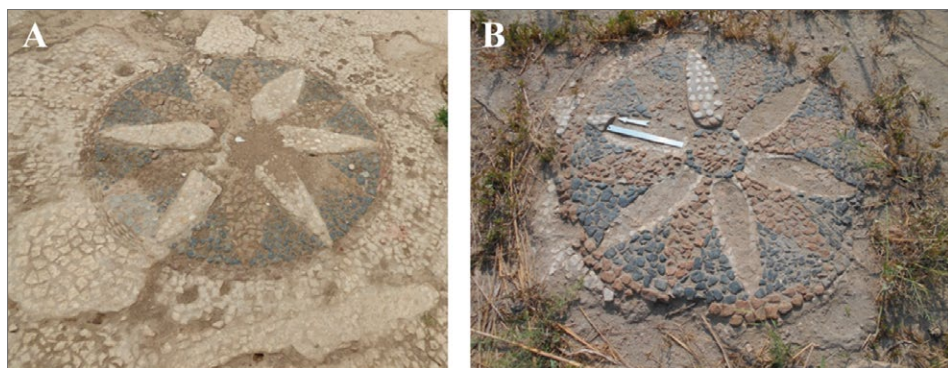
Fig. 15. Central floral decoration in the *tholoi*: A in Room 10; B in Room 11 (Photos Y. Mahmoud)

2. Chipped mosaic floors [see *Figs 11, 13, 15, 16*]: this type of mosaic resembles *opus tessellatum*, but the individual elements lack recognizable shapes such as squares or near-squares (Guimier-Sorbets and Redon 2017: 140). Chipped floors are observed in the pavements of Corridor 4, Room 8 and the inside of the two *tholoi* Rooms 10 and 11. These floors use small stone chips arranged in a random pattern, contributing to a distinct and visually intriguing mosaic effect throughout these spaces.

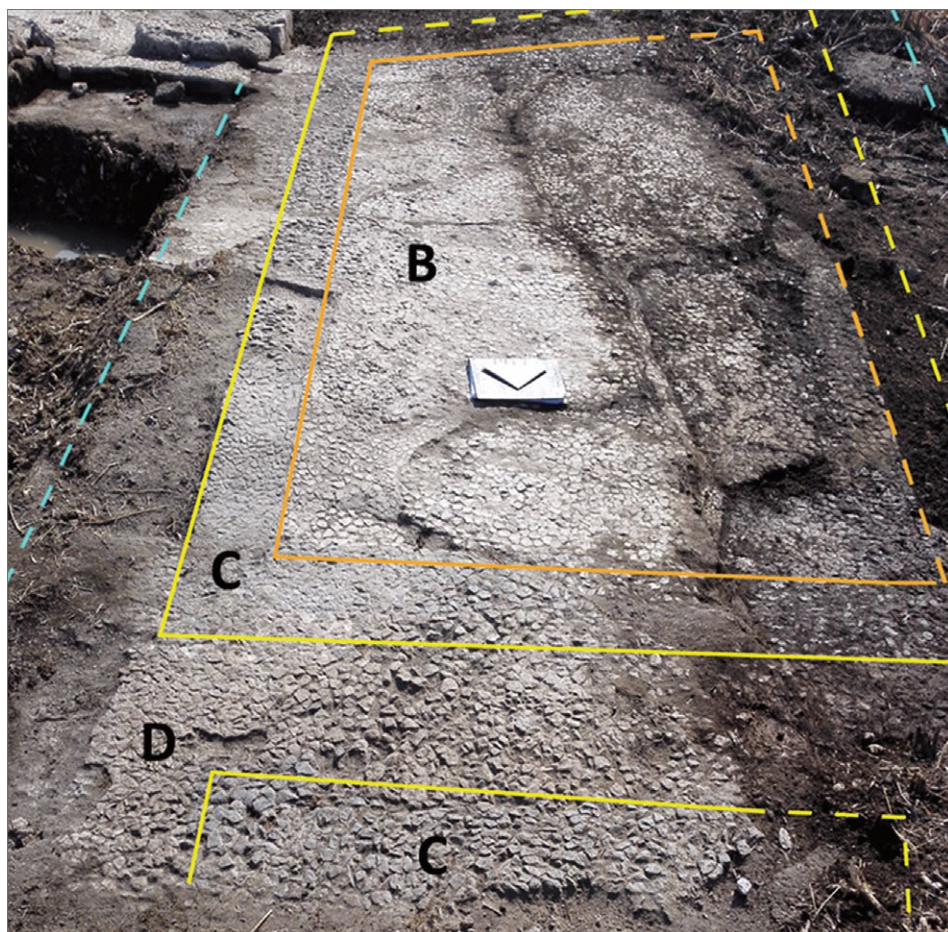
Fig. 16. Corridor 4 with outlined boundaries of the various stone types (see B, C, and D in Fig. 14) (Photo and processing Y. Mahmoud)
