# The technique and technology of wall paintings from the Villa of Theseus in Nea Paphos (Cyprus)

**Keywords:** Nea Paphos archaeological site, Villa of Theseus, Roman wall paintings, technique and technology, pigments, plasters, analytical techniques, SEM-EDS, Raman spectroscopy

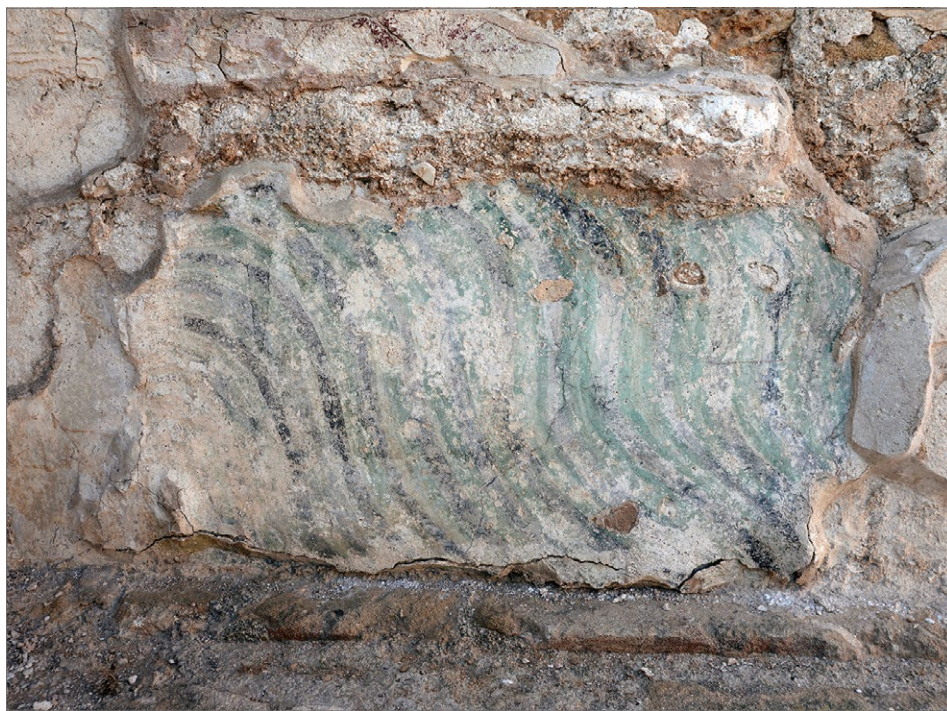
Fig. 2. Painted imitation of *marmor carystium* (*cipollino*) preserved in room No. R.44 VT (Photo A. Tomkowska)

seasons of archaeological excavations, we can conclude that the motifs fall into three categories of decoration. The first category is painted imitations of marble slabs, the best example being a large fragment with green streaks, known as *cipollino* (*marmor carystium*), preserved in room No. R.44. Additionally, on several small, broken fragments, we can identify the imitations of stone with irregular red veining on either a yellow (*giallo antico*) or white background [Figs 2, 3].

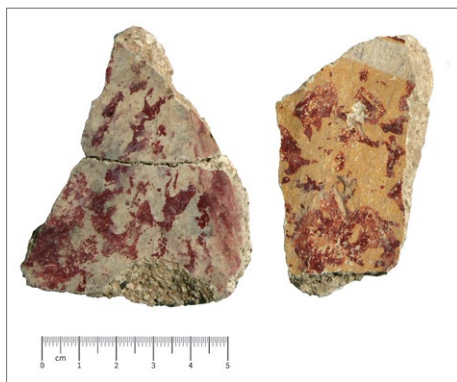
Fig. 3. Painted imitation of *giallo antico*. Left: fragment from context VT1. 1986 B. Right: fragment from context VT 1973 R.60 (Photo A. Tomkowska)

In fragments imitating *giallo antico* marble [see Fig. 3], the first layer of underpainting—yellow or white—shows structural variation created with red paint, partly achieved using impressions from a paint-soaked sponge.<sup>19</sup>

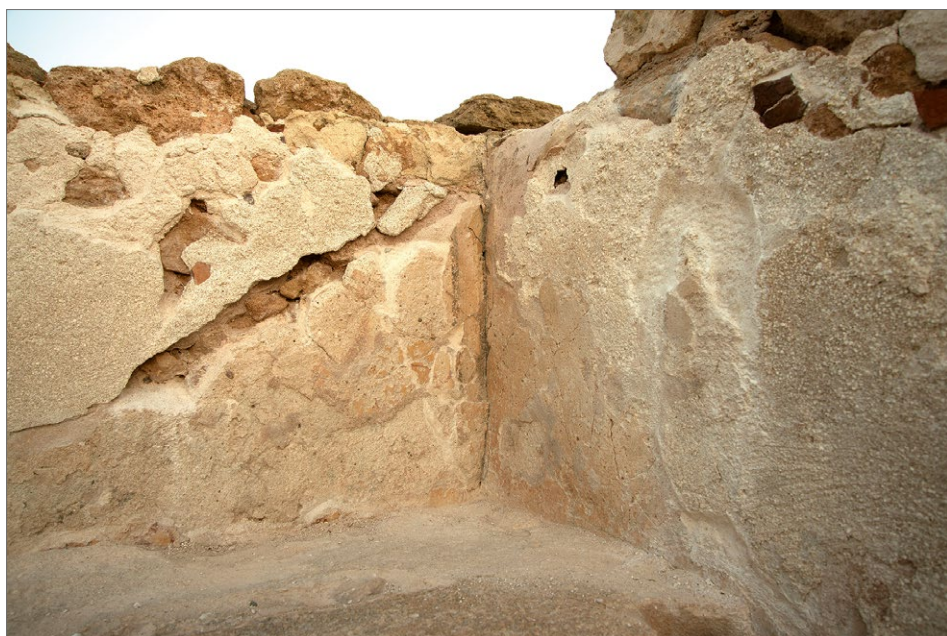
Fig. 5. Composition of thin black lines in the corner of room No. R.56 in the baths of the villa (Photo A. Tomkowska)

with simple, colorful geometric shapes imitating marble slabs. Fragments of thin black compositional lines have also survived in the lower part of one of the walls in the baths and in the lower section of the apse in room No. R.48B, one of the villa's representative chambers [Figs 4–6].

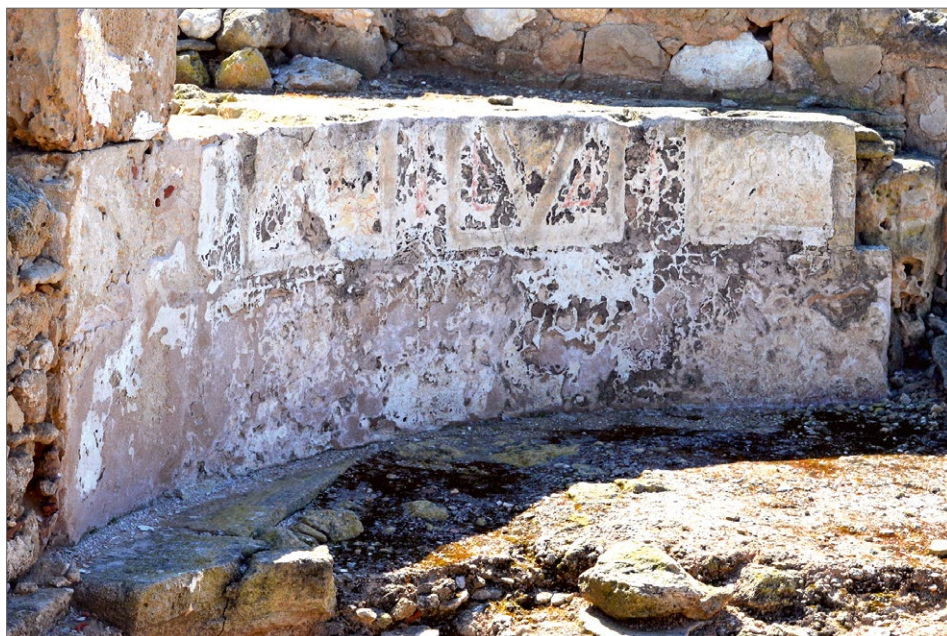
Fig. 6. Painted imitation of stone cladding in the apse of room No. R.48B VT (Photo A. Tomkowska)

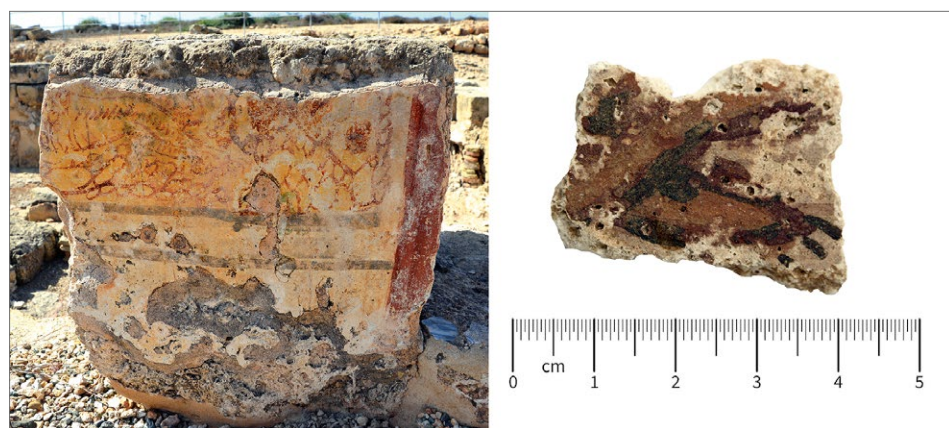
Fig. 8. Left: painted depiction of a running panther on the southern wall of room No. R.56 VT. Right: fragment from context VT 1973 R.60 featuring an animal's paw (Photos A. Tomkowska)

room No. R.56, the damaged outline of a running panther has been preserved, while on one of the loose fragments, there is a shape resembling an animal paw [Figs 7, 8].

Some color patches are outlined with a black contour, as seen in a small fragment resembling an animal's paw [see Fig. 7]. Traces of contour drawing can also be observed on a damaged fragment depicting a panther running along the pillar in the thermal rooms [see Fig. 7].<sup>20</sup> Due to the fragmentary state of preservation, it is difficult to assess the artistic quality in full. Nonetheless, the broad color fields, precisely drawn lines, and representations of plants and animals suggest a skilled hand—or hands—familiar with both artistic principles and the technical means to achieve specific artistic effects.

20 This fragment is currently very damaged, with only remnants of brown lines visible. It is possible that these are remnants of an initial compositional sketch.

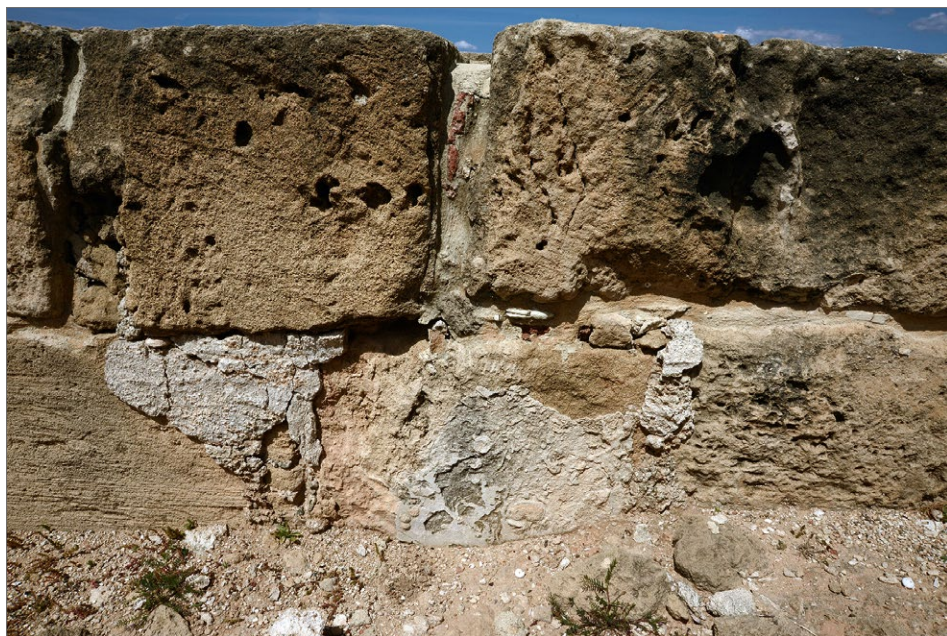
Fig. 15. Regular blocks of calcarenite used in constructing the apse of room No. R.39 VT (Photo A. Tomkowska)

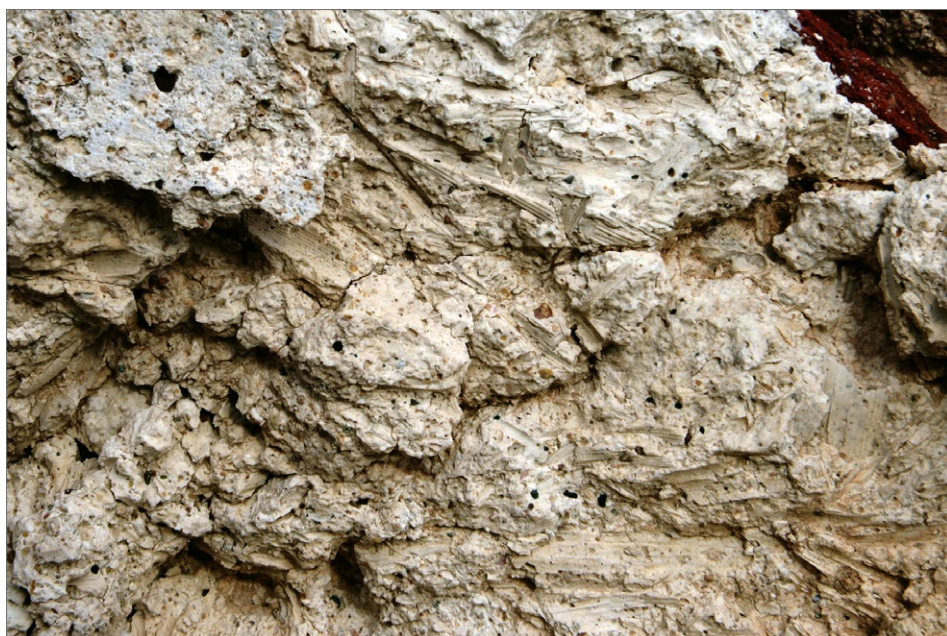
Fig. 16. Traces of organic fillers (fragments of straw) visible in the plaster on the eastern wall of room No. R.60 VT (Photo A. Tomkowska)

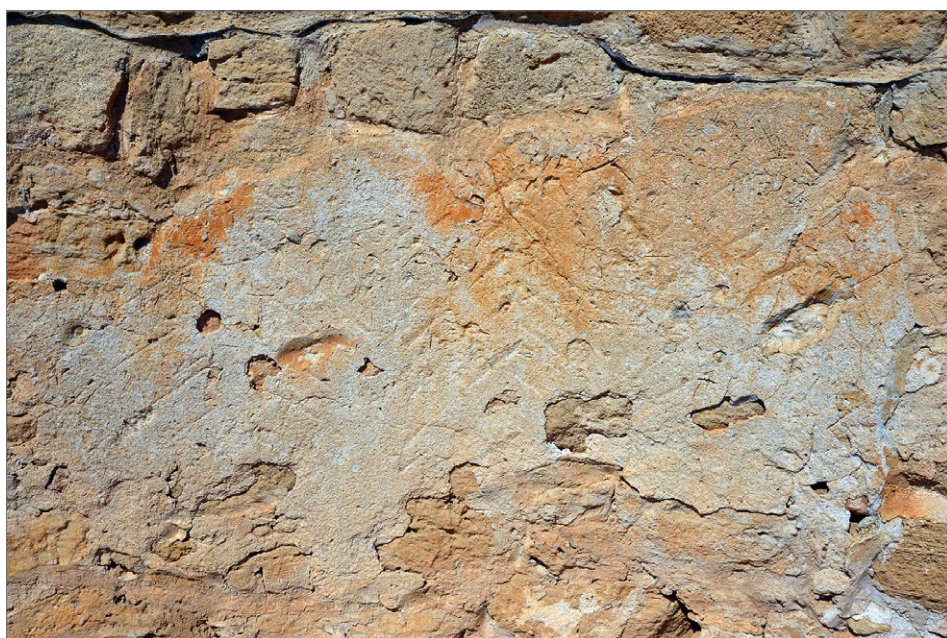
Fig. 17. Preparation of the base plaster for the upper layers: distinctive herringbone incisions on the western wall of room No. R.20 VT (Photo A. Tomkowska)

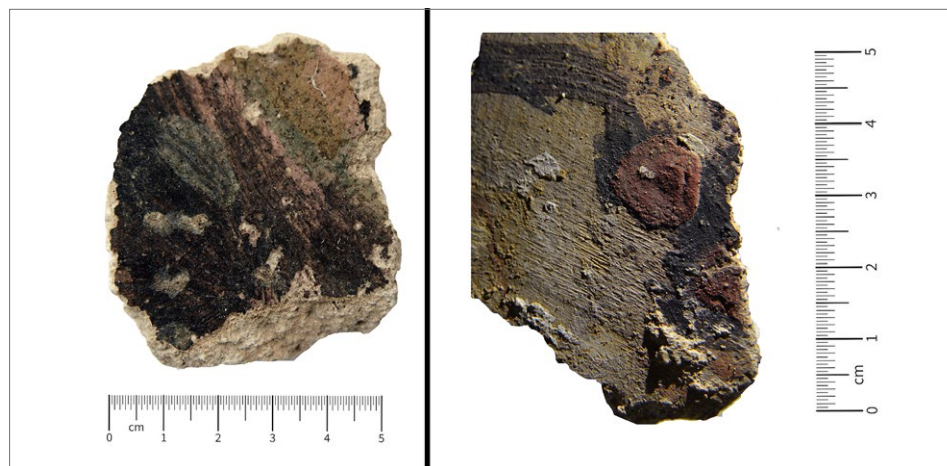
Fig. 22. Overlapping paint layers (left) and paint applied with the impasto technique under side lighting (right). Both fragments are from context VT 1973 R.60. Details like flower petals were painted with pigment mixed with a thicker binder—limewash—as indicated by the impasto (Photos A. Tomkowska)

Subsequent paint layers were likely applied to the still-damp plaster using brushes of varying widths, as evidenced by marks visible in the microscopic photographs of the surfaces of the paintings. In many fragments, the upper paint layer merges with the lower one. Impastos were created using pigments mixed with limewash [Figs 22, 23].

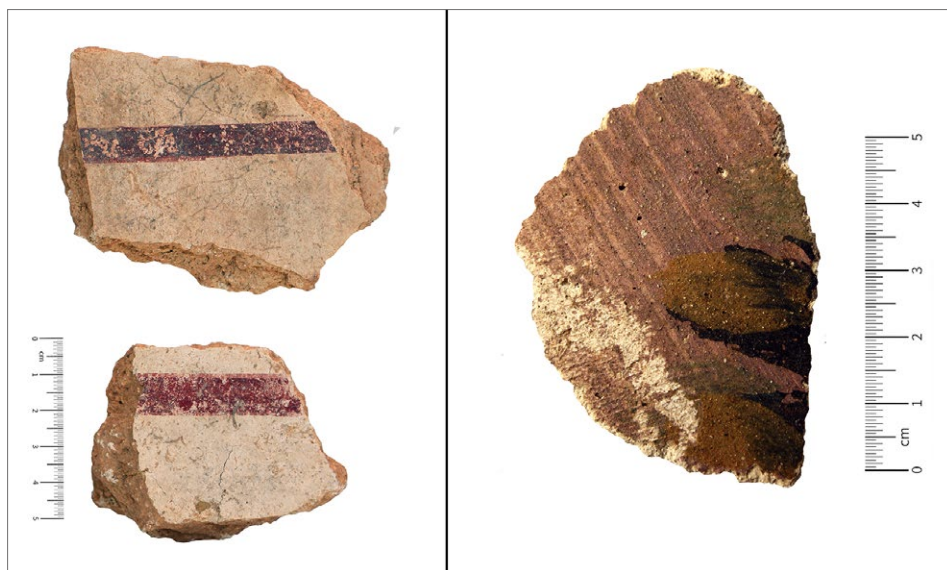
Fig. 23. Left: fragment from context VT 1977 R.44, showing red compositional lines painted with a single pigment. Right: fragment from context VT 1973 R.60, where colors were achieved by mixing various pigments (Photos A. Tomkowska)

Different sections of the decoration were painted either using a single pigment type (e.g., compositional lines) or with mixtures of two pigments. In some areas, two or three layers of different colors overlap, most clearly observed in fragments featuring painted flowers [see Fig. 23].

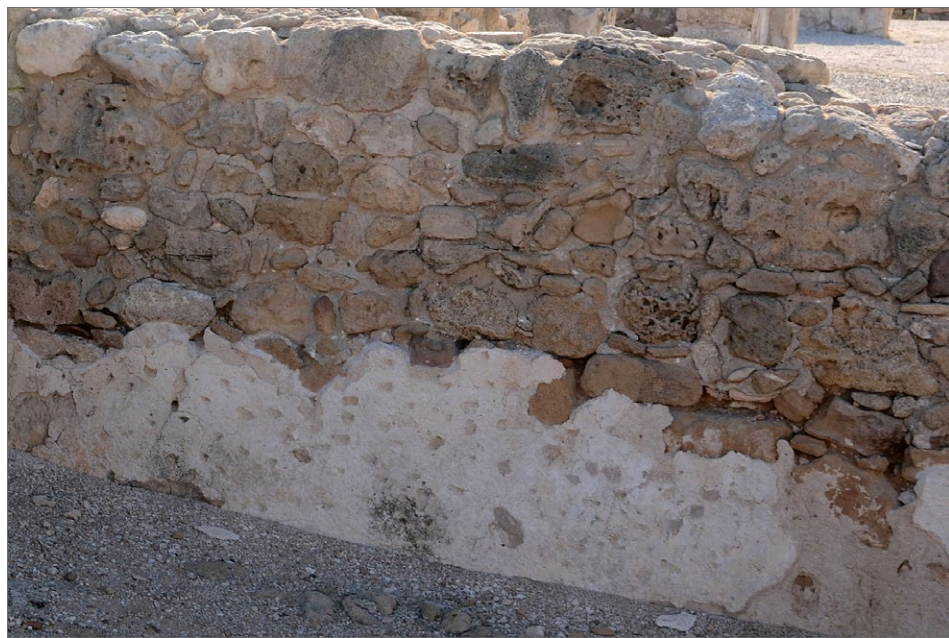
Fig. 25. Eastern wall of room No. R.42, showing clear signs of mortar keying on the plaster surface (Photo A. Tomkowska)
