Polychrome relief decoration in the Sanctuary of the Hathor Shrine: preliminary remarks

Abstract: The article reports on a conservation project carried out in the Sanctuary of the Hathor Shrine at the Temple of Hatshepsut in Deir el-Bahari within the framework of the Polish-Egyptian Archaeological and Conservation Expedition in 2023. The project, launched this season, aims to investigate the technique and technology of Eighteenth Dynasty polychrome relief decoration in the Sanctuary and to assess the state of its preservation in order to establish an appropriate conservation approach. In addition, an appraisal of previous conservation and restoration treatments in the Hathor Shrine was conducted. Preliminary cleaning tests were also performed to aid planning further works. The research led to a preliminary identification of deterioration factors, as well as types of damage to the limestone, plaster, and painting layers. Unique in this respect were the changes in color of the polychrome decoration and limestone, likely caused by high-temperature chemical reactions.

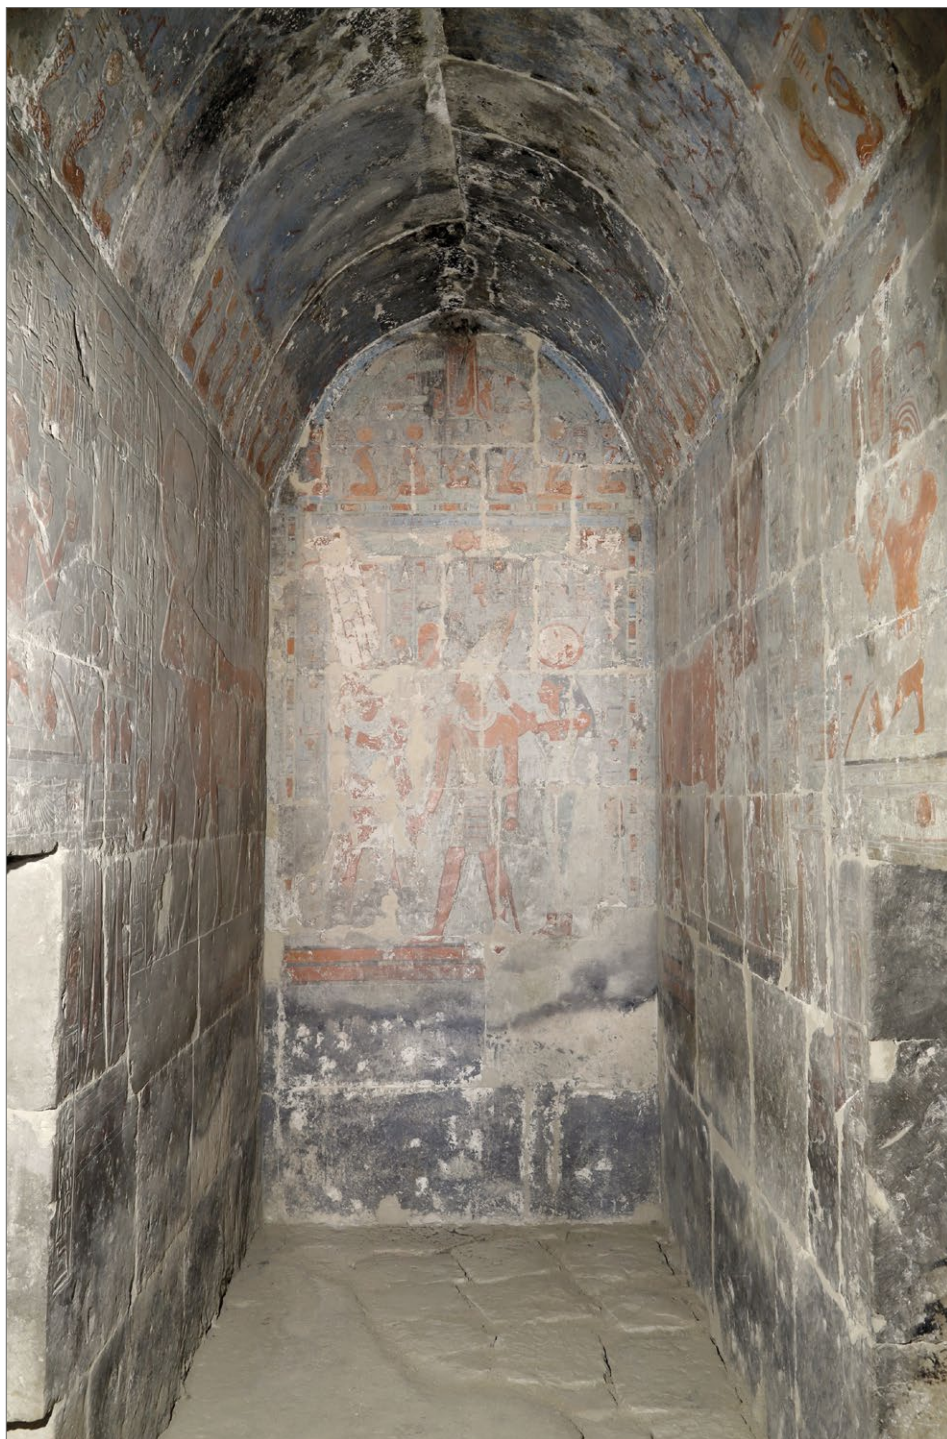
Fig. 2. General view of the Sanctuary of the Hathor Shrine (PCMA UW | photo M. Jawornicki)

The Sanctuary, a rectangular room with a vaulted ceiling and two niches symmetrically placed in the northern and southern walls [Fig. 2], is one of the few parts of the Temple where depictions of Queen Hatshepsut have survived. The decoration portrays Hatshepsut as a male king, wearing a false beard and

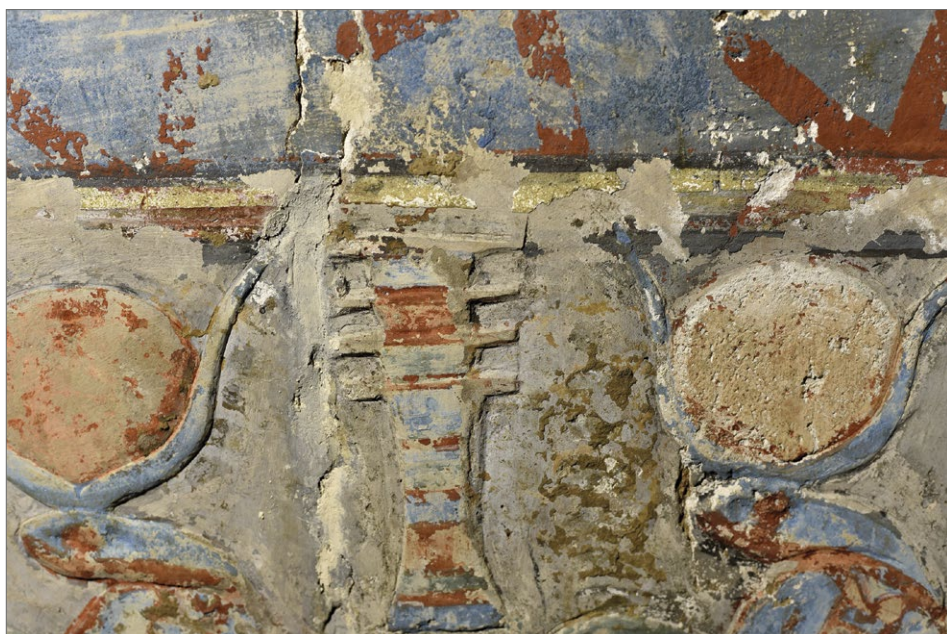
Fig. 3. Fragment of the painted relief decoration on the southern wall of the Sanctuary of the Hathor Shrine observed under visible light (PCMA UW | photo P. Staszewicz)

observation and preliminary photographic documentation in visible and ultraviolet light [Figs 3, 4], as well as observation with a portable digital microscope² [Fig. 5]. The work also consisted in a preliminary assessment of the state of preservation and identification of deterioration factors and types of damage of the limestone, plaster, and painting layers.

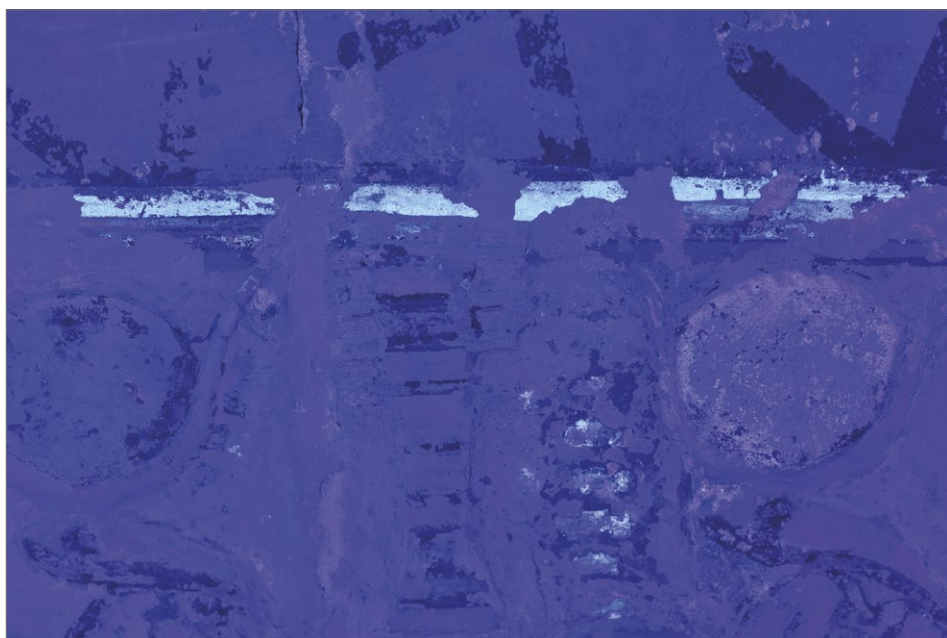
Fig. 4. Fragment of the painted relief decoration on the southern wall of the Sanctuary of the Hathor Shrine, observed under ultraviolet light, showing distinct luminescence in the strip above the uraeus frieze (PCMA UW | photo P. Staszewicz)

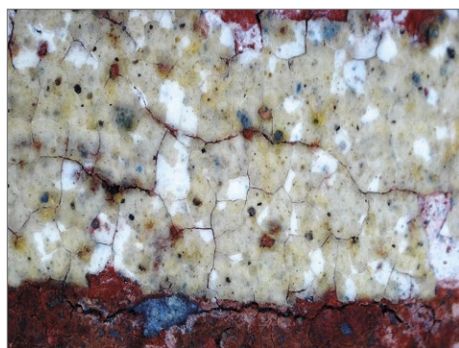
el-Bahari between 1200 and 900 BC (Karakhanyan and Avagyan 2010). Nonetheless, the decoration of the Sanctuary still suffered damage as a result of fire, human activity, and natural processes. Particularly remarkable in this context are the color changes that affected the polychrome decoration: areas originally painted yellow have turned red [Fig. 6:A]. This phenomenon is most likely the result of transition of a yellow ochre pigment, commonly found in New Kingdom wall

Fig. 5. Semi-transparent, yellowed layer covering the white paint layer, visible in the micro-photograph of the strip above the uraeus frieze (PCMA UW | photo P. Staszkieicz)

paintings and derived from local minerals (Afifi, Galal, and Ali Hassan 2020: 256). Initially composed of hydrated iron oxides such as goethite ($\text{FeO} \cdot \text{OH}$) and limonite ($\text{FeO} \cdot n\text{H}_2\text{O}$) (Colinart 2001), the yellow pigment turns red as these minerals transition to dehydrated red iron oxide (Fe_2O_3)—known as red ochre—when exposed to high temperatures. Transitions of this type usually take place at temperatures above 250–300°C, when goethite dehydrates, forming a disordered hematite. A complete crystallization of hematite occurs at temperatures exceeding 850°C, resulting in a red color (Domingo and Chieli 2021). In many cases, for instance in the Vestibule, the original yellow color is sometimes still found in the lower parts of the walls, where paintings were protected from the heat by layers of rubble [Fig. 6:B]. This phenomenon was also observed in Theban tombs, e.g. TT 104 and TT 112 (Hofmann 2015: 3). While the present study has identified only iron oxide transformations, similar phenomena of material transformation, such as the phase transformation of gypsum to an-

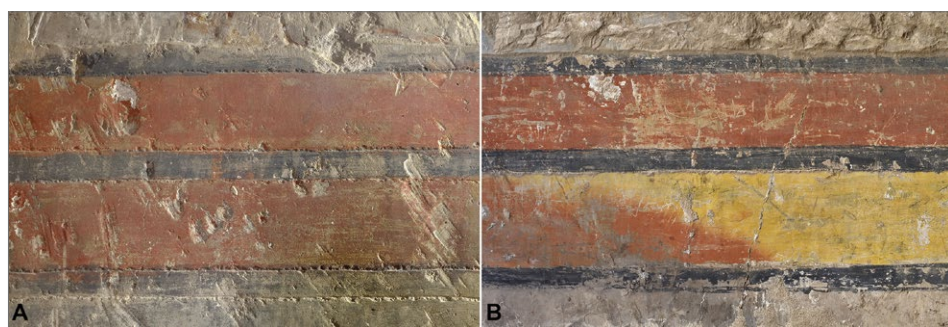
Fig. 6. Color change from yellow to red in the dado decoration: A – in the Sanctuary; B – on the northern wall of the Vestibule of the Hathor Shrine (PCMA UW | photo P. Staszkieicz)

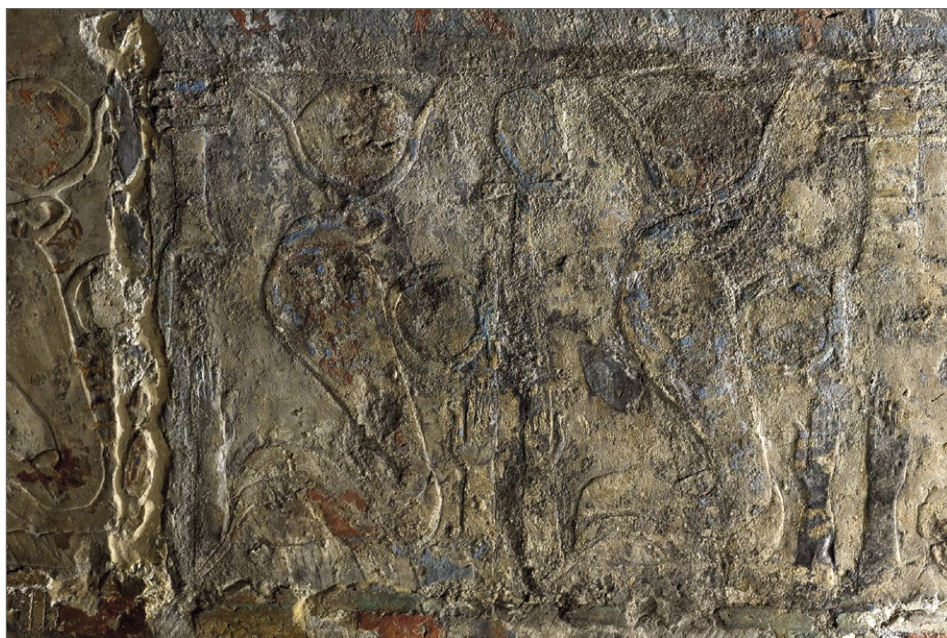
While most limestone blocks with relief decorations in the Sanctuary seemed to be in good condition, some, particularly those located centrally in the northern and southern walls and in the vaulted ceiling, had irregular, rough surfaces that contrasted with the smooth faces of other blocks [Fig. 7]. The inferior state of preservation of these surfaces could be linked to the poor quality of the material and exposure to damaging factors, likely including salt decay. Many blocks, especially in the vaulted ceiling, bore remains of wasp nests as well as bird and bat excrements [Fig. 8]. The presence of such accretions on the surface of the painted reliefs is detrimental to their state of preservation, as it increases moisture absorption

and degrades the binder. Therefore, the state of the polychrome decoration on the stone blocks forming the vaulted ceiling varied depending on their exposure to these detrimental factors — some blocks barely retained any paint, while others featured only a thin layer of paint that appeared washed out. The original mortar filling the joints and irregularities in the stone blocks was delaminating and in need of stabilization. The overlying paint flaked off, exposing conspicuous spots of white mortar that drew the viewer's attention away from the polychrome decoration.

Fig. 7. Block from the northern wall displaying an irregular, rough surface likely caused by salt decay, potentially poor material quality, and exposure to damaging factors (PCMA UW | photo P. Staszkievicz)

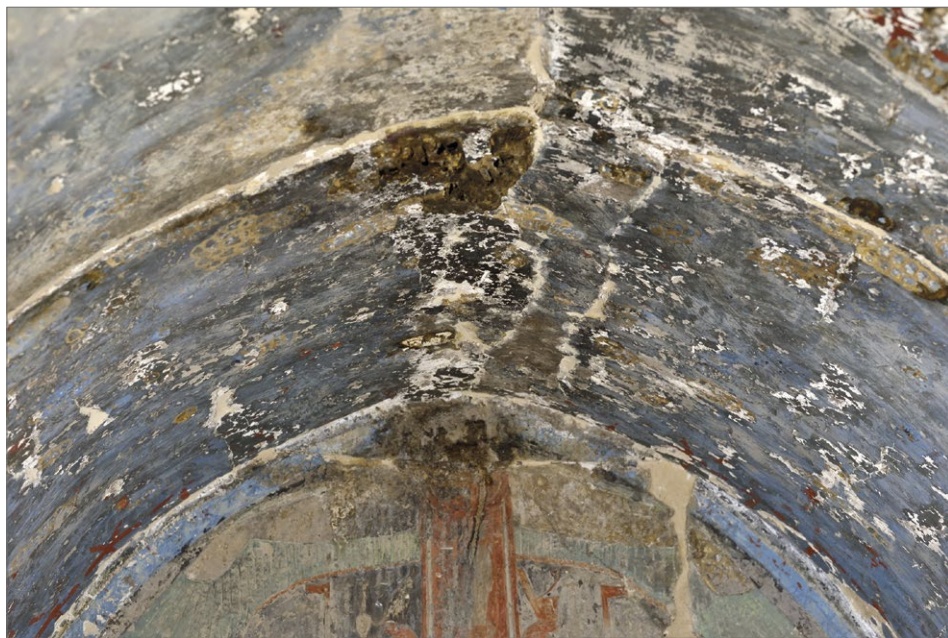
Fig. 8. Vaulted ceiling in a poor state of preservation, with visible remains of wasp nests, as well as bird and bat excrements (PCMA UW | photo P. Staszkievicz)
