Enigma of the niches in the eastern wall of the Royal Mortuary Cult Complex in the Temple of Hatshepsut at Deir el-Bahari

Abstract: The paper offers an explanation of the misalignment of blocks and their decorations in two cultic niches in the Vestibule of the Chapel of Hatshepsut in the Royal Mortuary Cult Complex. Detachment of the niches from the adjacent walls, discrepancies in their dimensions, and intentional absence of jambs have led the author to conclude that the niches were reconstructed in this spot after having been removed from their original location in another part of the temple.

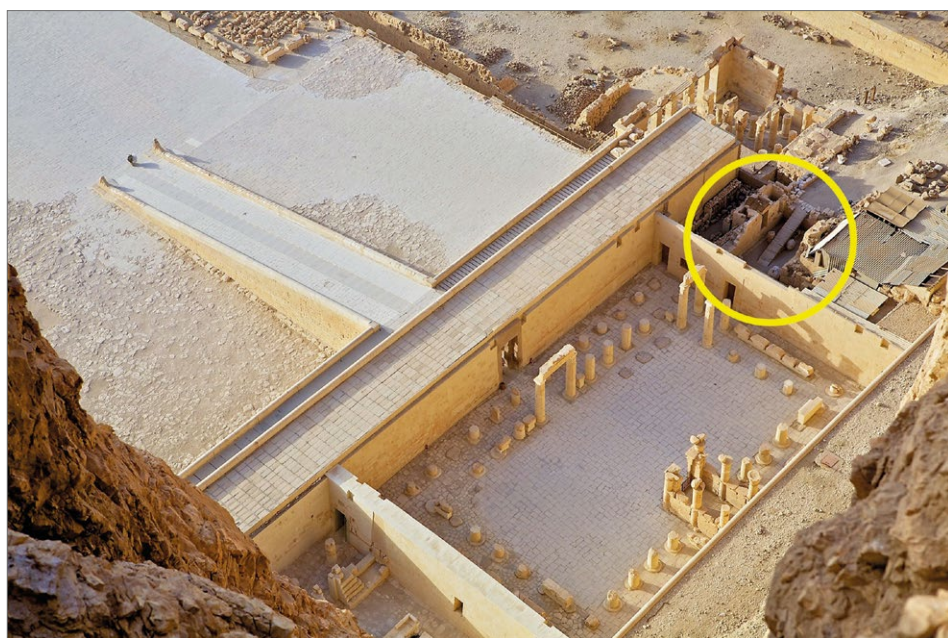
Fig. 1. Location of the Royal Mortuary Cult Complex on the southern edge of the Upper Terrace of the Temple of Hatshepsut (Photo M. Jawornicki; processing A. Kwaśnica)

One of the most important parts of the temple, the Royal Mortuary Cult Complex, was located on the southern edge of the Upper Terrace [Fig. 1]. This complex consisted of two chapels and vestibules, five niches, and a courtyard. Out of these rooms, the most important

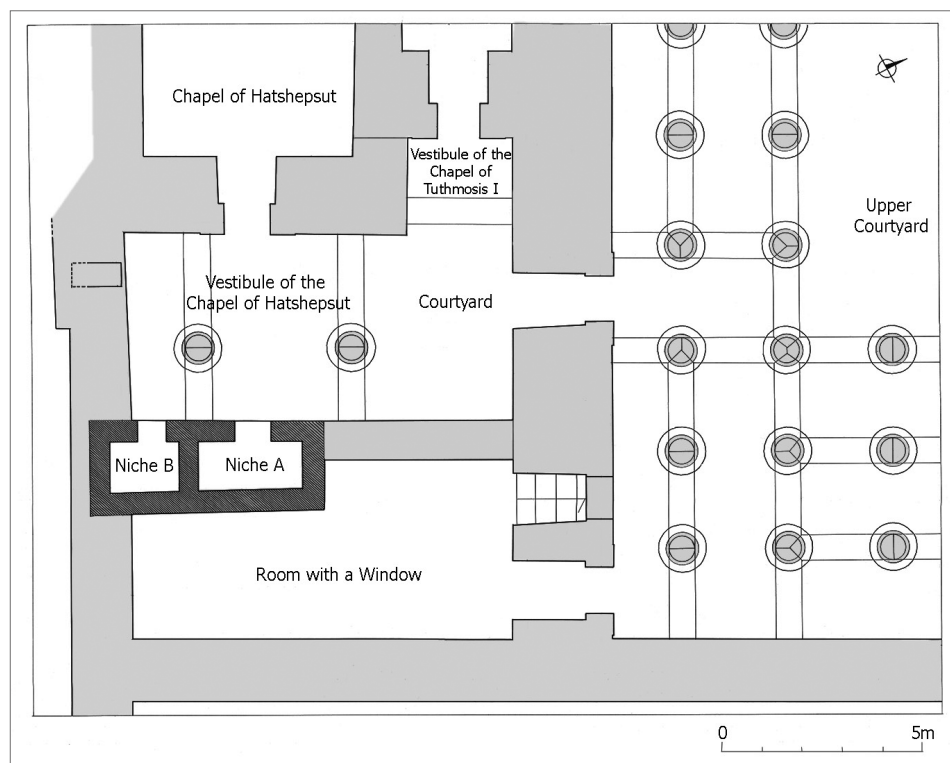
Fig. 2. Niches A and B located between the Vestibule of the Chapel of Hatshepsut and the Room with a Window (Drawing A. Kwaśnica)

and their placement severely distorted the otherwise regular layout of the latter room [Fig. 2].³ In addition, several blocks used in their construction had been cut in a way that had caused damage to their decoration. The slope of the flooring inside the niches has led researchers to attribute their state to an earthquake, land subsidence, or the pressure of the tower of the Coptic monastery that stood partly on top of the walls of the vestibule niches, which could have led to deformation and

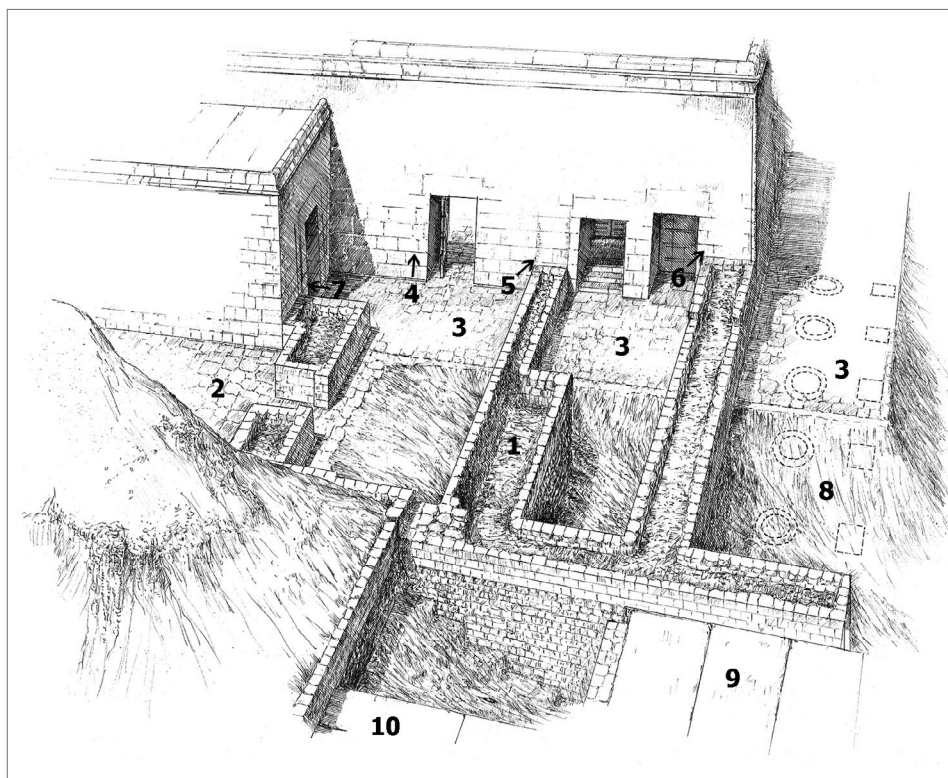
Fig. 3. Visualization of the southern part of the Upper Terrace at the time of the construction of the Royal Mortuary Cult Complex. View from the south. 1 – location of Niches A and B; 2 – Chapel of Hatshepsut; 3 – artificial platform in the southeastern corner of the Upper Court, built in the early construction phase of the temple; 4 – portal leading to the Upper Court, lacking the decorative band [see Fig. 5]; 5 – added eastern wall of the Royal Mortuary Cult Complex [see Fig. 7]; 6 – added southern part of the wall of the Upper Portico [see Fig. 6]; 7 – decorative band cut in an originally flat wall after transformation of the storage room into the Chapel of Thutmose I; 8 – location of the columns and pillars of the Upper Portico; 9 – roof slabs of the Hather Shrine, Second Hypostyle Hall; 10 – roof slabs of the Vestibule of the Hather Shrine (Drawing A. Kwaśnica)

room (the later Chapel of Thutmose I) [Fig. 3].

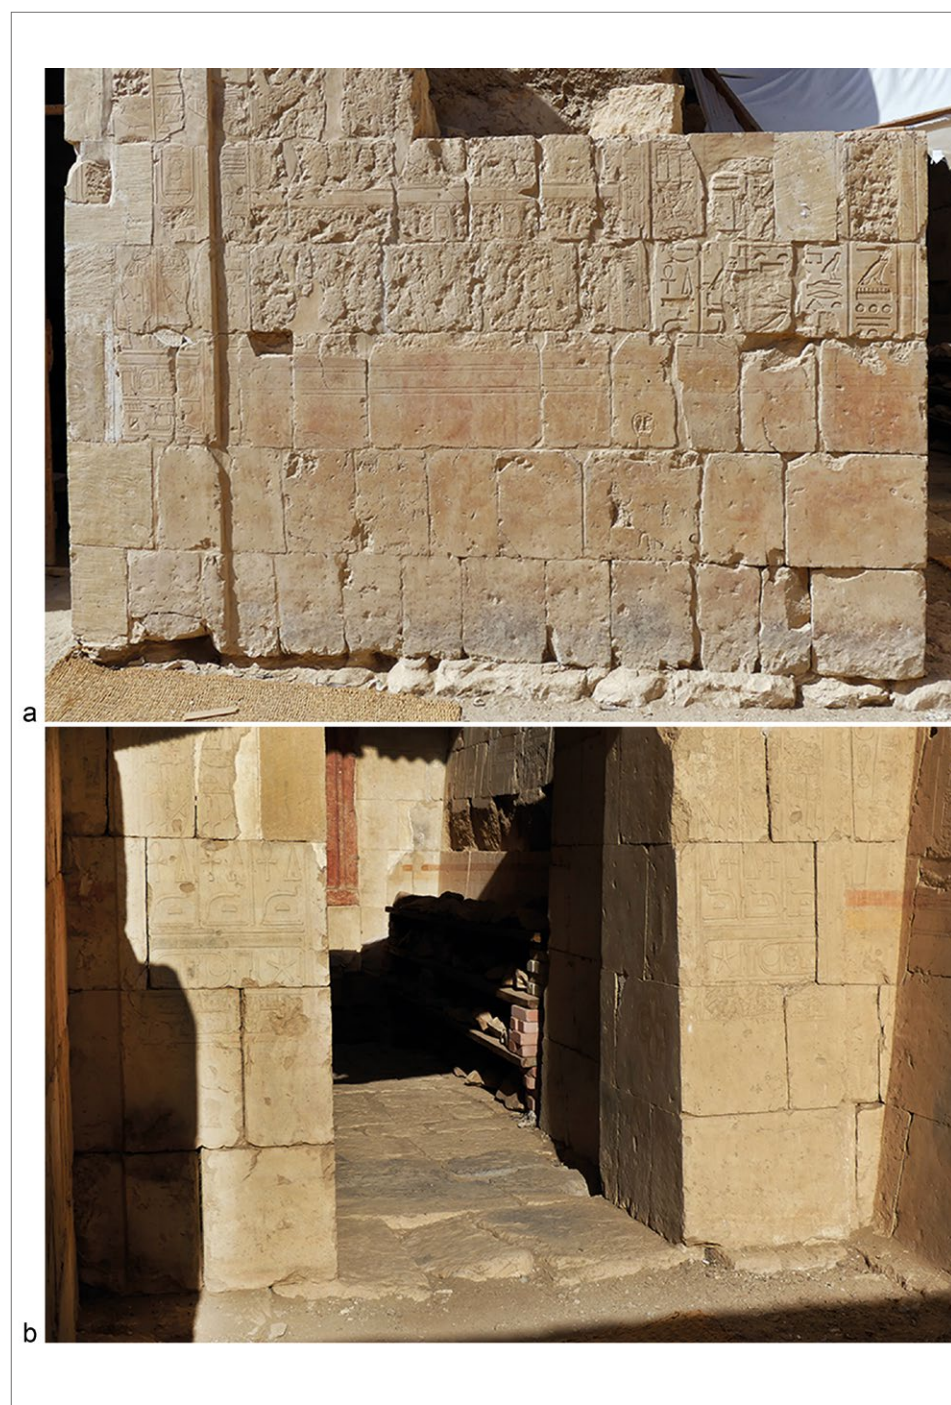
Fig. 4. Differences in the construction of the façades: a – Chapel of Hatshepsut and b – Chapel of Thutmose I (Photos A. Kwaśnica)

while the extension was built of much smaller blocks [Fig. 4:a, b].⁶

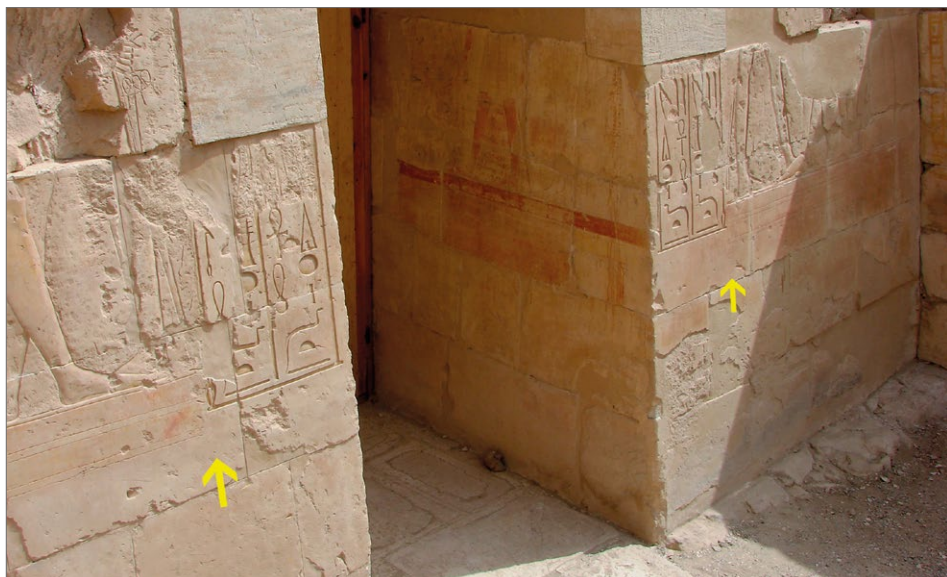
Fig. 5. Portal lacking a band around the entrance. Arrows indicate the place where it should have been. Decorations were executed on a flat wall, originally meant to be plain [see Fig. 3:4] (Photo and processing A. Kwaśnica)

Walls in this part of the temple were originally not meant to be decorated, as indicated by the lack of decorative bands around the portals [Fig. 5].⁷ The decorations were executed after the establishment of the Mortuary Cult Complex.

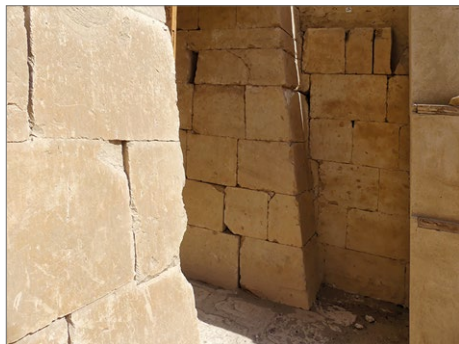
Fig. 6. Joint of the southern wall of the Upper Courtyard (left) and the eastern wall of the Room with a Window, which is simultaneously the southern part of the Upper Portico [see Fig. 3:6] (Photo A. Kwaśnica)

[Fig. 6].⁸ Jadwiga Iwaszczuk (2017: 89) also suggests that originally there was only a floor on the site of the Upper Portico, and the columns were a later addition.

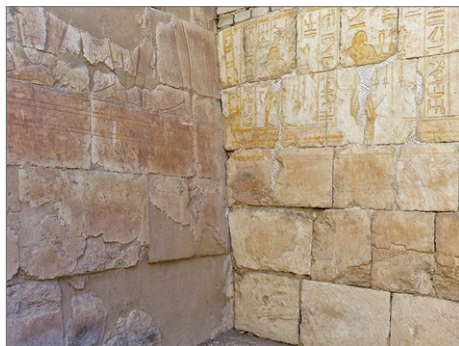
Fig. 7. Eastern wall of the Royal Mortuary Cult Complex abutting the southern wall of the Upper Courtyard [see Fig. 3:5]. The later wall was built of smaller blocks (Photo A. Kwaśnica)

Royal Mortuary Cult Complex was separated from the Room with a Window by a new wall with niches, which was attached to the already standing southern wall of the Upper Courtyard [Fig. 7] (Wysocki 1992: 246–248).

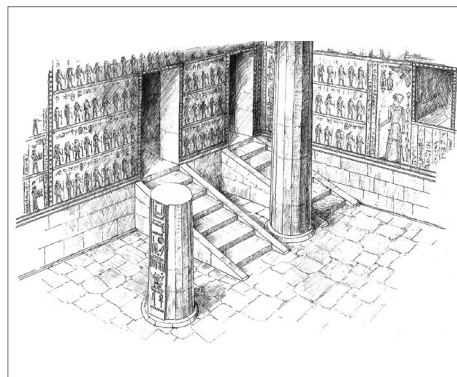
Fig. 8. Visualization of the southeastern corner of the Vestibule of the Chapel of Hatshepsut (Drawing A. Kwaśnica)

Barwik and Dziedzic 2021: 37–41). In addition, a small open niche is present in the southern wall of the Vestibule of the Chapel of Hatshepsut, 2.09 m above the floor [see Fig. 8]. In the case of large niches, however, no such examples have been found, and all other niches, chapels, and portals always had doors and could be closed. This raises the question of why Niches A and B were constructed differently.

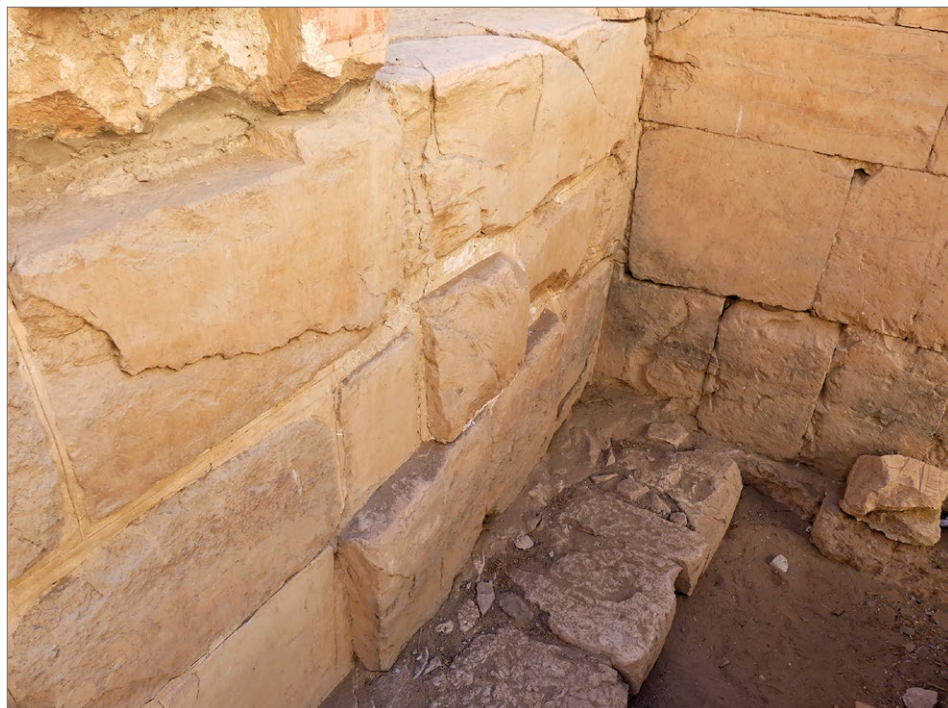
Fig. 9. Blocks protruding from the face of the wall beneath the entrance to Niche B (Photo A. Kwaśnica)

of blocks protruding from the face of the wall beneath the entrance to Niche B. They appear to be remains of a structure anchoring the stairs to the wall [Fig. 9].¹⁴ The elevation of the entrances was not haphazard, given that the niches perfectly fit the decorations. The builders could have placed them 0.40–0.50 m above the ground, making access to them easier, but that was not the priority. Instead, the most important goal was apparently to harmoniously integrate the niches with the decorations of the western and southern walls.

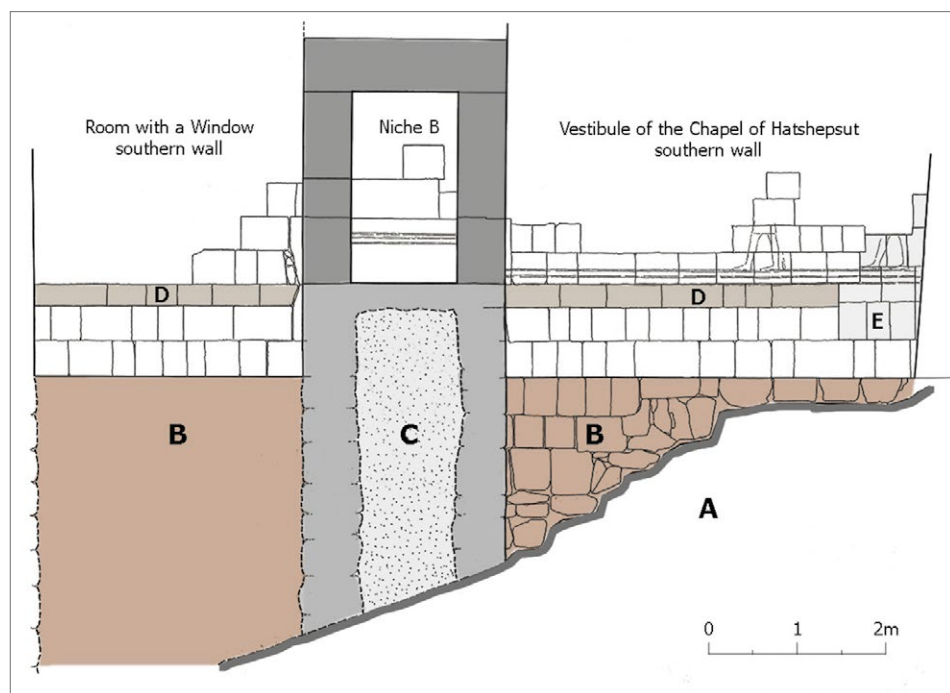
Fig. 10. Cross-section of the eastern wall of the Vestibule of the Chapel of Hatshepsut with a view of its southern wall and of the southern wall of the Room with a Window. A – Esna shale; B – stone foundation of the walls; C – rock debris; D – third layer of blocks leveling the walls and the platform under the niches; E – earlier fragment of the wall (PCMA UW | drawing A. Kwaśnica, based on a drawing of A. Brzozowska-Jawornicka)

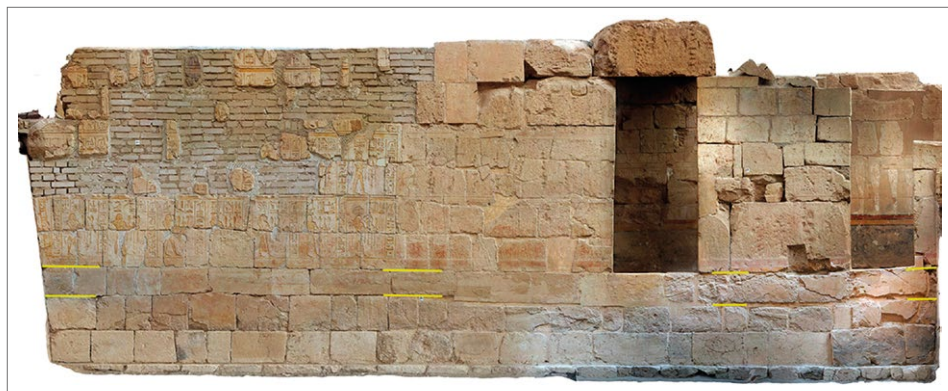
Fig. 11. Eastern wall of the Vestibule of the Chapel of Hatshepsut with its third layer highlighted. In the southern part, this layer serves as the floor of both niches (PCMA UW | photo M. Caban, processing A. Kwaśnica)

tions was gradually filled to bring both areas (the vestibule and the Room with a Window) to level, thus creating an extension of the platform in the southern corner of the Upper Terrace. At that point, the builders reached for an interesting solution in construction of the floors of the niches. Once the walls of the T-shaped structure were two layers high above the flooring, the third layer was laid using narrow, long blocks. Their top surfaces, which formed a level, horizontal line in the wall faces, constituted the flooring of both niches [Figs 11–12].

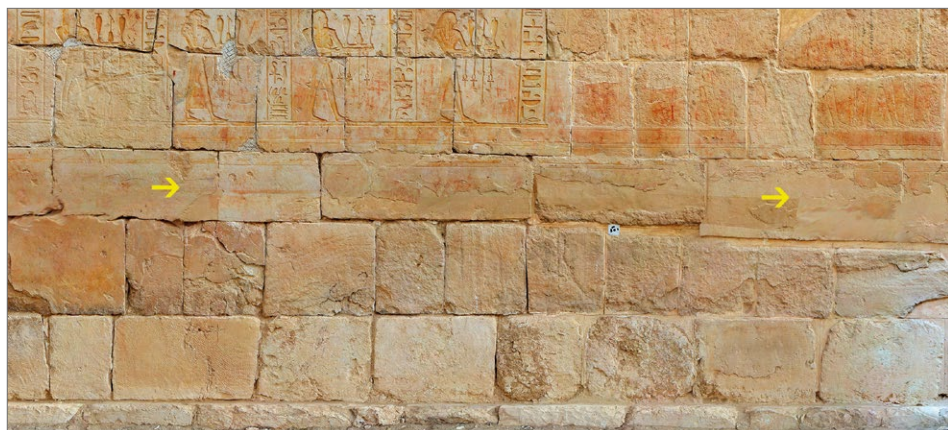
Fig. 12. Third layer of blocks marked with arrows. The blocks in this layer are longer and thinner than in other layers of the eastern wall of the vestibule. The top surface of this layer forms an even, horizontal line. The layer continues throughout the entire length of the southern wall of the vestibule and the Room with a Window [see Fig. 10] (PCMA UW | photo M. Caban, processing A. Kwaśnica)

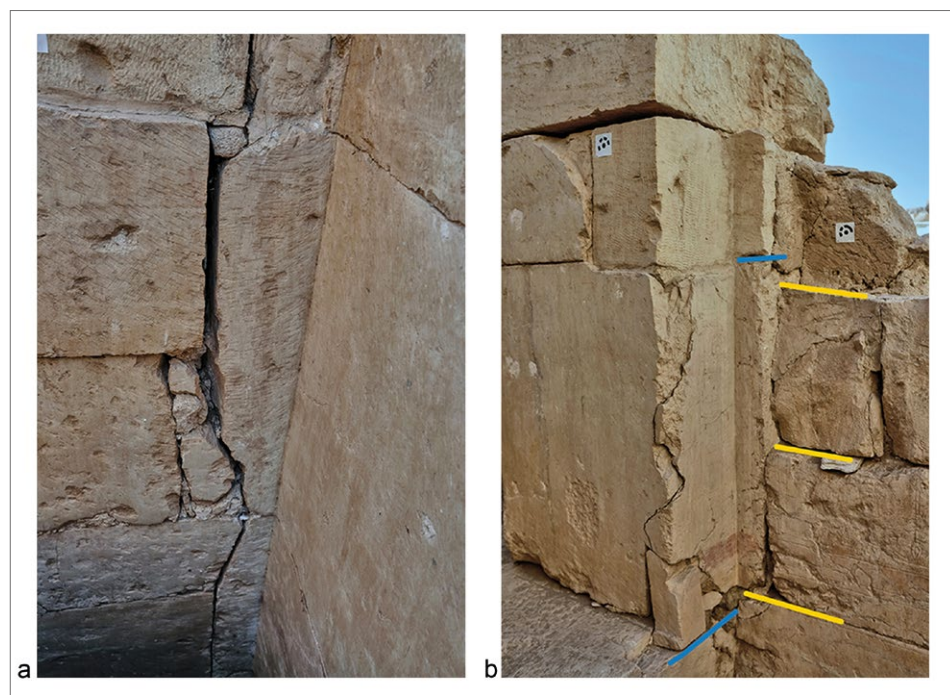
Fig. 13. Lack of bonding between niches and adjacent walls: a – blocks of Niche B added to the southern wall of the Room with a Window and the Vestibule of the Chapel of Hatshepsut (Photo M. Jawornicki); b – much smaller blocks adjoining the blocks of the niche (Photo M. Jawornicki, processing A. Kwaśnica)

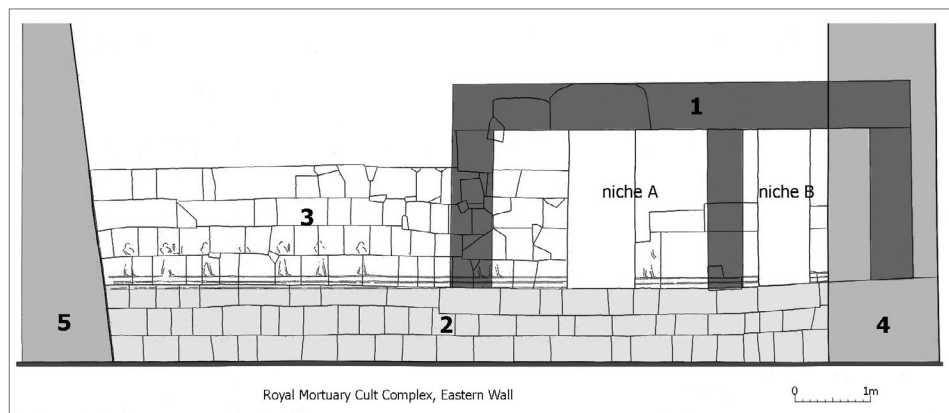
Fig. 14. Placement of Niches A and B in the northern part of the eastern wall: 1 – niches; 2 – three layers of the eastern wall; 3 – part of the wall with regular layers of blocks; 4 – southern wall of the vestibule; 5 – southern wall of the Upper Courtyard (Drawing A. Kwaśnica)

the wall to the north. The layers of stone are not interlaced, and the blocks of the whole structure are haphazardly arranged. This leads to a conclusion that the niches were built separately from the wall adjoining them from the north [Fig. 14].

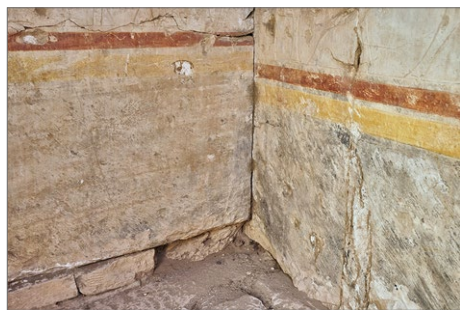
Fig. 15. Corner of the northern and eastern walls of Niche A (Photo M. Jawornicki)

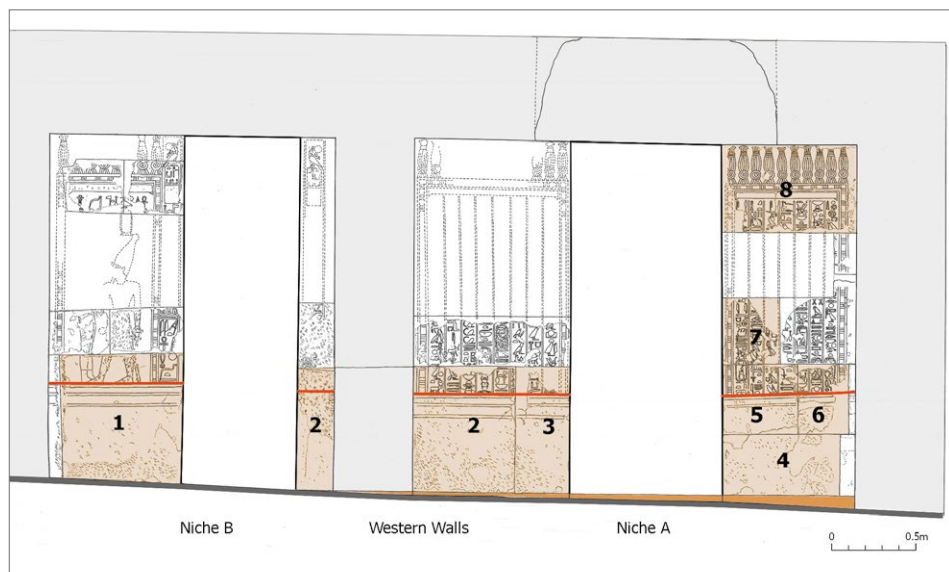
Fig. 16. Western wall of Niches A and B. The marked and numbered blocks were decorated on both sides. A wedge leveling this part of the wall is visible in the lower right corner, under Block 4 (Drawing A. Kwaśnica, on the basis of Egyptological documentation by J. Karkowski)

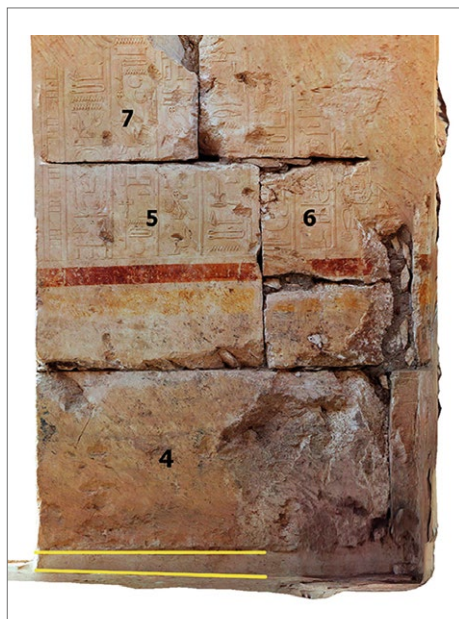
Fig. 17. Blocks Nos 4–7 in the western wall of Niche A. The red line indicates where the top of the dado rail should be; the yellow line marks the wedge-shaped plinth (PCMA UW | photo M. Caban, processing A. Kwaśnica)

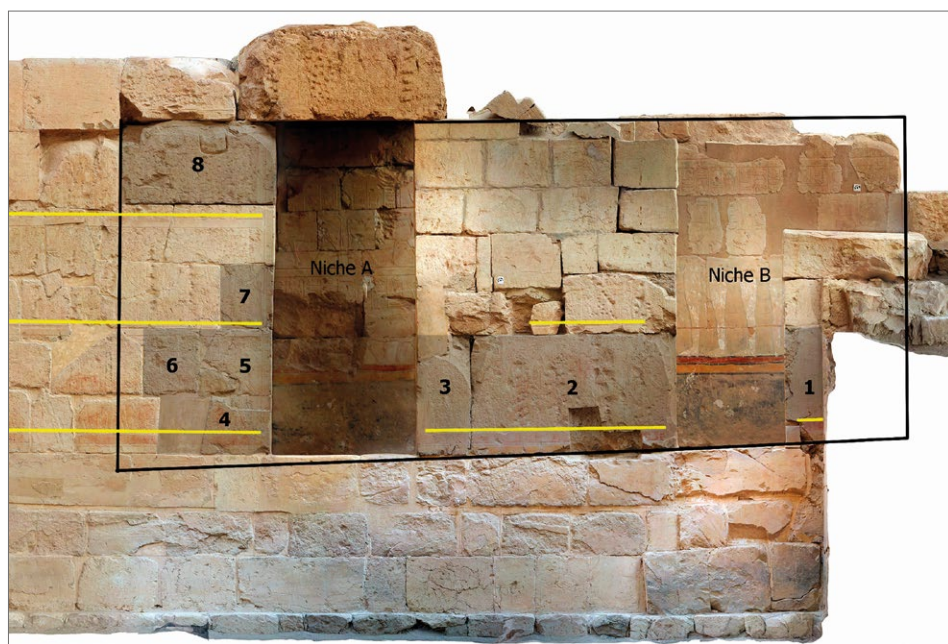
Fig. 18. Eastern wall of the Vestibule of the Chapel of Hatshepsut with the wedge-shaped plinth and the walls of the niches marked. Blocks Nos 1–8 are decorated on both sides. Yellow lines mark the horizontal elements (parallel to the floor) in the decorative scenes on the exteriors of the niches (PCMA UW | photo M. Caban, processing A. Kwaśnica)

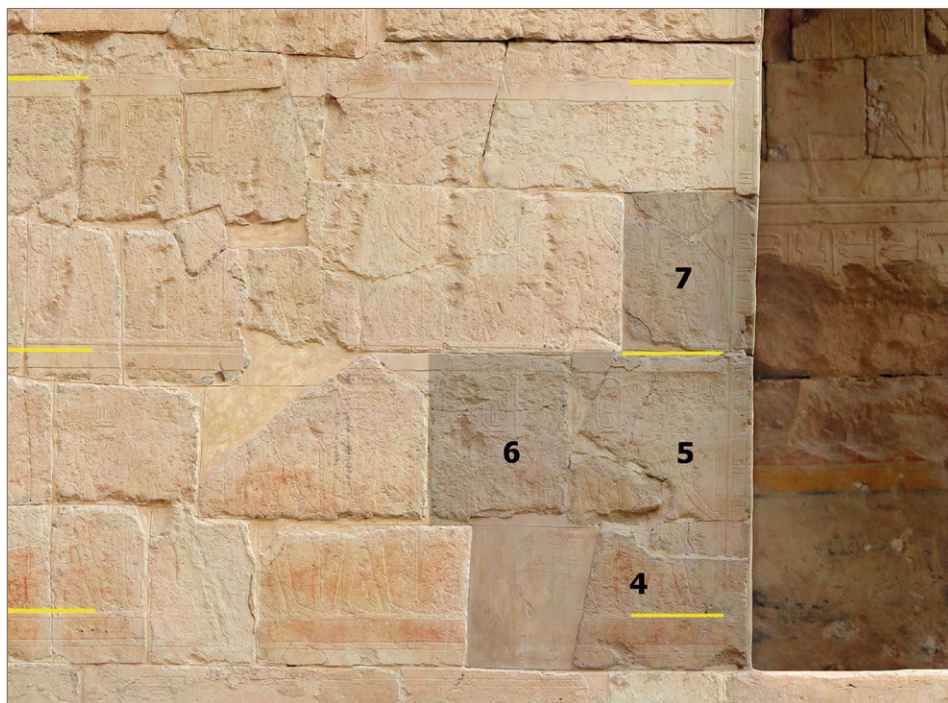
Fig. 19. Eastern wall of the Vestibule of the Chapel of Hatshepsut. Blocks Nos 4–7 are decorated on both sides, which means that they could not have been moved without destroying the scenes. The exterior decoration on the walls of the niches must have been executed when these blocks were placed in their present position (PCMA UW | photo M. Caban, processing A. Kwaśnica)

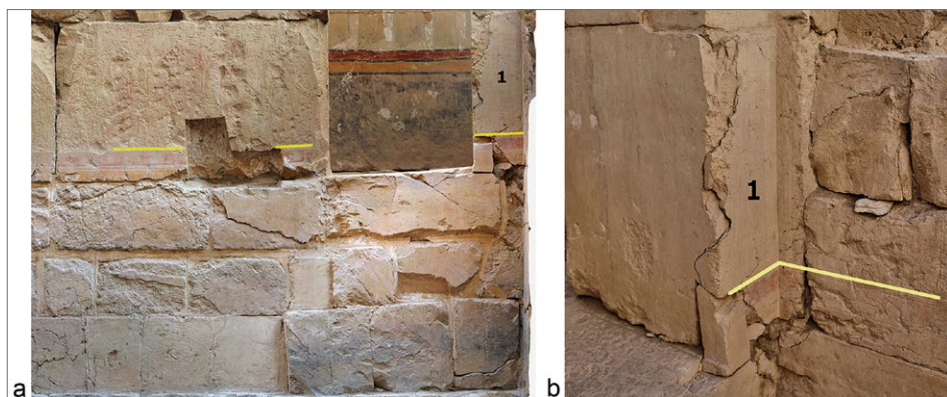
Fig. 20. Connection of the eastern and southern walls of the Vestibule of the Chapel of Hatshepsut: a – the dado rail on the eastern wall of the vestibule (PCMA UW | photo M. Caban, processing A. Kwaśnica); b – the dado rail on both walls is on the same level (Photo M. Jawornicki, processing A. Kwaśnica)

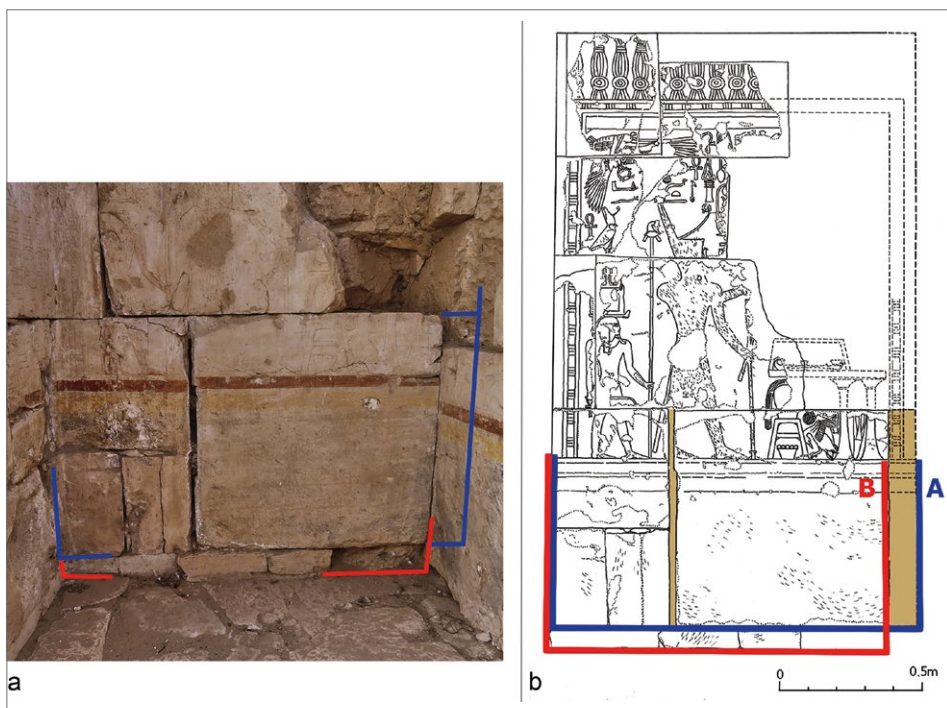
Fig. 21. Northern wall of Niche A: a – the blue line marks the original length of the wall, and the red line shows its current condition (Photo and processing A. Kwaśnica A. Kwaśnica); b – reconstruction of the wall. The cut fragments of the blocks are highlighted in brown. The blue line (A) marks the original floor level and width of the niche. The red line (B) shows the current floor level and width of the niche (Drawing A. Kwaśnica, on the basis of Egyptological documentation by J. Karkowski)

the other side. The original large block with the dado and the offering table had been trimmed by several centimeters on the right-hand side, depriving the scene of the decorative border in that part. A sketch of the missing fragment [Fig. 21:a] and a reconstruction of the scene on the northern wall of Niche A are provided herein [see Fig. 21:b].

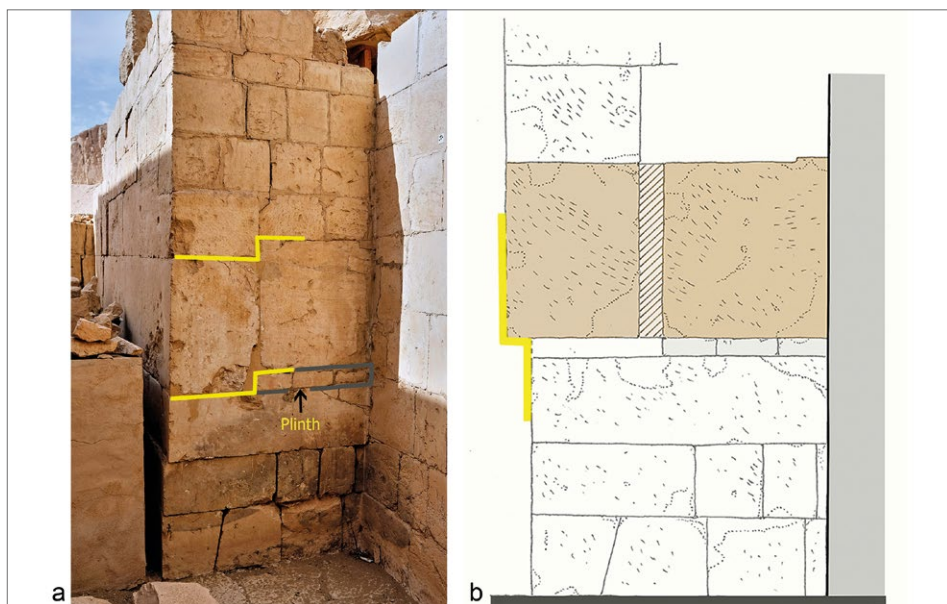
Fig. 22. Northern wall of Niche A: a – in the Room with a Window, showing the effects of placing the plinth under the wall (Photo M. Jawornicki, processing A. Kwaśnica); b – the drawing shows the niche in its original width (Drawing A. Kwaśnica)

thickness of one block. Thus, any attempt to recreate the original appearance of the decorations on the northern wall inside Niche A would have caused the niche to protrude beyond the plinth [Fig. 22:a, b].

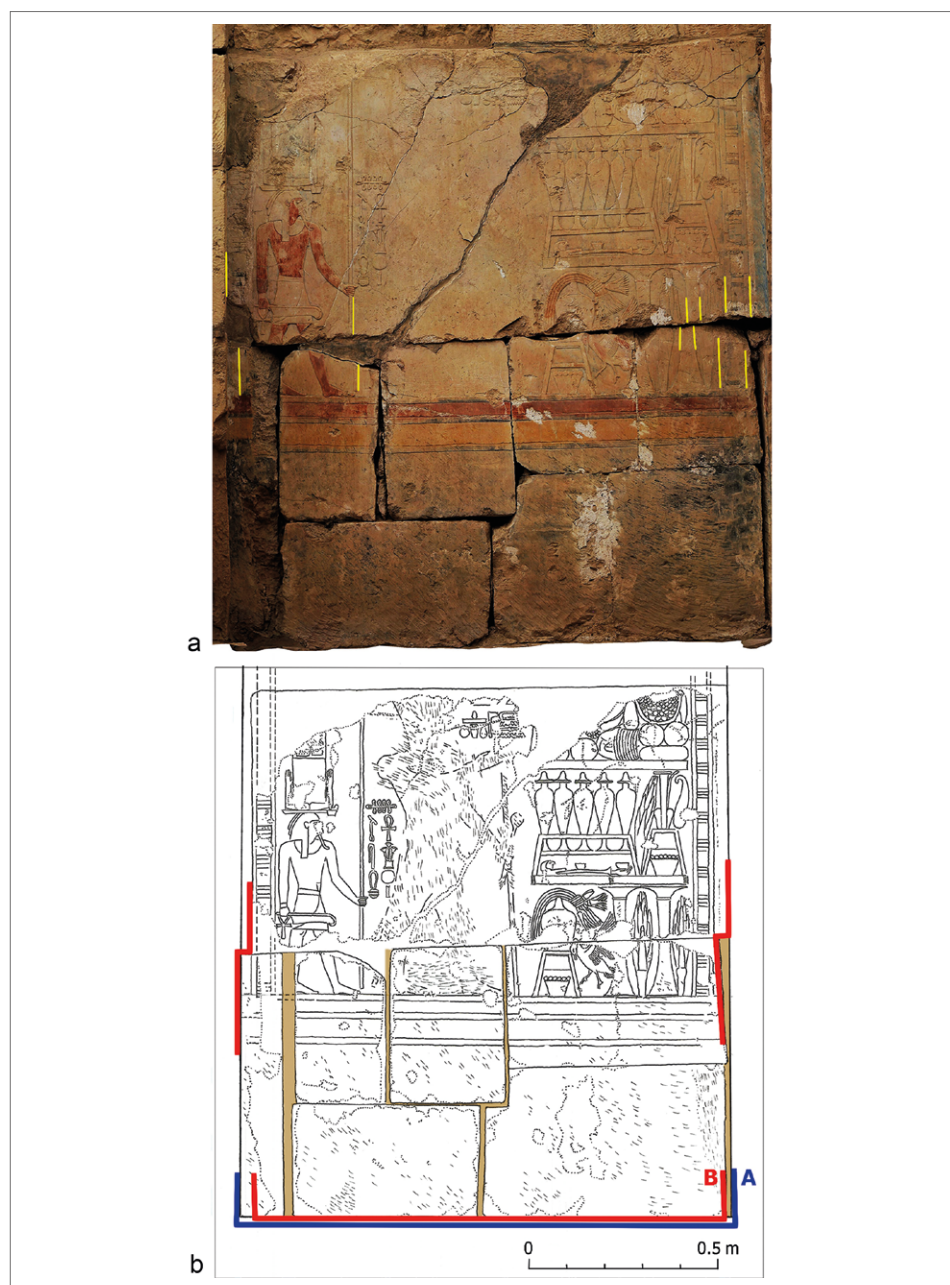
Fig. 23. Northern wall of Niche B separating it from Niche A: a – photo with the yellow lines showing the incorrect arrangement of the upper and lower blocks, which resulted in the deformation of the decoration (Photo M. Caban, processing A. Kwaśnica); b – reconstruction of the wall with the cut-off fragments of blocks highlighted in brown. The blue line (A) marks the original width of the niche. The red line (B) shows the current width of the niche (Drawing A. Kwaśnica, on the basis of Egyptological documentation by J. Karkowski)

The wall separating the two niches is a similar case: it was also built of blocks, which had been decorated and subsequently cut in several places [Fig. 23:a, b]. Reassembly of the blocks to keep the original decoration was impeded by the limited space between the side walls of the niche, too small to recreate the full length of the northern wall. The eastern wall would have to be shifted by 6–7 cm to accommodate original decoration including the missing part. Interestingly, the blocks that had been cut off

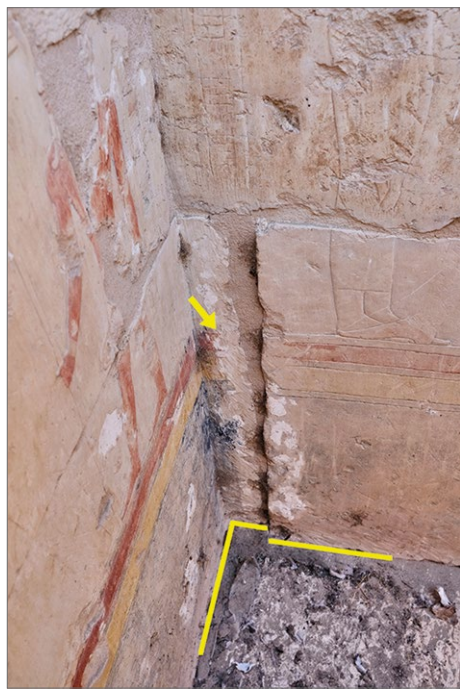
Fig. 24. Southwestern corner of Niche B. The faces of adjacent blocks do not form a single plane. In the time of Hatshepsut, both blocks were cut, plastered and covered with polychromy. Traces of ancient plaster are still visible on the surface (Photo M. Jawornicki, processing A. Kwaśnica)

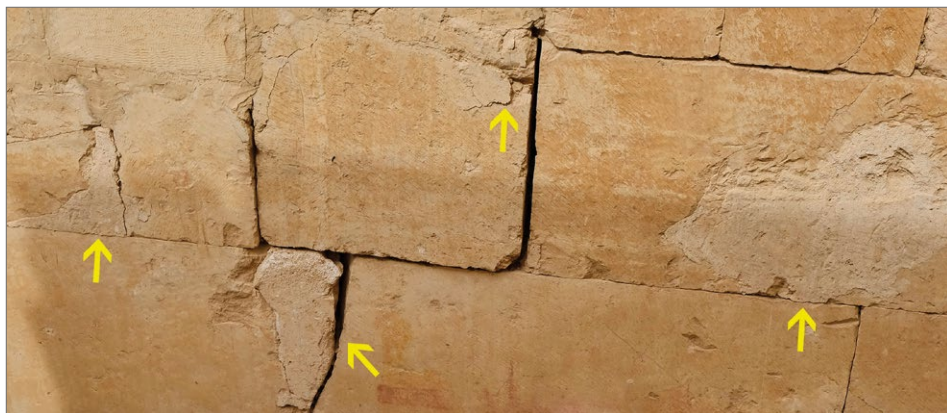
Fig. 25. Eastern wall of Niche B in the Room with a Window. Arrows indicate cavities patched with lime mortar most likely at the time of erecting the niches (Photo M. Jawornicki; processing A. Kwaśnica)

quired careful masonry work. However, it was not possible to cut each block separately. Firstly, both niches had to be reassembled in the new location, and only then could the rough blocks, which simultaneously became the face of the western wall of the Room with a Window, be cut down and leveled.¹⁸ Cutting off too much would make the walls too thin. Leaving the walls too thick would lead to many uneven surfaces. As a result, after the final leveling of the face, there were still rough surfaces that had to be hidden under the mortar. Remains of this mortar and rough surfaces are still visible today [Fig. 25].

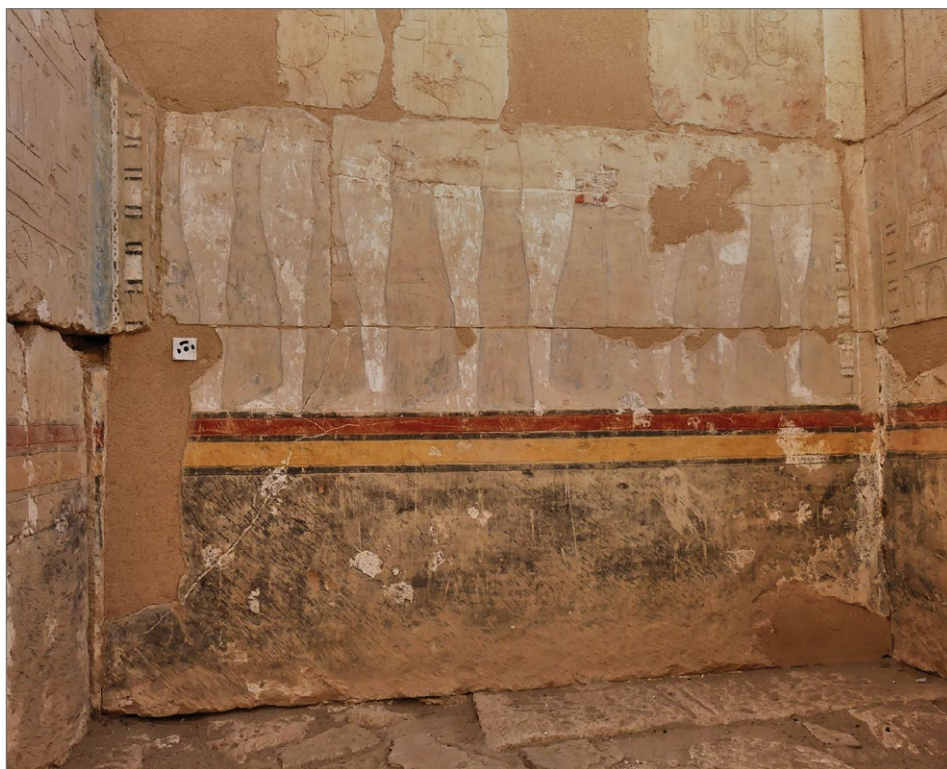
Fig. 26. Large limestone slab in the eastern wall of Niche B (Photo A. Kwaśnica)

In the light of the above, the exact dimensions of the plinth are nearly impossible to calculate. The final external dimensions of the niches had to be corrected on site during their reassembly. The only mistake that could have been avoided was building a platform with a non-sloping upper surface. On the other hand, the slope of the plinth may have also been caused by uncontrollable subsidence of a part of the foundations, which seems very likely upon examination of the third leveling layer of blocks of the eastern wall of the vestibule. At the time of construction, the plinth should have been parallel to the floor of the vestibule, and now it is not [see Niche B, Figs 11, 14]. Reconstruction of the niches in a new place, on a new pedestal, began with the placement of large slabs 0.74–0.76 m high around the entire plinth [Fig. 26].

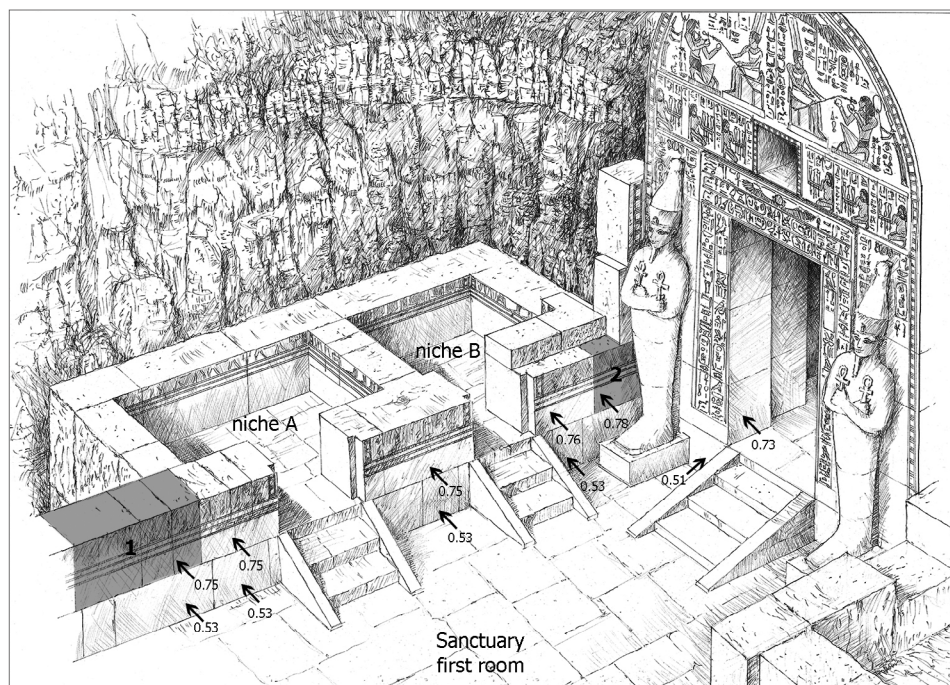
Fig. 27. Visualization of the first room of the Sanctuary prior to the removal of Niches A and B. 1, 2 – blocks that remained *in situ*. The blocks with specified heights (e.g. 0.75), given in meters, are indicated with arrows. The sizes of the blocks indicate that the lower course of the southern wall of the sanctuary and the lower course of blocks from Niches A and B had originally formed one structure (Drawing A. Kwaśnica)
