Alexandria, Kom el-Dikka, season 2021

Abstract: Excavations of the central part of the Kom el-Dikka archaeological site in Alexandria have reached early Roman levels and the current investigations of the PCMA UW expedition are focused on completing the excavation of some of the partly uncovered architecture. The southwestern part of House FA was explored, uncovering two fragments of colourful mosaic floors. Building chronology was established based on finds from two deep stratigraphic probes dug inside the structure. The main phases of occupation of House FA turned out to be comprised in a period between the 1st and 3rd centuries CE.

Grzegorz Majcherek

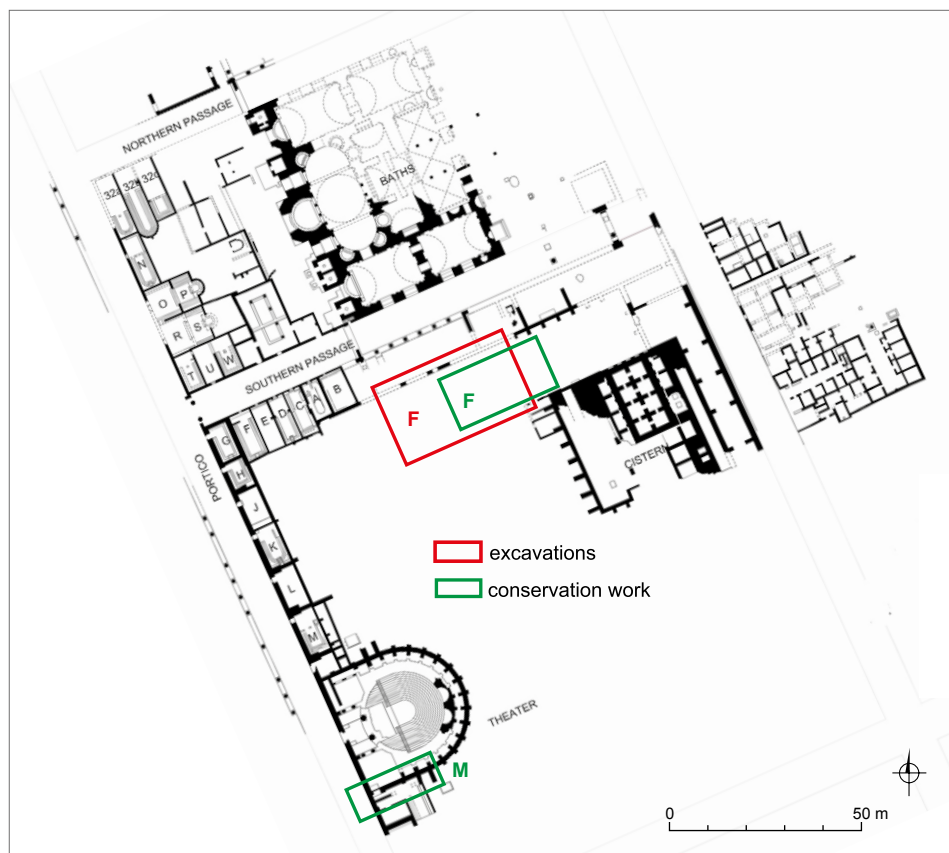
Fig. 1. Kom el Dikka archaeological site: areas of excavation and conservation work completed in the 2021 season (PCMA UW | drawing W. Kołtąj, updated D. Tarara)

Following a forced, pandemic-induced disruption of the fieldwork in 2020, the expedition returned to the site with an annual multi-faceted programme of archaeological research and preservation work. The conservation programme is currently geared to needed repairs and maintenance work across the site, whereas archaeological excavations in the 2021 season were concentrated in the central part of the site (sector F) [Fig. 1].

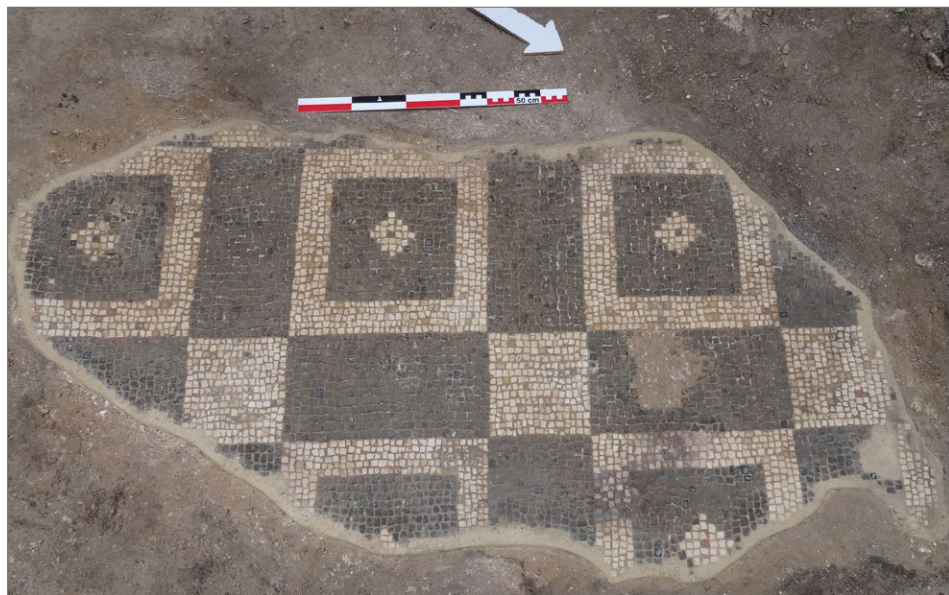
Fig. 3. Remains of a mosaic floor in room FA-9 (PCMA UW | photo G. Majcherek)

Fragmentary mosaic floors were discovered in the respective rooms at approximately 6.10–6.20 m asl, directly below the destruction layers. The smaller mosaic fragment (2045.21), in FA-9, measuring roughly 0.70 m by 1.50 m, featured a simple geometric design, composed of

regularly set squares of black tesserae, surrounded with white ones and separated by black rectangles [Fig. 3].

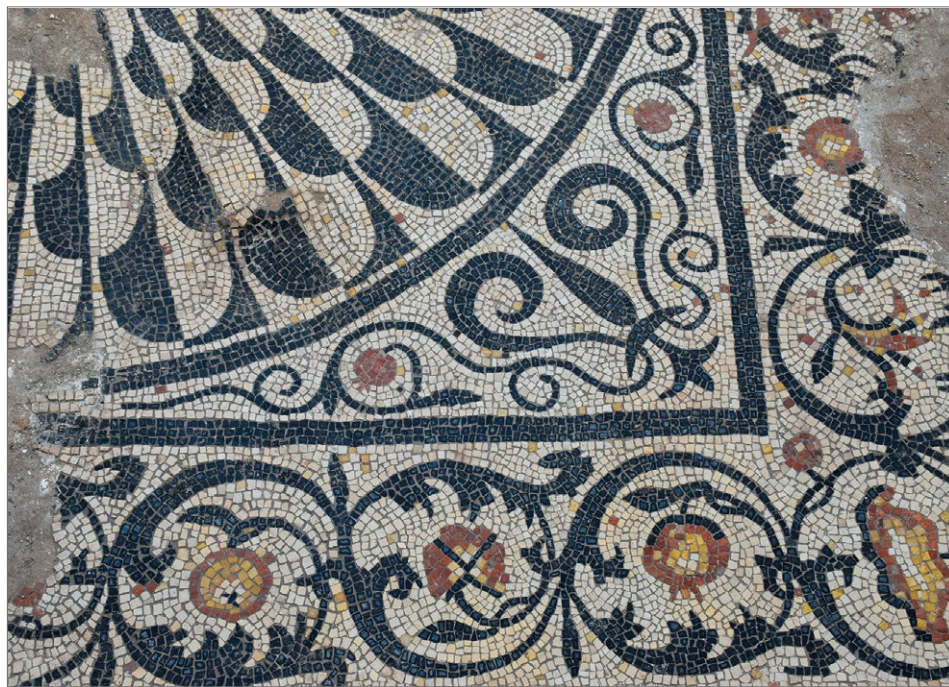
Fig. 4. Mosaic floor in room FA-10 (PCMA UW | photo G. Majcherek)

The larger mosaic (2018.21) in the adjoining room FA-10 was far better preserved. The main tessellated field, formed a square, 2.90 m to the side, framed by a band of six rows of black cubes, enclosing a strip of inhabited acanthus scroll, on a white background [Fig. 4]. A single running scroll stems from an acanthus foot, located in the center of the eastern side of the panel. Inside each loop there are additional flower sprouts, buds, pomegranates and *hederae*. The vegetal ornament was made of tesserae in four principal colors: white for the background, and mostly black, orange-red and yellow for the scrolling pattern. A band of three rows of black cubes separated the scroll ornament from the central panel, which measured 2.00 m to the side. The panel had an inscribed shield of black-and-

white interchanging scales. The spandrels were filled with a schematic vegetal scroll, featuring also pomegranates and *hederae*. There was a small central emblem (approximately 0.30 m in diameter), which has not survived. The mosaic was executed using medium-size tesserae, with a mean density of about 85–90 cubes per square decimetre ($\approx 100 \text{ cm}^2$). The tesserae were cut from common, widely available stone, such as basalt or greywacke, Proconnesian marble, *breccia corallina*, *giallo antico* and Egyptian limestone.

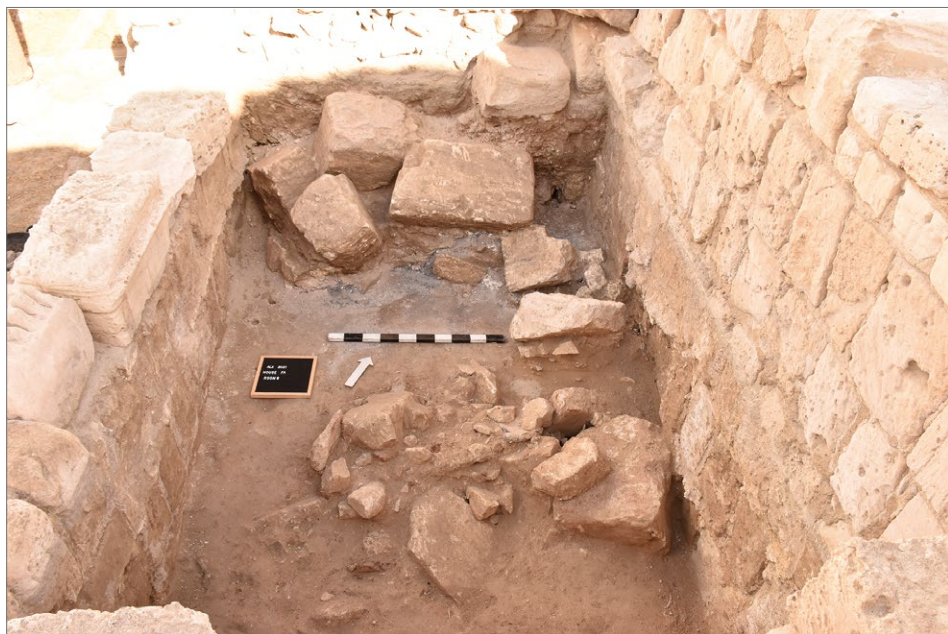
Fig. 5. Stone collapse in room FA-9, looking north (PCMA UW | photo G. Majcherek)

A notable feature was a stone collapse, accompanied by fragments of multicoloured plastering, found in room FA-9 (contexts 2011.21 and 2022.21) [Fig. 5]. Some of the ashlar, apparently originating from the damaged or dismantled walls of the room, were particularly large, often exceeding 1 m in length. They bear witness to a well-developed technique of wall structuring. The north wall of room FA-9 was found to be almost entirely dismantled. It is tempting to associate this operation with the subsequent construction of a double well in the adjacent room FA-7. Similarly, the west wall of room FA-9 had been robbed in antiquity and was largely restored within the framework of the current preservation programme.

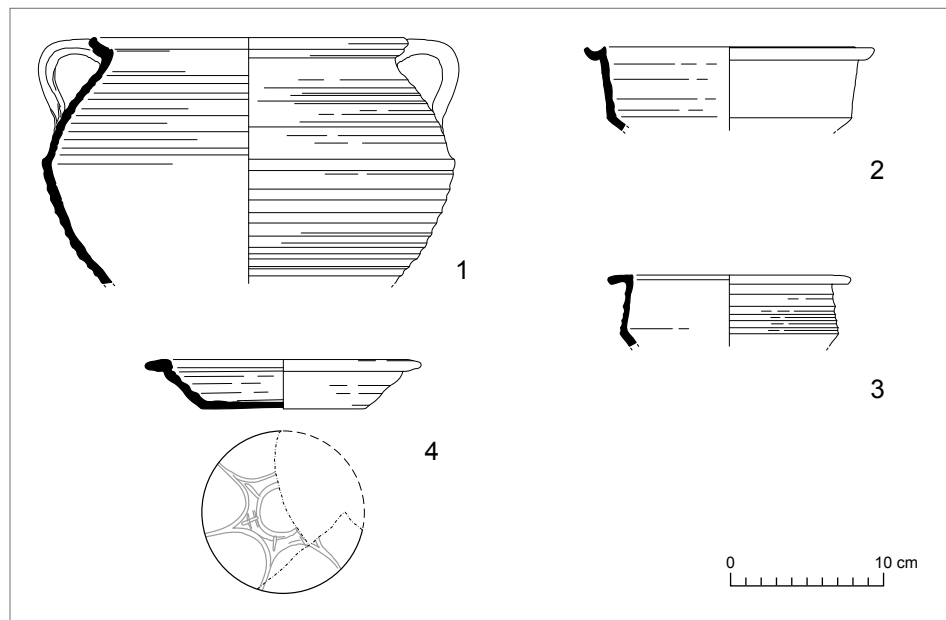
Fig. 4. Selection of early Roman pottery from rooms FA-9 and FA-10 (PCMA UW | drawing G. Majcherek, E. Kulicka. digitizing M. Momot)

tion of this part of the building. Finds demonstrated the usual range of forms and types, typical of the 2nd–3rd/early 4th centuries CE horizon [Fig. 6]. Most of the fragments recorded belong to transport containers. In addition to the quite sizeable presence of Mareotic and Nile silt AE3 amphorae (Dixneuf 2011: 97–128), there was quite a collection of foreign vessels. Sherds of small cylindrical, white-washed amphorae from Cilicia (Agora M239), and varied forms of Cretan (Marangou-Lerat 1995, forms AC1–3) as well as other Aegean amphorae were well in evidence. A number of double-handled, wide-mouth water jugs, with a distinctive heavily profiled foot, was also recorded. Characteristic features of their Nile silt fabric indicate that they could have originated from the workshops of the western Delta, although so far their presence on a larger scale has been recorded only in Alexandria.

Kitchen ware vessels made in very similar fabric were prolific. Apart from typical globular cooking pots [Fig. 6:1] and casseroles [Fig. 6:2–3], a number of Egyptian made pans of the *orlo bifido* type was recorded. Of great interest was a small casserole (2017.13.21) with everted rim and unusual, *post cocturam* incised decoration located on the underside of the bottom [Fig. 6:4]. It featured a six-petalled star-like rosette with an inscribed circle.

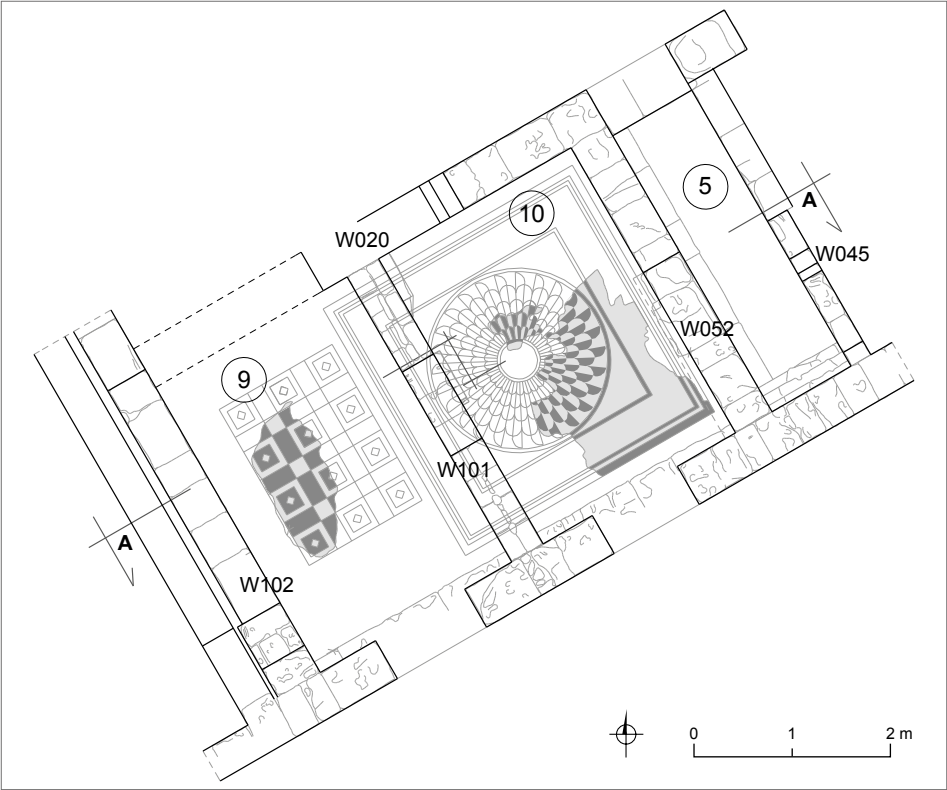
Fig. 7. Mosaic floor from a chamber later divided into Rooms FA-9 and FA-10 (PCMA UW | drawing M. Polak)

Finding the two mosaic fragments is crucial for a reinterpretation of the two rooms FA-9 and FA-10. The size and disposition of the preserved fragments imply one large mosaic floor originally decorating a single, large room (5.10 m by 3.30 m), which was only later divided into two smaller rooms FA-9 and 10 [Figs 7–8]. The

In this later phase, the newly formed Rooms FA-9 and FA-10 must have had their mosaics covered with new floors and were most probably used as shops (*tabernae/oikemata*) as implied by their total separation from the main body of the house, and the presence of doors giving access to the respective rooms directly from the street [see Figs 7–8].

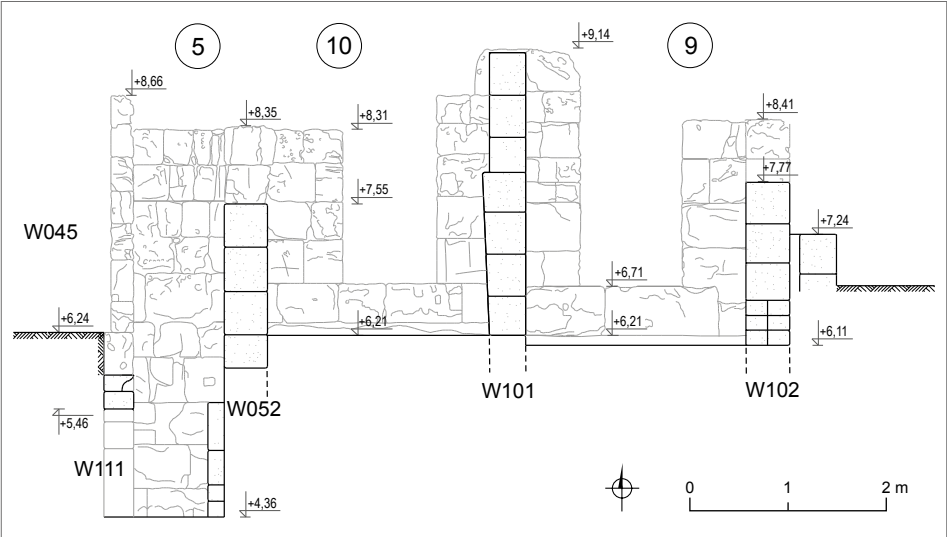
Fig. 8. Rooms FA-9 and FA-10, east-west cross section (PCMA UW | drawing M. Polak)

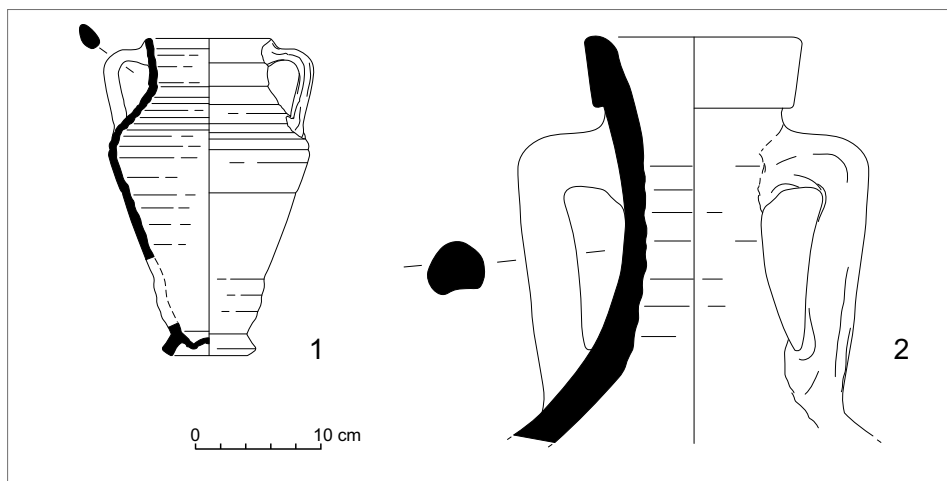
Fig. 11. Pottery finds from the cesspool in room FA-5 (PCMA UW | drawing G.Majcherek, digitizing M. Momot)

meaningful finds one should list an almost complete, 3rd-century-CE, profiled foot jug, manufactured in Nile silt fabric [*Fig. 11:1*] and an upper fragment of a large Dressel 6A class amphora [*Fig. 11:2*], produced in the 1st century BCE–1st century CE in the Italian/Adriatic region (Cipriano and Carre 1989). This amphora, which is rather rare from excavations in Alexandria and Egypt in general, was used principally as a container for wine or olive oil (Şenol 2018: 301–320).

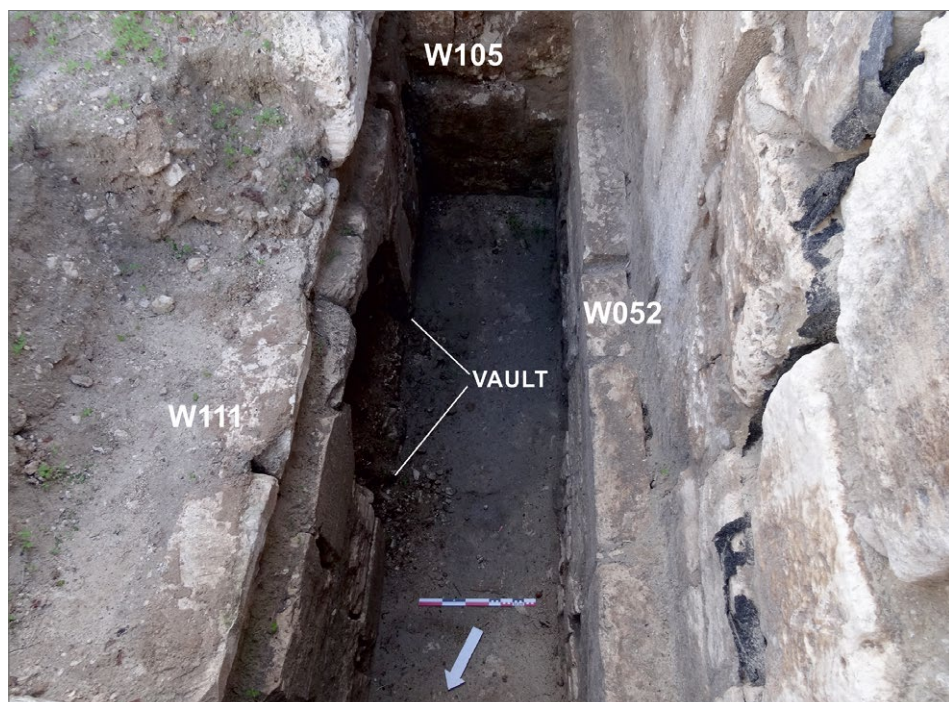
Fig. 10. Cesspool in Room FA-5, looking south (PCMA UW | photo G. Majcherek)

In room FA-5, adjoining room FA-10 from the east, a well preserved reservoir, most probably serving as a cesspool, was cleared [Fig. 10]. The reservoir (3.20 m by 0.78–0.80 m) was sunk some 1.85 m below the floor level. The cesspool was in all probability designed to receive sewage

from a nearby vertical shaft (0.30 × 0.40 m in section), evacuating waste water from the second floor, was identified in the southeastern corner of the cesspool. Yet another smaller inlet (0.45 m by 0.20 m) was uncovered in the west wall (W111), leading from the nearby room FA-10. A large stone arch in the east wall (W111), with a span of 1.10 m, leads to another, most likely twin chamber [see *Fig. 10*]. The chamber, cleared this season, was obviously vaulted as evidenced by a distinct, deep undercut designed to support bricks, preserved in its east wall and a similar offset in the western one.

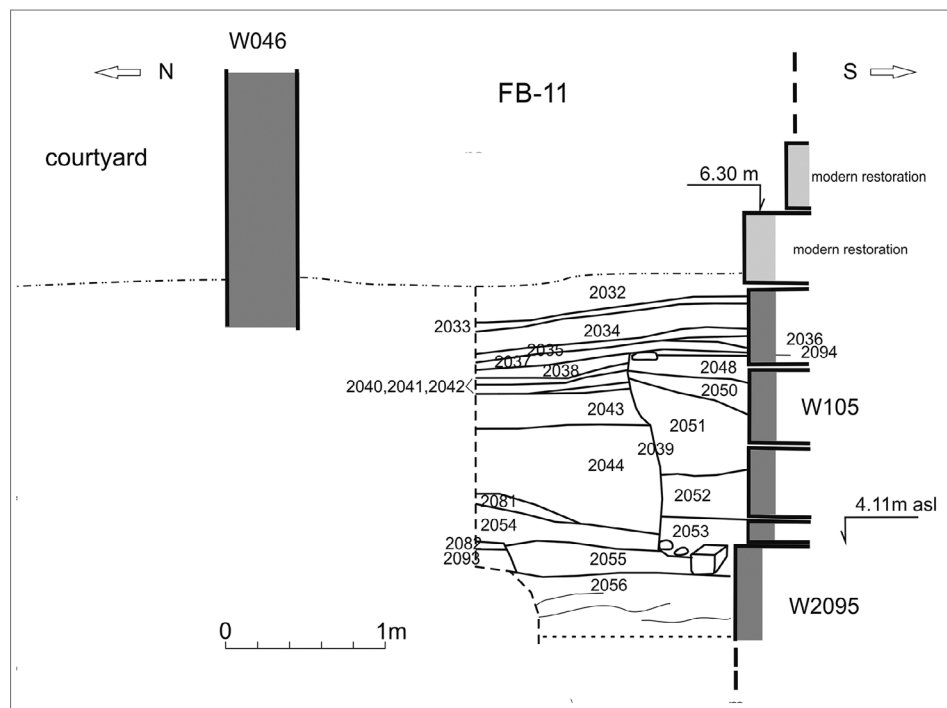
Fig. 12. Eastern face of a probe dug in room FA-11 [see *Fig. 13*] (PCMA UW | drawing E. Kulicka)

The trench, measuring roughly 2.05 m by 3.20 m, was an extension of a pit excavated there in 1998. The excavation now halted at 3.20 m asl, which is the current water table level. A stratigraphic sequence of layers, reaching a total thickness of 2.20 m, documents the transformations of this part of the building [Fig. 12].

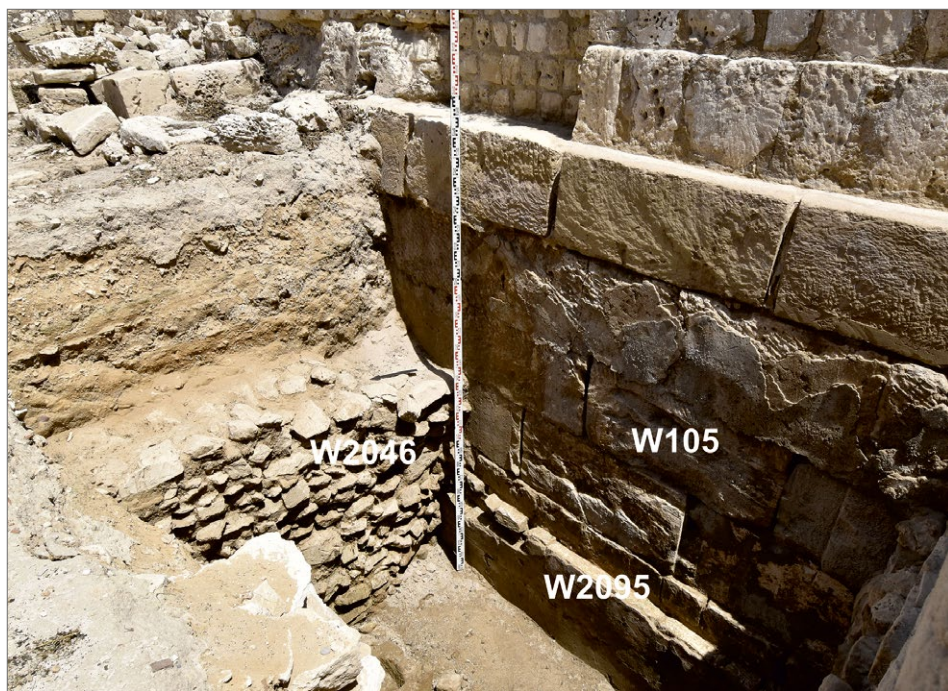
Fig. 13. Probe in room FA-11, looking southeast [see Fig. 12] (PCMA UW | photo G. Majcherek)

It now appears that the Roman House FA was built over the remnants of an earlier construction, in all probability also a house. A section of the late Ptolemaic/early Roman wall (W105), approximately 3.20 m long, was cleared. It was built using carefully worked, extremely large limestone blocks, exceeding 1.20 m in length [Fig. 13]. A single course of

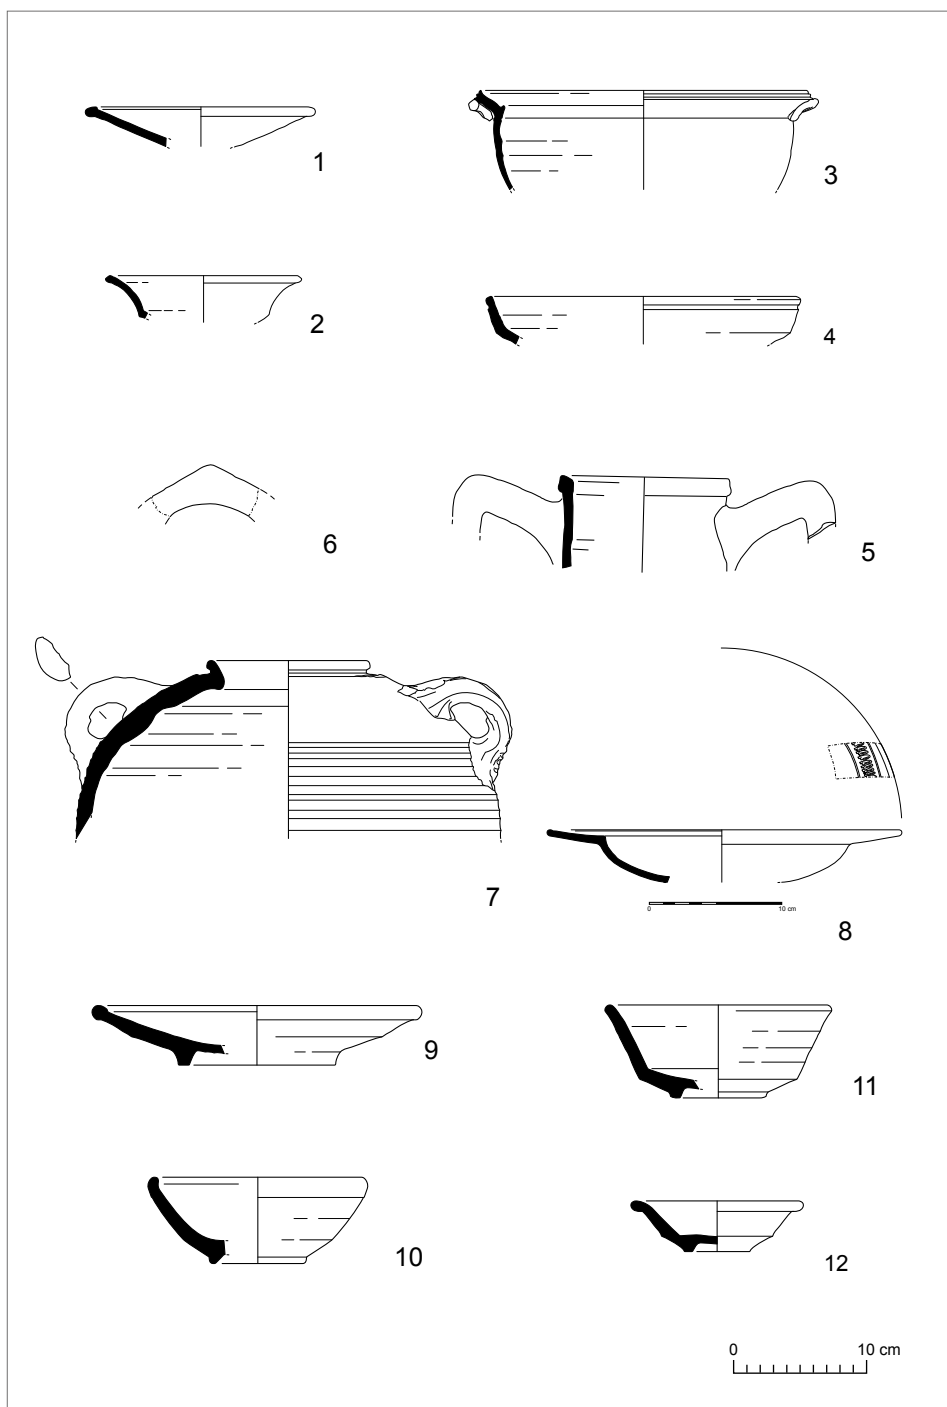
Fig. 14. Selection of pottery finds from probes 1998-11B (1–8) and 2021-2 (9–12) (PCMA UW | drawing E. Kulicka, G. Majcherek; digitizing M. Momot)

were noted: *echinus* bowls, lipped dishes, and flared cups/bowls [Fig. 14:1–2]. The dating of these forms is unfortunately too broad and far from precise. They are generally situated between the 2nd and 1st centuries BCE, but can extend even into the Roman period.

The Roman-age occupational layers inside the house (contexts 2032–2035.21) produced a chronologically mixed set of finds. The ceramic finds, albeit numerous, had a limited chronological potential. The bulk of the recorded fragments represents an early (2nd–3rd centuries CE) version of Gazan amphorae (Majcherek 1995b) [Fig. 14:7]. This is but more proof of the preference for Palestinian wine on the Alexandrian market even at such an early date. Scattered sherds of Cretan Amphorae (unidentified forms) and the northwestern Syrian (Ras el-Bassit) version of Pompei-5-type vessels were also identified (Mills and Reynolds 2014). One of the few pieces of fineware is a fragment of a large bowl of ARS form 45, dated to the 3rd century CE [Fig. 14:8].

A thick sequence of earlier accumulations (contexts 2062.21–2080.21) produced invariably late Hellenistic material (2nd–1st centuries BCE). Also here, a significant representation of Egyptian Black Gloss Ware was observed, with all three standard forms well in evidence [Fig. 14:9–12].

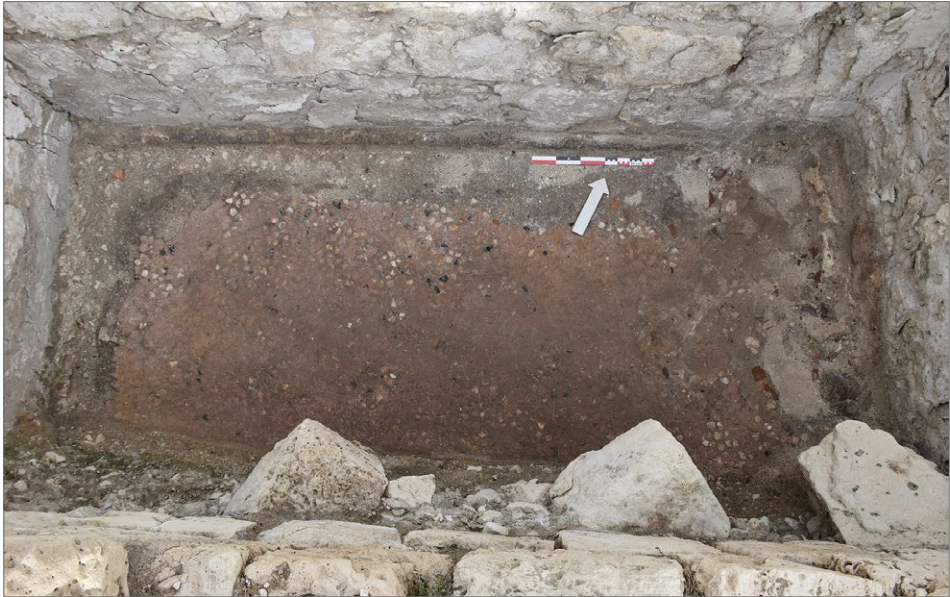
Fig. 15. Floor in room FB-12 of House FB (PCMA UW | photo G. Majcherek)

In all of the rooms the floors turned out to be made of assorted, small and irregularly cut stones embedded in lime mortar [Fig. 15], creating a solid surface. Floors made in the same way were previously discovered also in the western wing of House FB (rooms FB-13, FB15–16, and FB-18). The floors in rooms FB-12 and FB-5 were relatively well preserved, while in FB-10 and FB-11 only small sections have survived. Moreover, in the latter two, the floor level appeared to slope significantly towards the west, probably in consequence of seismic events.

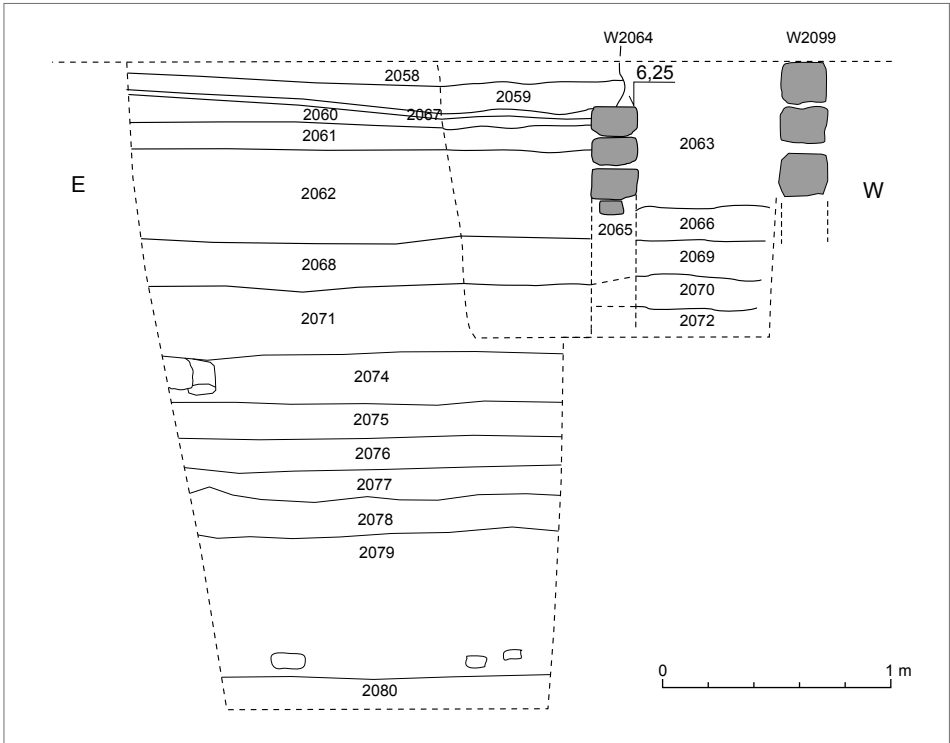
Fig. 16. East-west cross-section through the probe in room FB-16/17 (PCMA UW | drawing E. Kulicka)

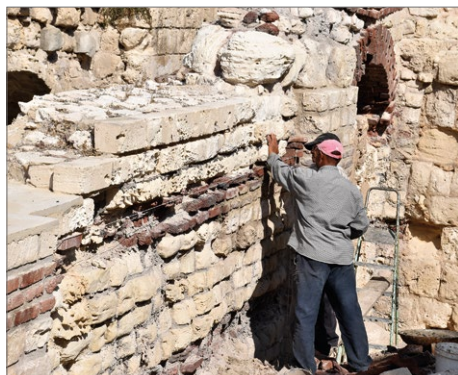
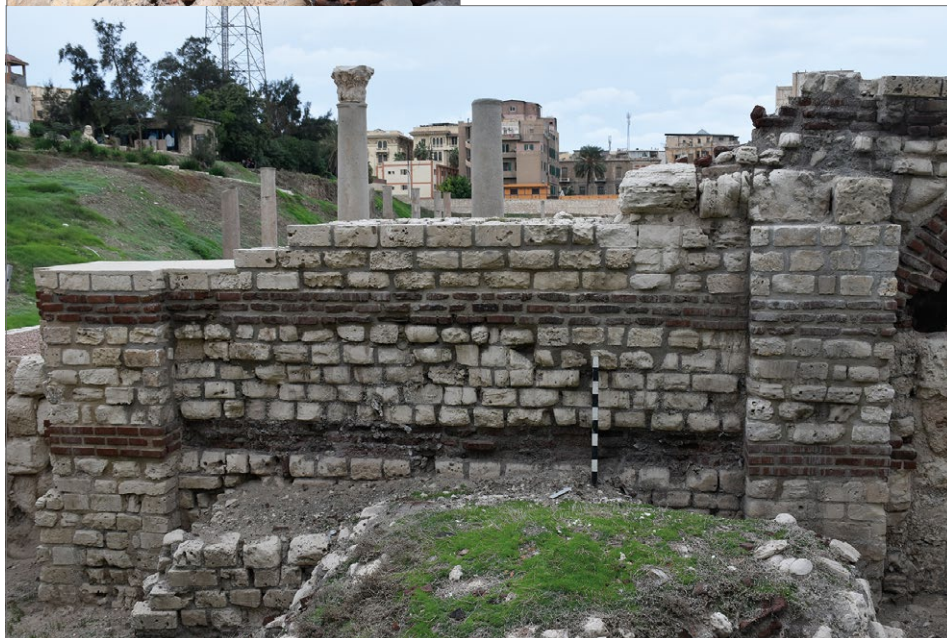
Fig. 17. Theatre, south wall during (top) and following conservation work in 2021 (PCMA UW | photo G. Majcherek)

The wall was originally structured using a typical Late Roman technique: core of mortared rubble bonded with lime-ash mortar, faced with small ashlar and levelled with brick-bonding courses made of three bricks running through

the core and acting as a structural layer. The same technique has been observed in the portico backwall and the outer walls of the cistern. The damage concerned square bricks (26 cm to the side), which were critically damaged, in most instances deeply cracked and eroded, as well as the mortar, which in many parts had lost coherence and disintegrated [Fig. 17 top]. Many of the blocks and bricks have been almost totally detached from the wall. The entire exposed length (the lower courses of the wall are still unexcavated) of the southern face, stretching west of the vaulted entrance to the southern *vomitorium*, was now restored under Majcherek's supervision). The small section of the northern face close to the western end was likewise subject to conservation measures. Some badly deteriorated ashlar were replaced with new ones found nearby in the excavation and most likely belonging originally to this particular structure. Missing or disintegrated bricks were also completed with similar ones from the site, which had been recorded as stray finds [Fig. 17 bottom]. Weakened and deteriorated joints were refilled with new mortar and re-pointed. The new mortar was a visual match for the original one and was, as always, based on a formula akin to the ancient one: one part of lime to two parts of sand and one part of ash. The latter was collected from the thick ash deposits once discarded from the heating system of the late Roman bath in the central part of the site.

Moreover, the wall coping was reshaped and covered with a protective layer of lime reinforced with cement in order to prevent water infiltration. It was shaped to slope to the outside (to

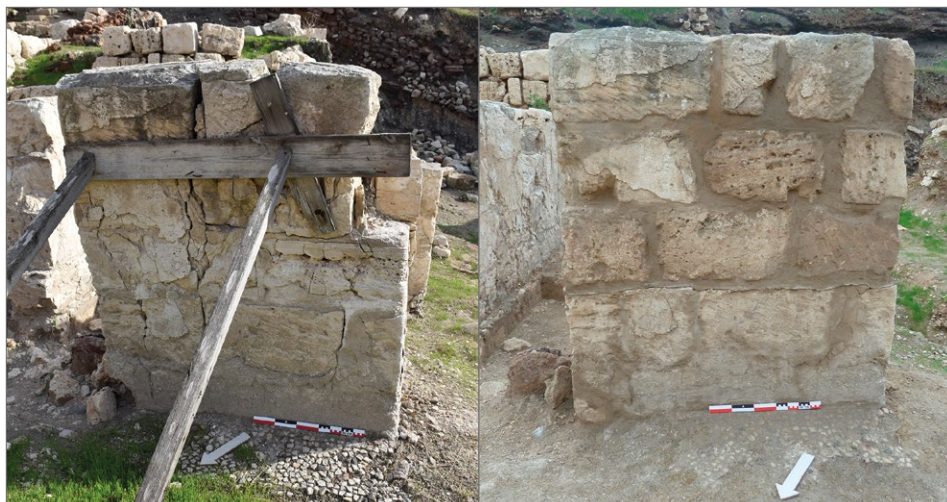
Fig. 18. House FB: north wall of room FB-10: left, before restoration; right, following restoration in 2021 (PCMA UW | photos G. Majcherek)

The north wall of room FB-10, leaning considerably (most probably due to an earthquake), was now treated (work supervised by M. Polak) [Fig. 18 left]. The wall had been provisionally shored up with wooden beams during the excavations. It was structured in regular ashlar masonry, approximately 0.45 m thick. The procedure necessitated a partial dismantling: four courses of the masonry were carefully disassembled after the shoring had been removed. Some of the ashlar were crushed and disintegrated to such a degree that they could not be saved and had to be replaced. The whole structure was then reassembled [Fig. 18 right]. The work was done using mortar based on a standard formula: one part lime putty to three parts washed, well graded sand. In keeping with established international conservation standards, the present intervention was marked with a separating strip of bitumen tar paper.

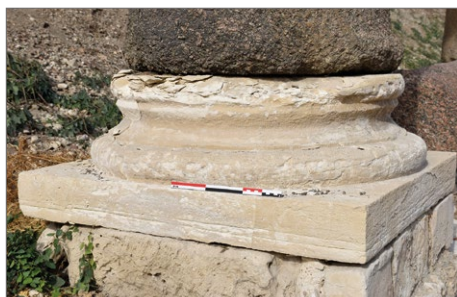
Fig. 19. Column base in the Theatre Portico: left, deteriorated state before restoration; bottom, state after restoration (PCMA UW | photos G. Majcherek)

Another area of maintenance conservation was the so-called Theatre Portico and more specifically the huge monolithic columns of Aswan granite in the southern section of the portico, which had undergone anastylosis in 2005–2006. At the time, new bases made of limestone replaced two of the missing marble ones. These new bases, however, did not stand up well to adverse environmental conditions: sun exposure, heavy rainfall and the resulting salination [Fig. 19 top]. The stone surface had flaked off considerably, a condition particularly evident in the case of the upper torus. The degree of deterioration on the south side was far greater, clearly indicating the destructive effect of overexposure to the sun.

Treatment (by Szymon Gąsienica-Sieczka) commenced with a thorough desalination using lignin poultices soaked in distilled water and additionally protected with polyethylene film, applied for a seven-day period. A strenghtener (Remmers KSE 510) was brushed on to impregnate the stone [Fig. 19 bottom]. To slow down evaporation, the bases were kept for approximately two weeks under plastic sheeting, with additional water containers placed underneath. The losses (mostly in the upper torus) were then restored using cement and sand mortar, coloured with dry mineral pigment.

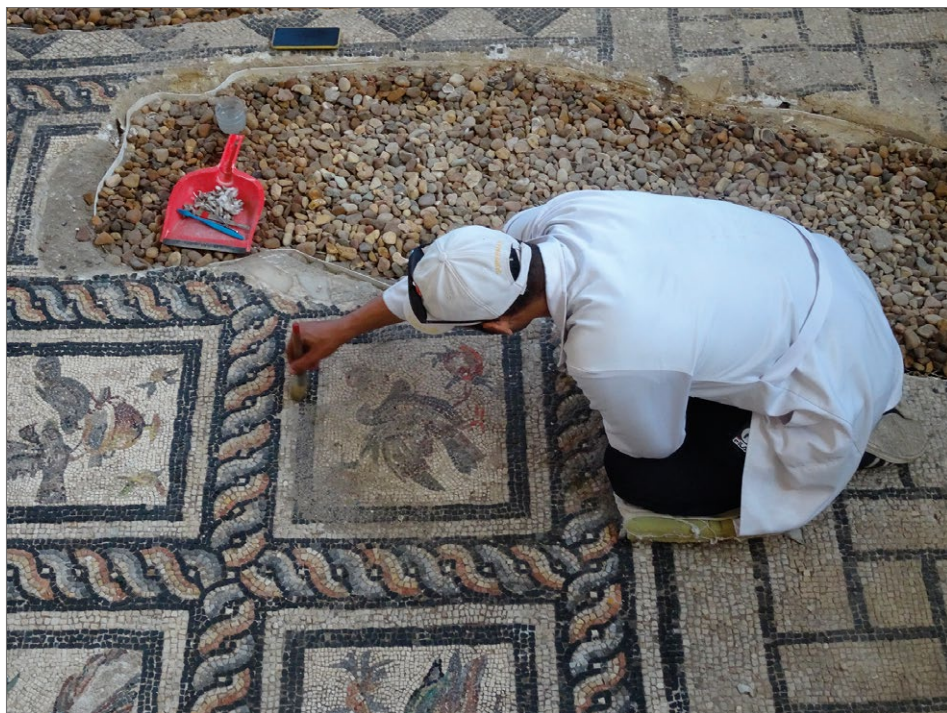
Fig. 20. Cleaning of a mosaic floor inside the "Villa of the Birds" mosaic shelter (PCMA UW | photo G. Majcherek)

Regular conservation work was carried out on the two mosaics: α -5 (with the Birds) and α -6 (with the Panther). The mosaic bedding had disintegrated in places and the tesserae in these areas were detached. The disintegrated protective edgings were removed, the edge surfaces of the mosaics were cleaned and new protective edgings were fitted.

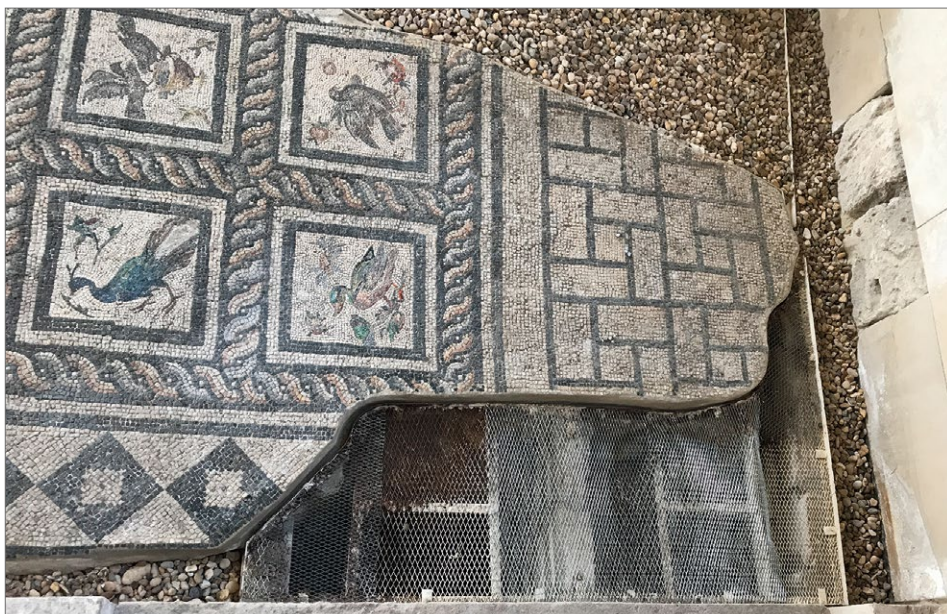
Fig. 21. Repaired steel panel readied for installation (PCMA UW | photo G. Majcherek)

Prompt restoration treatment was essential. The operation, skilfully performed by Gąsienica-Sieczka with Karim Adel Abd el-Fatah, Mohammed Fawzi Mohammed and Assam Morsi, was divided into a number of stages. The mosaic floors were first dusted and carefully cleaned mechanically [Fig. 20]. The pebble layer surrounding mosaics α -2, α -5 and α -6, was temporarily removed. All the collected pebbles were washed and desalinated. The steel panels with mesh supporting the pebble layer and separating it from the ventilation channels, which had suffered some mechanical damage, were repaired. Rusted sections of the mesh were replaced [Fig. 21].
