# From Roman industrial center to early Islamic town: archaeological excavations at 'Marea'/Philoxenite in the 2020–2021 field seasons

**Abstract:** Being one of the biggest and best preserved archaeological sites in the western hinterland of Alexandria, 'Marea'/Philoxenite is, therefore, one of the most important points of reference for studies of the Mareotis region. Despite the fact that the site has been investigated for many years, by various excavation teams, the nature and chronology of the different phases of settlement remain unclear. Since 2018, systematic stratigraphic excavations have been carried out at the site with the aim of investigating insufficiently studied parts of the settlement. In 2020 and 2021, this goal was achieved by opening and surveying 11 trenches in the southwestern part of the site. This led to the identification of hitherto unknown structures: two churches, two tombs, an irrigation system and numerous rubbish dumps associated with the Roman, Byzantine and early Islamic phases. The study also determined the extent and functional changes of various parts of this settlement, in different historical periods.

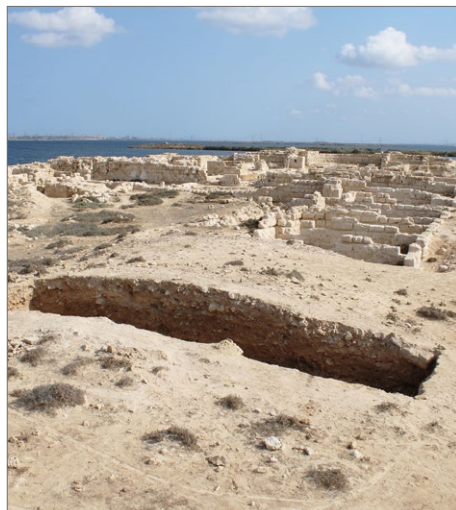
Fig. 3. Trench A2-1: view of the eastern section of the trench looking northeast, with the atrium of the great basilica in the background (University of Warsaw Marea Archaeological Project | photo M. Gwiazda)

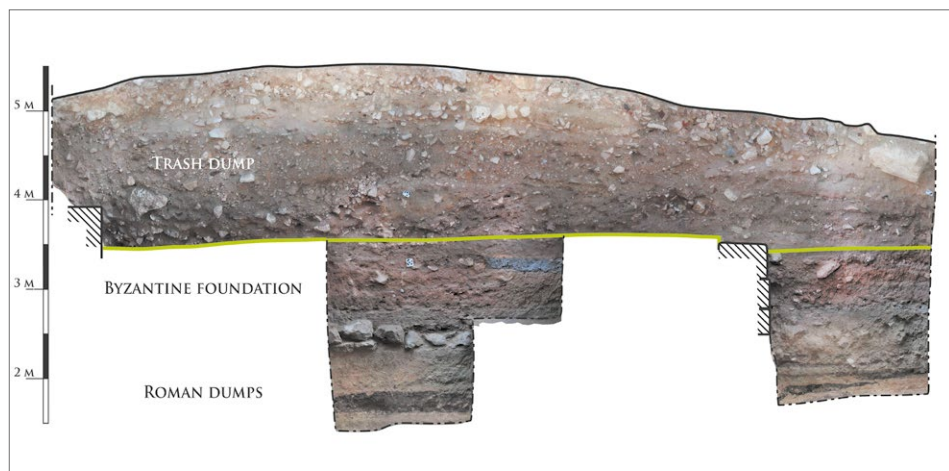
Fig. 4. Trench A2-1: eastern section (University of Warsaw Marea Archaeological Project | orthophotographs & processing M. Gwiazda)

The oldest deposit was a layer of greyish-yellow silt, that is, loess, rising to the south [Fig. 4]. Distinct cracks were observed on the top of this layer [Fig. 5], suggesting a sediment that was wet and dried in the sun. The deposit contained crushed shells alongside a small number of potsherds and baked bricks, indicating that it was a man-made feature.

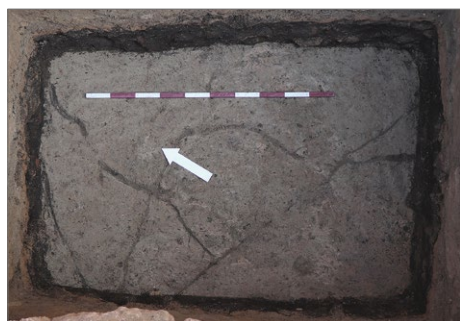
*Fig. 5.* Trench A2-1: cracking observed on the top of a layer of silt (University of Warsaw Marea Archaeological Project | photo E. Chołodowska-Kamińska)

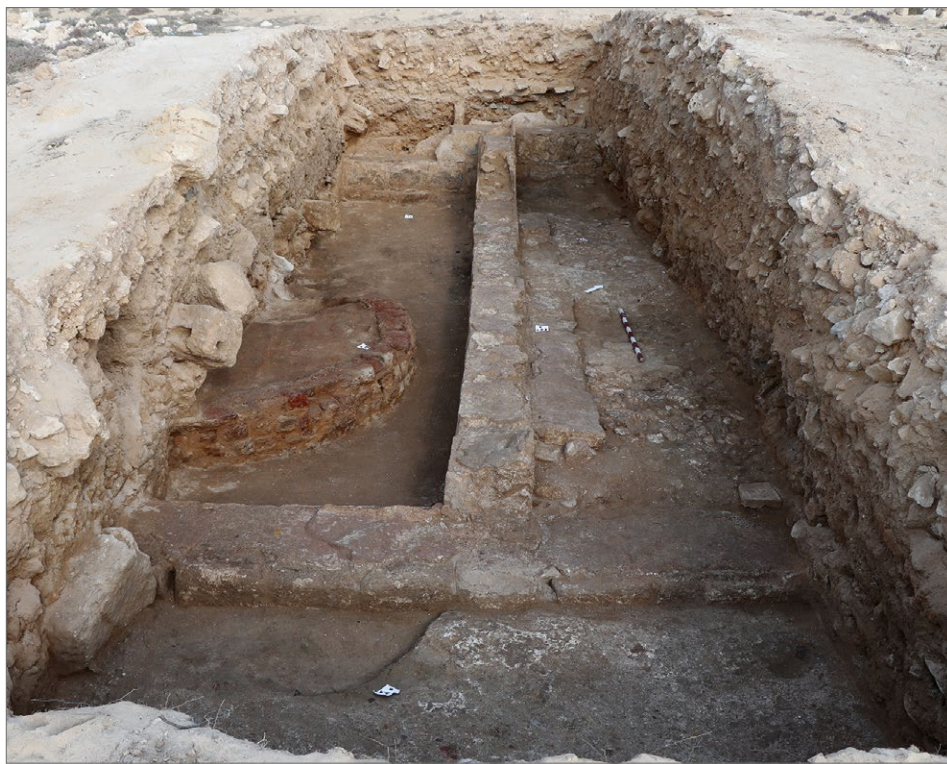
Fig. 6. Trench A2-1: two units of a building divided by a partition wall, located north of a street, seen at bottom (University of Warsaw Marea Archaeological Project | photo M. Gwiazda)

Once the building site had been prepared, three walls were erected in this location in an orthogonal arrangement. Two walls, oriented roughly east–west, marked the northern and southern boundaries of a structure, while the third, a partition wall running perpendicular to them, separated two adjacent spaces [*Fig. 6*]. Like most Byzantine walls, in this part of the site, they were built of limestone pseudo-ashlars.<sup>2</sup> The spaces between the stones were filled with large amounts of mortar, and their faces were covered with thick layers of white plaster. The floor of the western room was completely destroyed, even as heavily damaged remains of limestone slabs could be seen in the unit to the east. No evidence of the original function of these two units was found within the trench.

The 6th-century-CE levelling layer also served as a bedding for a street running on the south side of the building. Its surface was made of tamped earth covered with a thin layer of crushed lime or gypsum [see *Fig. 6*]. The street appears to have been deliberately profiled, dropping ever so slightly toward the north.

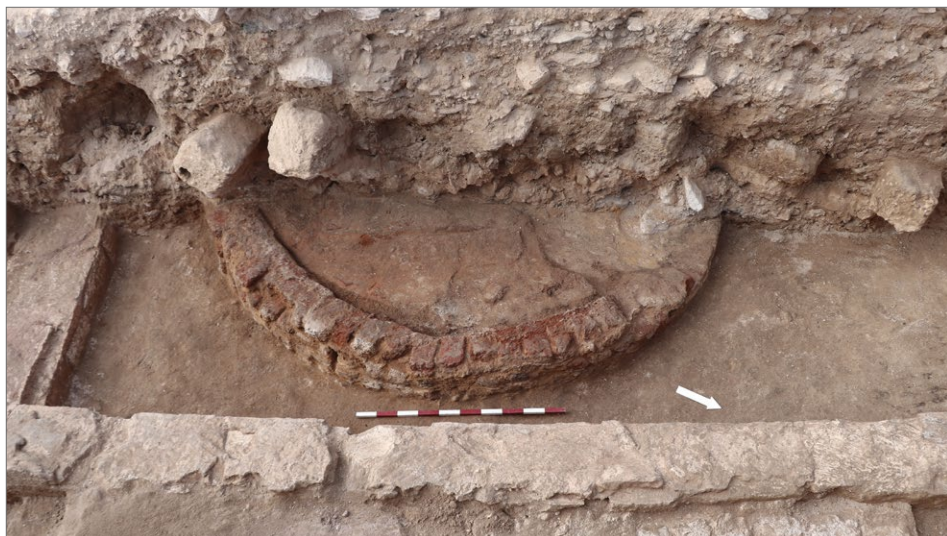
Fig. 7. Fragment of a baked brick furnace in trench A2-1, looking westward (University of Warsaw Marea Archaeological Project | photo M. Gwiazda)

ered with an isolating layer of clay [Fig. 7]. Nothing to identify the purpose of this furnace was found, possibly because the upper part of this structure was demolished in a subsequent phase.

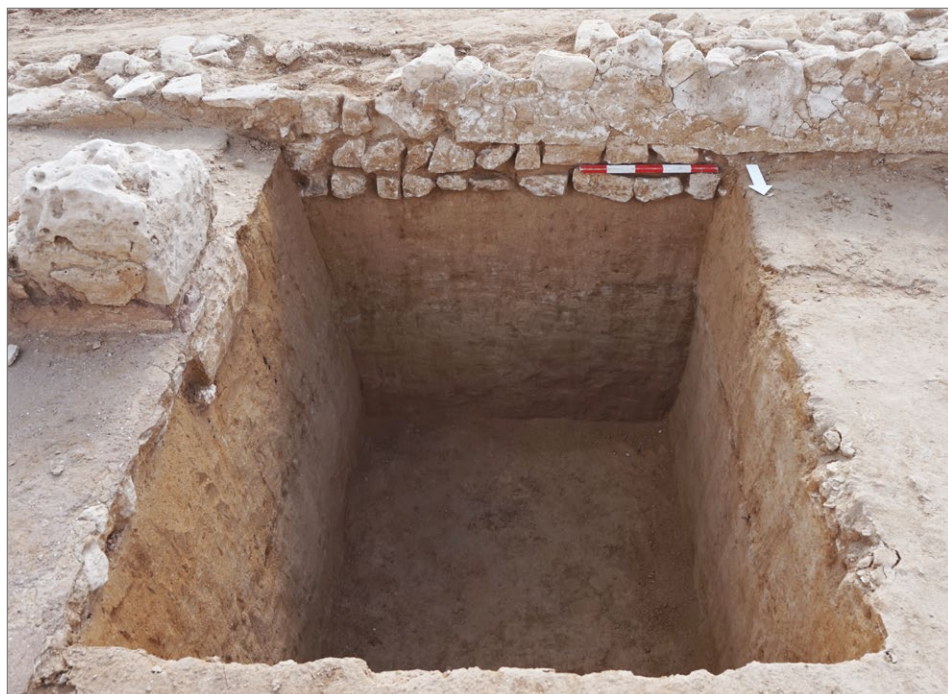
Fig. 10. Trench CH2: stratigraphic probe under the building foundations (University of Warsaw Marea Archaeological Project | photo T. Barański)

The remains of a regular building on a natural mound on the southeastern outskirts of the town attracted the attention of the field team. A deep probe dug inside the remains showed that the building had very shallow foundations of broken limestone without any bonding mortar [Fig. 10]. The

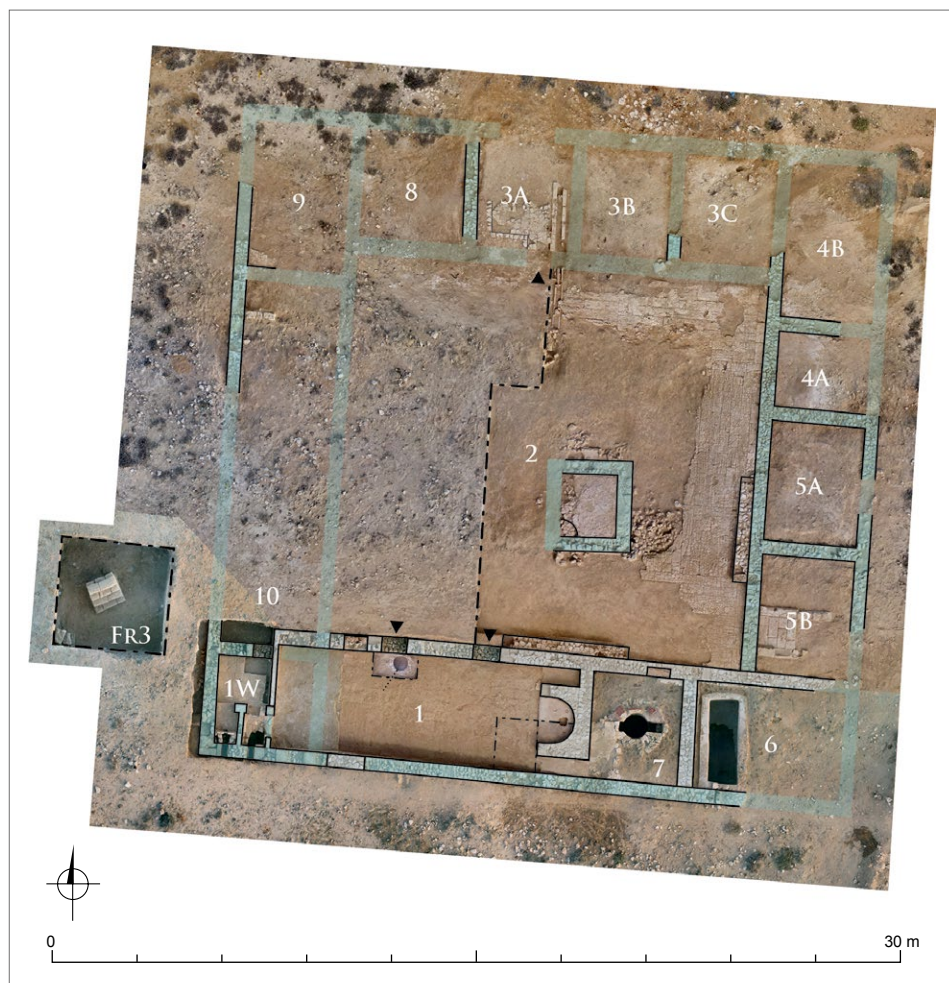
Fig. 11. Overview of trench CH2 with small trench FR3 on the left. Black dashed lines mark the limits of excavation trenches (University of Warsaw Marea Archaeological Project | orthophoto & processing M. Gwiazda)

The structure was square in plan with sides about 24 m long [Fig. 11]. It consisted of a central courtyard paved with stone slabbing, surrounded by rooms. Sherds of AE 5/6 containers found in the wall structure point to a construction date no earlier than the second half of the 6th century CE.

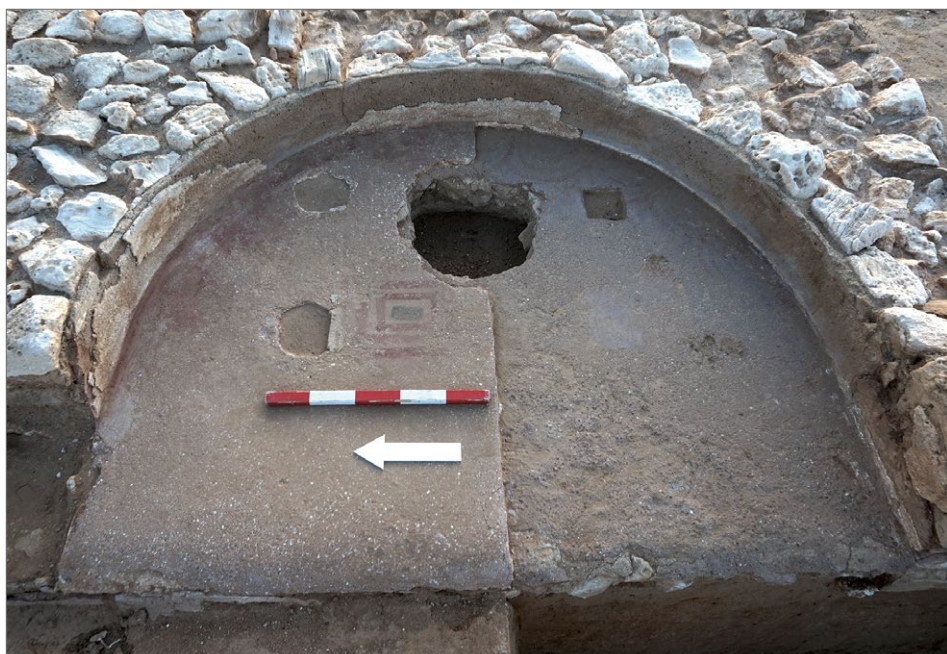
Fig. 12. Apse with two layers of floors preserving the impressions of altar supports (trench CH2) (University of Warsaw Marea Archaeological Project | photo T. Barański)

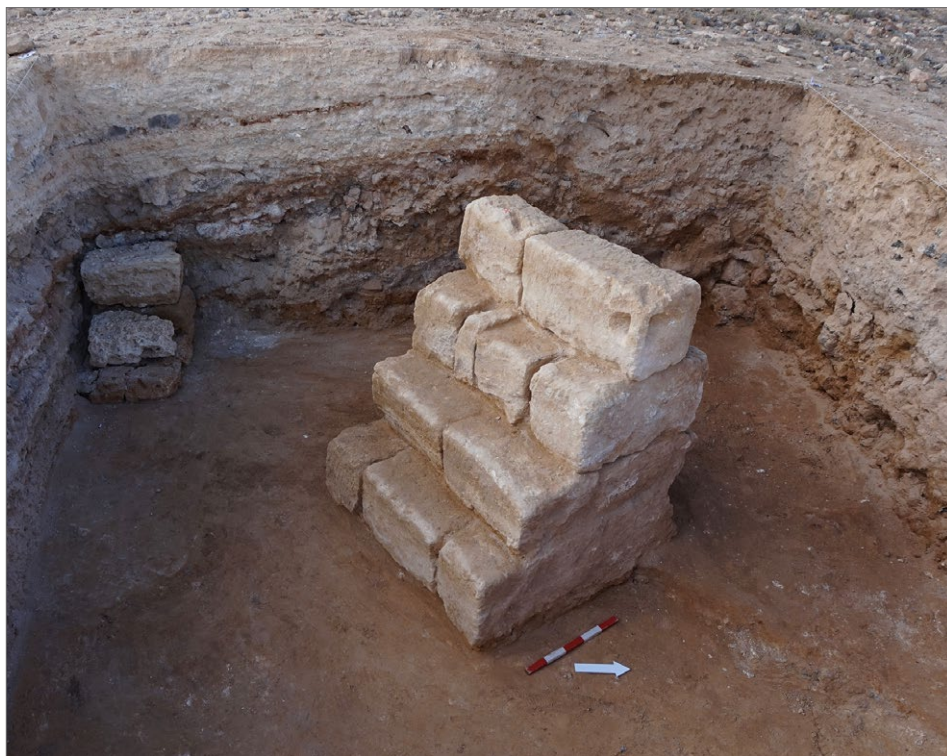
Fig. 15. Stepped structure in trench FR3; robber trench visible in the northwestern corner of the trench (University of Warsaw Marea Archaeological Project | photo T. Barański)

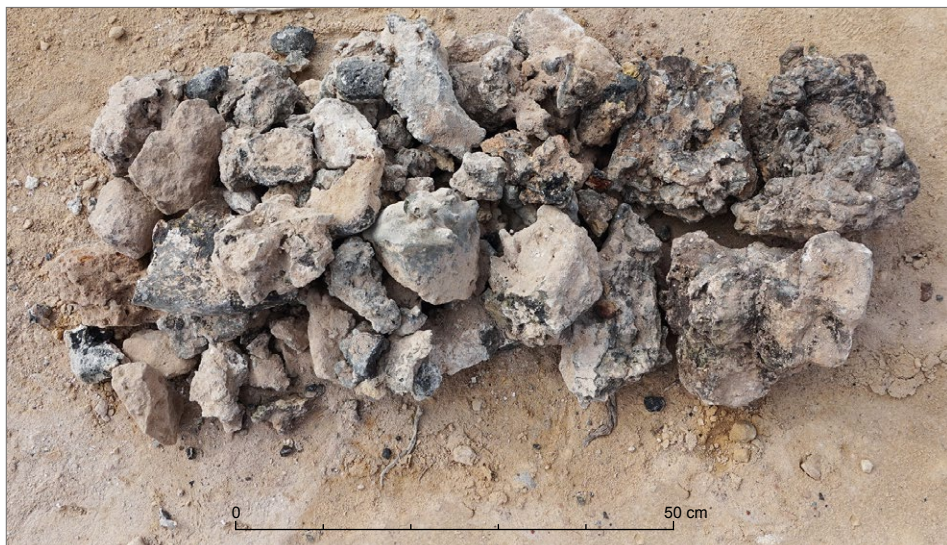
Fig. 16. Waste produced during the burning of lime/gypsum (University of Warsaw Marea Archaeological Project | photo T. Barański)

The site was later covered with waste from the production of lime or gypsum. This waste included crushed limestone with signs of burning, baked bricks, some of which were vitrified, and black slag-like lumps [Fig. 16]. In addition, numerous fragments of nummulitic limestone and marble objects were encountered in the deposit. Among these were fragments of wall revetment, capitals, columns, some of which bore traces of burning and soot-

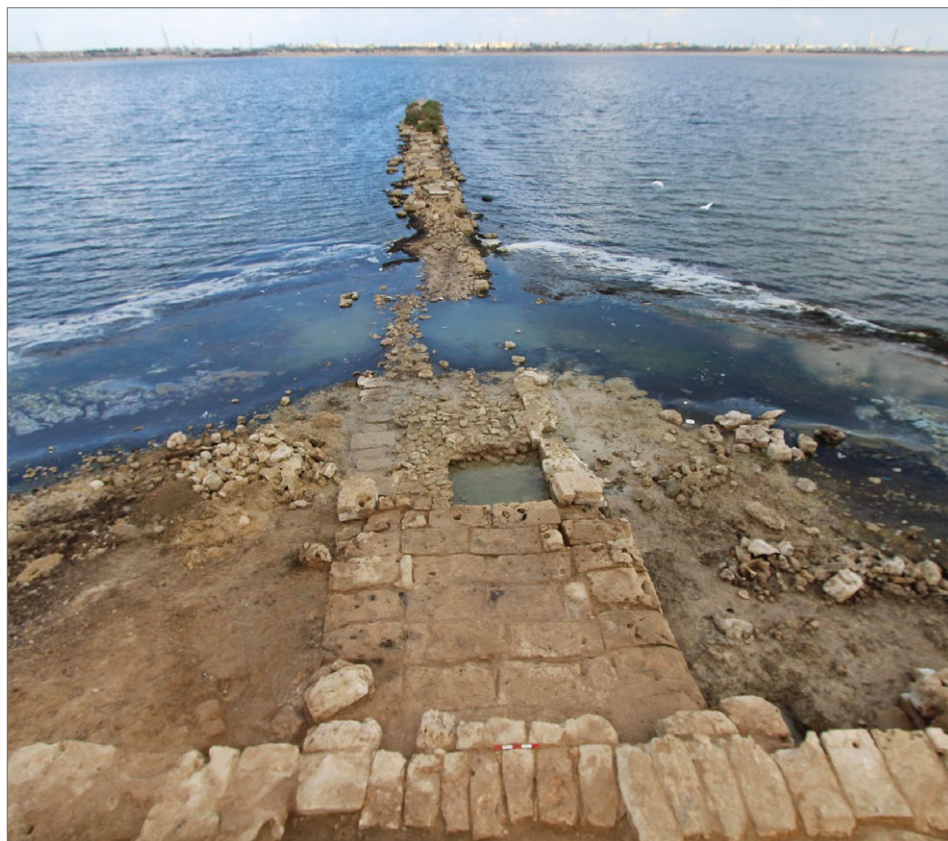
Fig. 19. Pier 2: view from the south; in the center, trench P2 in the pier cap (University of Warsaw Marea Archaeological Project | photo M. Gwiazda)

with the waterfront wall. The cap was cleared and a trench was opened in this location [Fig. 19]. The exploration was limited to the removal of some crushed limestone filling the space between walls of limestone pseudo-ashlars on the east and west. Under the rubble, the upper part of the foundation of the eastern one

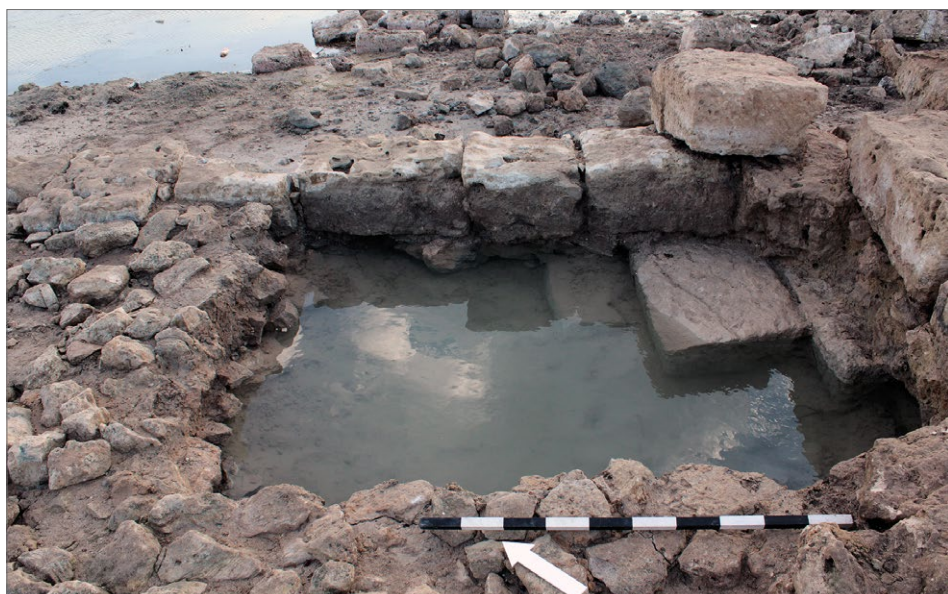
Fig. 20. Trench P2: ashlar foundations of the eastern pier boundary wall seen from the west (University of Warsaw Marea Archaeological Project | photo K. Żochowski)

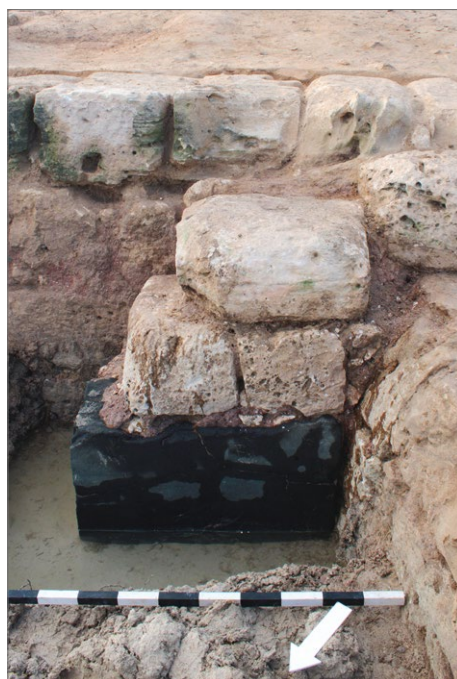
Fig. 21. Black ashlar used in the construction of Pier 2 (University of Warsaw Marea Archaeological Project | photo K. Żochowski)

An added structure was found on the eastern side of the trench. It consisted of three cut limestone pseudo-ashlars and one block made of black stone (dimensions  $0.86 \times 0.61 \times 0.50$  m), bonded with hydraulic mortar [Fig. 21]. From a functional point of view, it probably reinforced the junction of the pier and waterfront. Of greater, and possibly symbolic importance is the use of black stone as building material, which has not been attested at 'Marea'/Philoxenite so far. Moreover, this kind of stone does not occur naturally in northern Egypt. The block in the structure had five smooth surfaces and one that was irregularly chipped, suggesting reuse. However, given the uniqueness of this material and its position at the base of the pier, it is possible that it

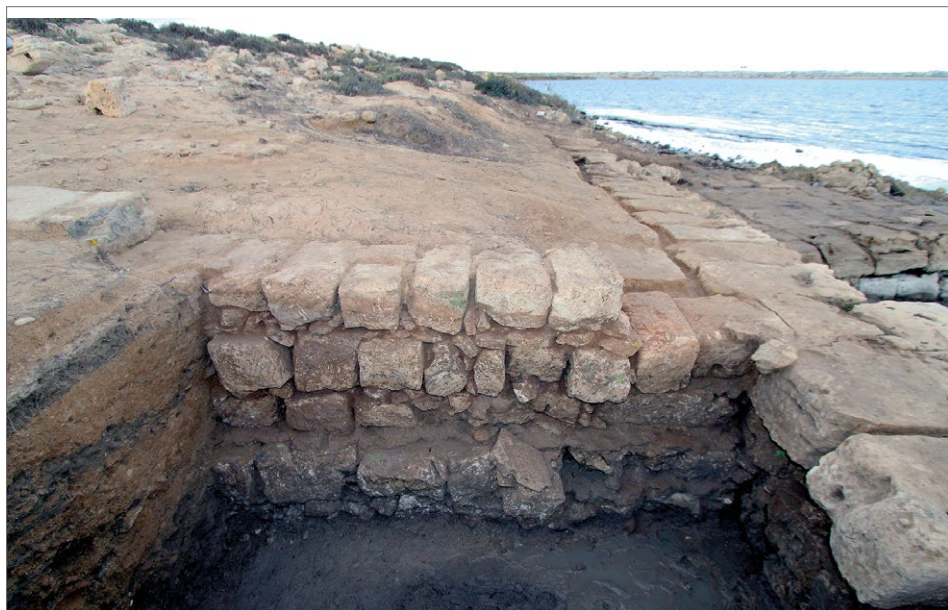
Fig. 22. Trench WF17-1: wall at the western end of the trench, looking west, perpendicular to the waterfront wall visible at right; at left, intercalated layers of silt filling the space (University of Warsaw Marea Archaeological Project | photo M. Gwiazda)

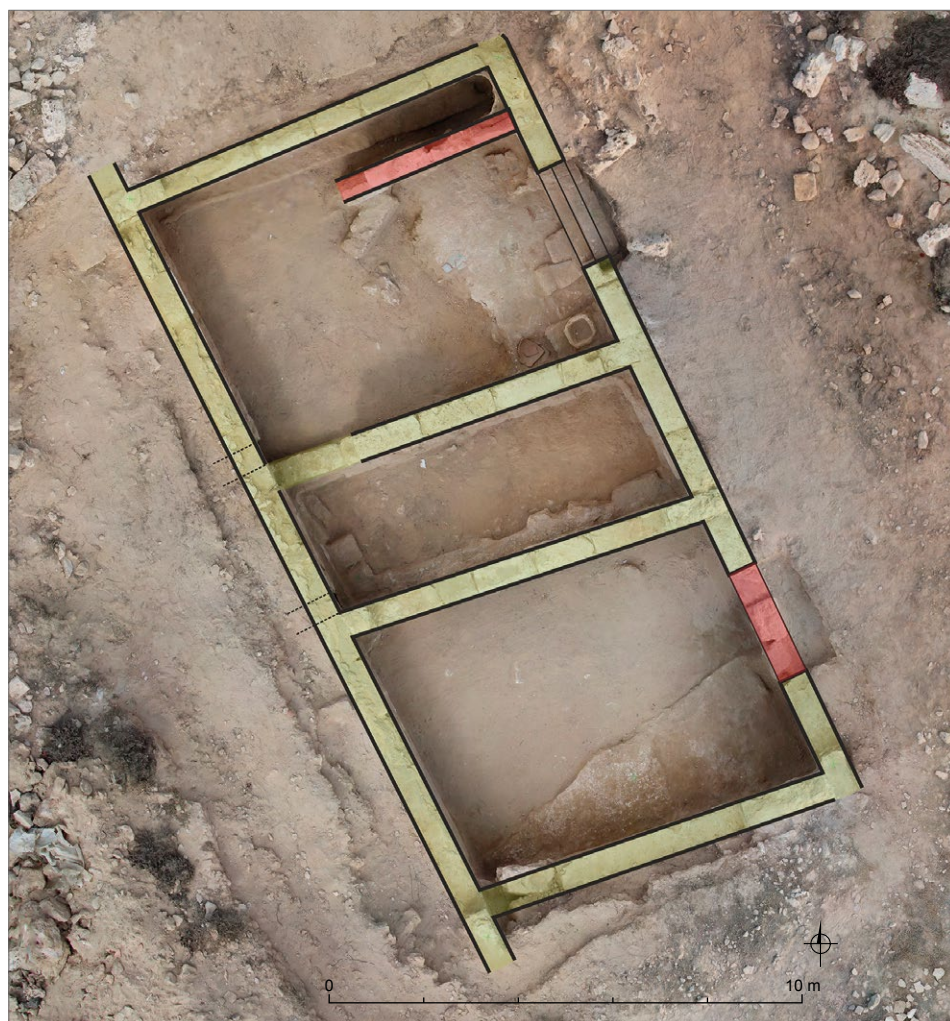
Fig. 23. Trench F2: orthophotoplan of the three reexcavated rooms (University of Warsaw Marea Archaeological Project | orthophotoplan M. Gwiazda)

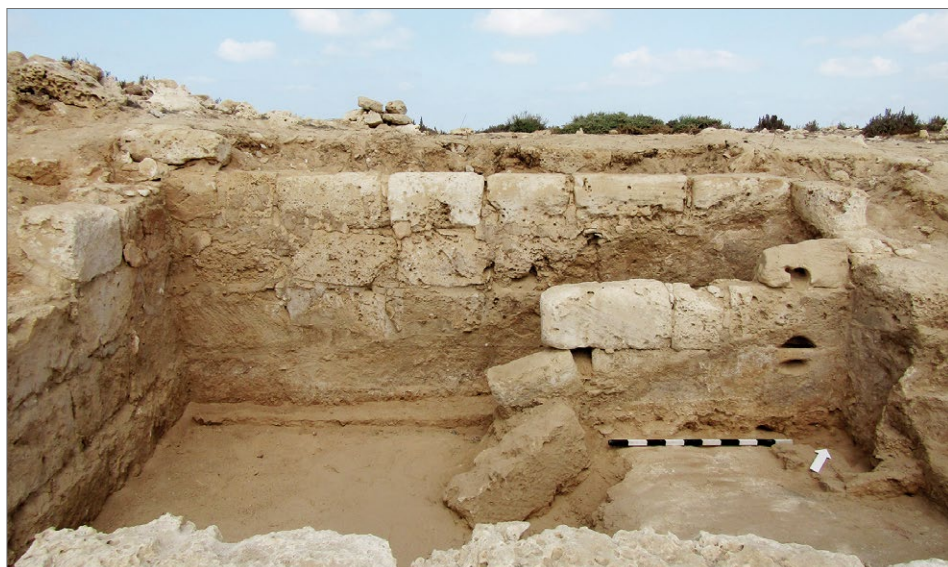
Fig. 24. Trench F2: preserved eastern end of a stone-built trough from the second phase of occupation in the northern room (University of Warsaw Marea Archaeological Project | photo M. Żmuda)

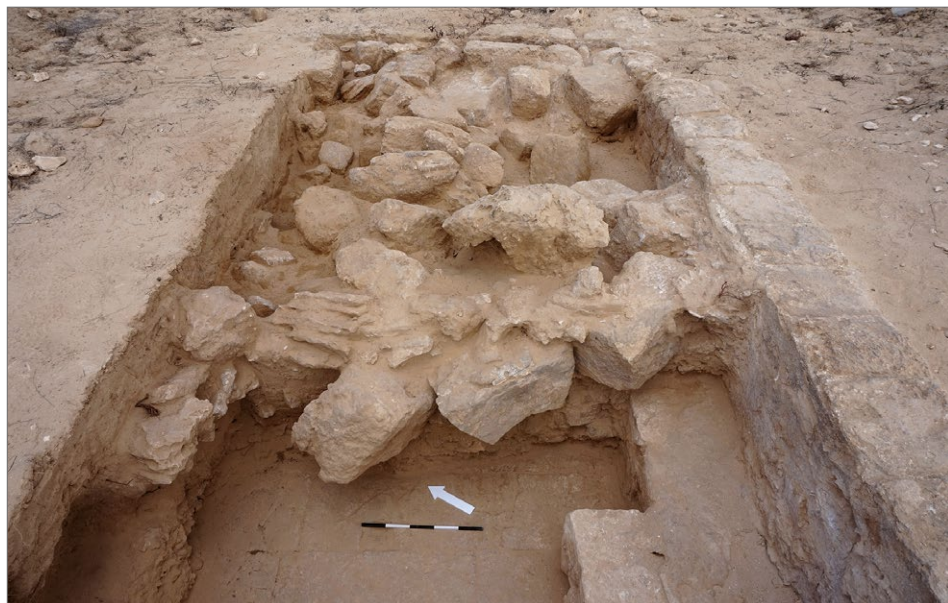
Fig. 27. Debris in trench N1-1, looking east (University of Warsaw Marea Archaeological Project | photo T. Barański)

The rubble filling the room consisted of limestone pseudo-ashlars including elements of arches [Fig. 27]. The fill also yielded fragments of wall painting with figural and geometric motifs [Fig. 28],

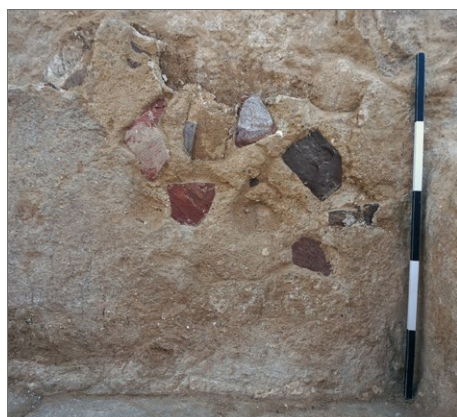
Fig. 29. Potsherds in a mortar wall coat in trench N1-1 (University of Warsaw Marea Archaeological Project | photo T. Barański)

*lon* with glass lamps. Potsherds no earlier than the 6th century CE, were discovered stuck in the mortar of the walls [Fig. 29]

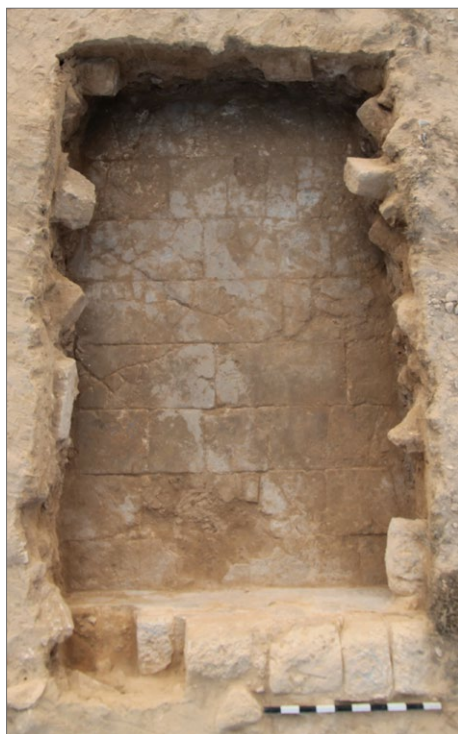
Fig. 31. Pavement in trench N1-5, looking south (University of Warsaw Marea Archaeological Project | photo M. Gwiazda)

A pavement of regular limestone slabs was discovered in trench N1-5 located northeast of N1-1 [Fig. 31]. No other in-

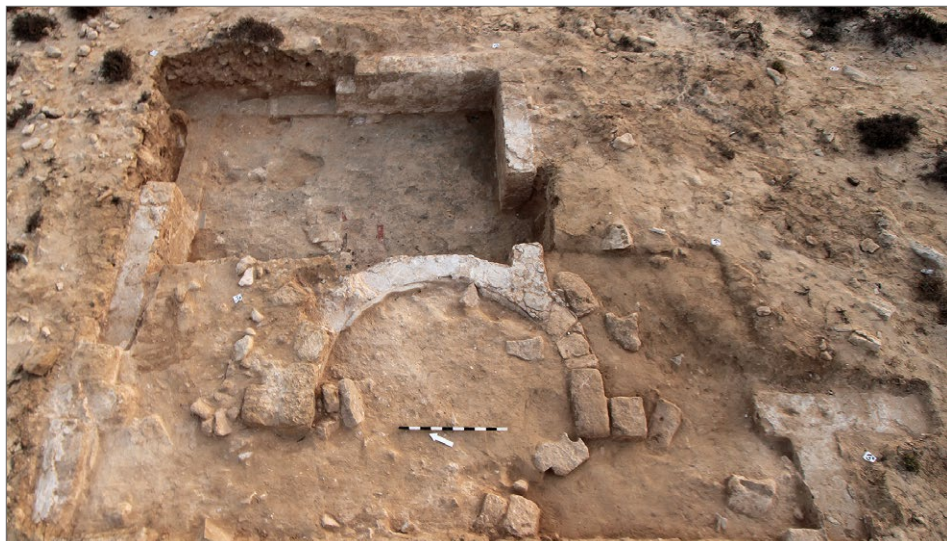
Fig. 32. Trench N1-7: apse of the church (University of Warsaw Marea Archaeological Project | photo M. Gwiazda)

Exploration of trench N1-7 in the northeastern corner was crucial for the identification of this structure as a church. The tops of the walls of an apse were cleared [Fig. 32]. The number of marble tiles in the rubble suggests that the inner walls of the apse were revetted in marble [see Fig. 31:N1-7]. The scope of the excavation was limited due to time constraints and no attempt was made to expose the floor of the presbytery this season. Nevertheless, it was established that there

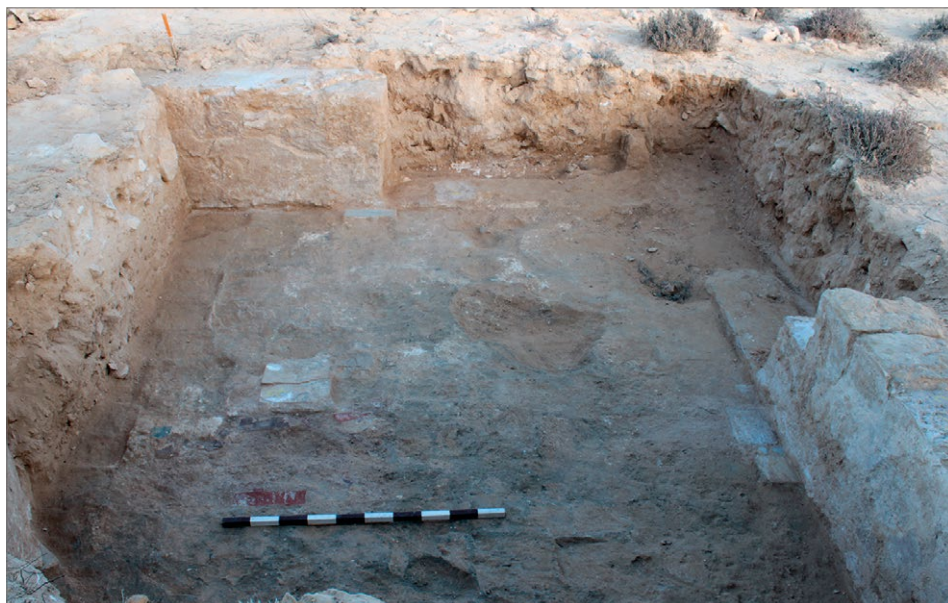
Fig. 33. Trench N1-7: *opus sectile* floor (University of Warsaw Marea Archaeological Project | photo M. Gwiazda)

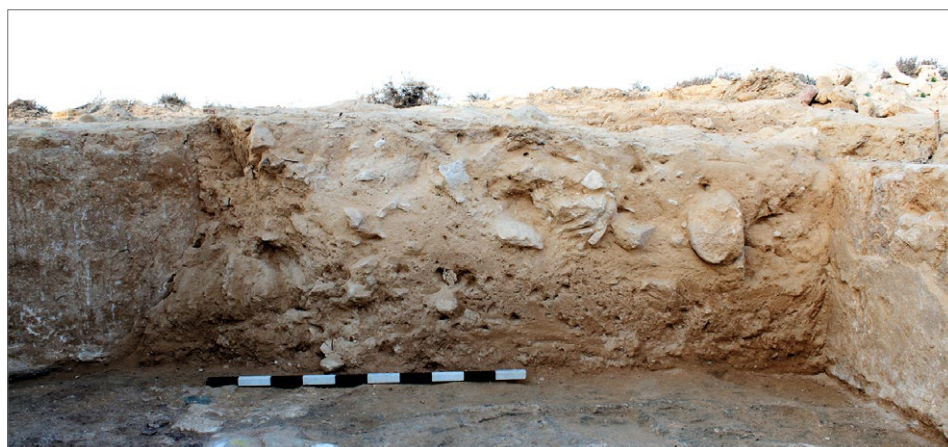
Fig. 34. Trench N1-7: view of the western baulk (University of Warsaw Marea Archaeological Project | photo M. Gwiazda)

these walls were dismantled along with the marble floor. Consequently, only small amounts of stone rubble were found in the abandonment fill [Fig. 34].

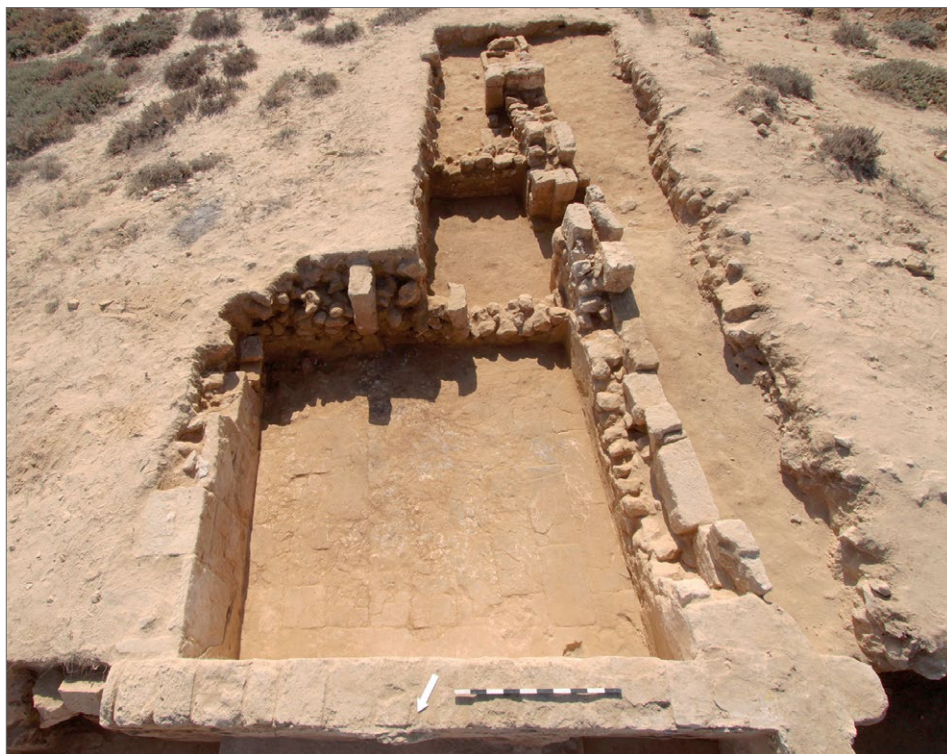
Fig. 35. Trench N1-4: rooms on the south side of the church (University of Warsaw Marea Archaeological Project | photo M. Gwiazda)

On the south side of the building, in trench N1-4, at least two interconnected rooms were discovered. The northern one was paved with limestone slabs, while the southern one had a tamped earth floor. The west wall of this complex merits attention. It was built of limestone pseudo-ashlars—primarily in the western face of the wall—and of crushed limestone predominantly on the eastern side [Fig. 35]. The northern end of this wall abuts the corner of the building exposed in Trench N1-1, and a doorway in it leads outside. At the southern end, a monolithic rectangular limestone basin stood against the wall, discharging liquids through an opening in the bottom and into a channel that emptied outside the

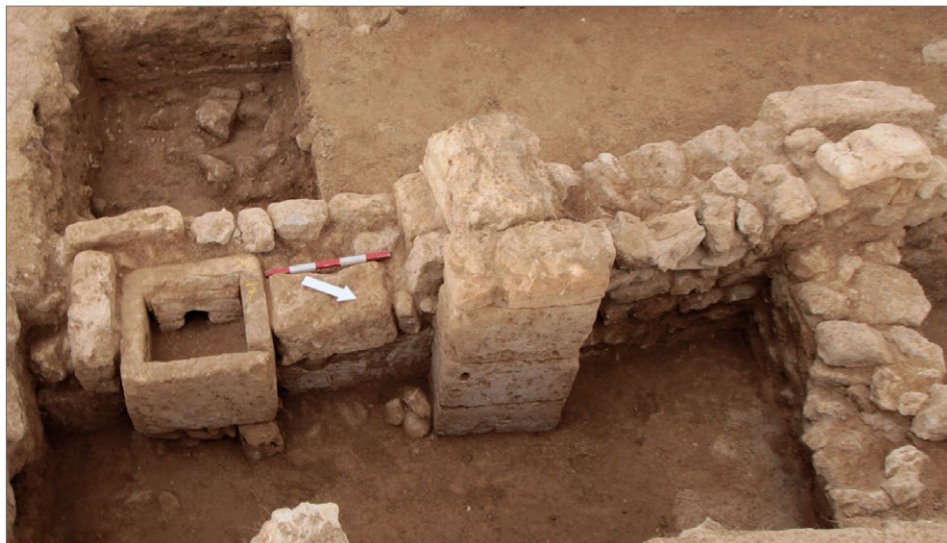
Fig. 36. Trench N1-4: stone basin and pilaster (University of Warsaw Marea Archaeological Project | photo M. Gwiazda)

building [Fig. 36]. Attached to the wall next to this basin was a pillar, 0.50 m wide, built of limestone pseudo-ashlars. It can be assumed that it was the base of an arch supporting the ceiling of the room.

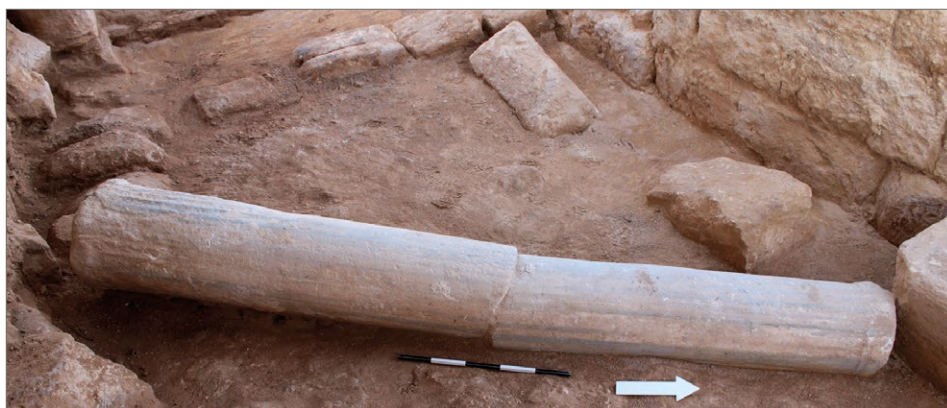
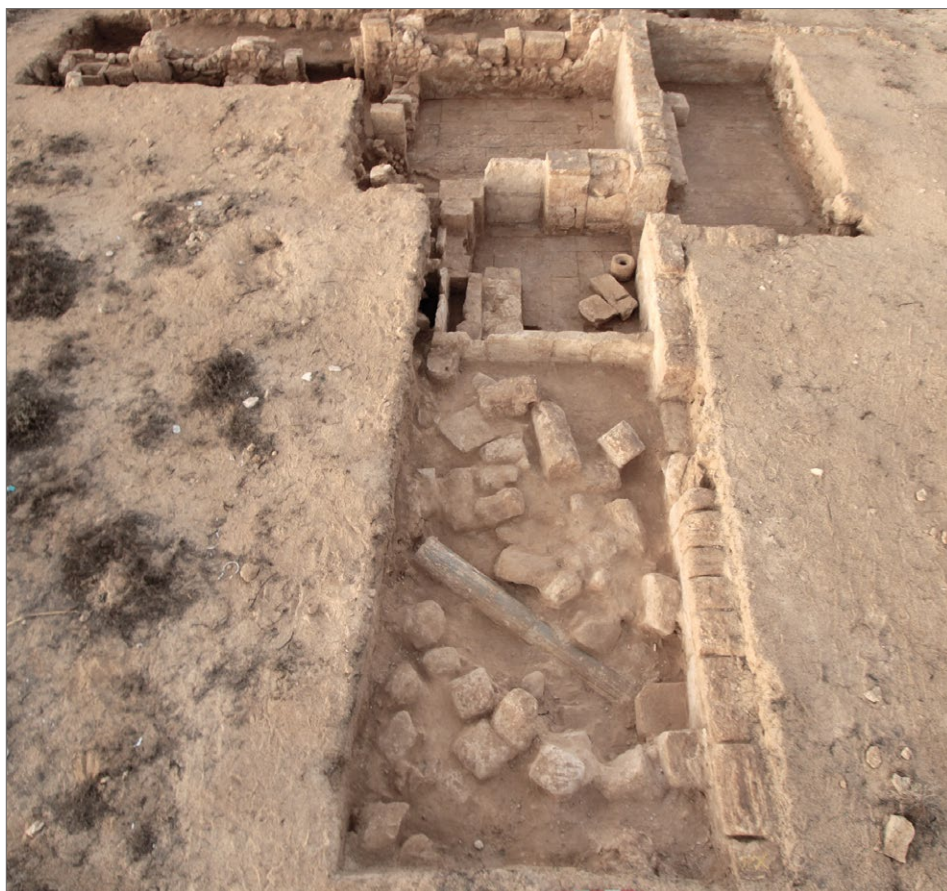
Fig. 38. Trench N1-6: marble column and stylobate in the portico in front of the southern church façade (University of Warsaw Marea Archaeological Project | photo T. Barański)

Fig. 39. Trench N1-6: stone rubble filling the space; note position of column illustrated in *Fig. 38* (University of Warsaw Marea Archaeological Project | photo M. Gwiazda)

column described above also rested directly on this level [Figs 38, 39]. The rubble included fragments of stone arches and decorated limestone cornices. A broken and incomplete tabletop was also found in this context [Fig. 13:3].

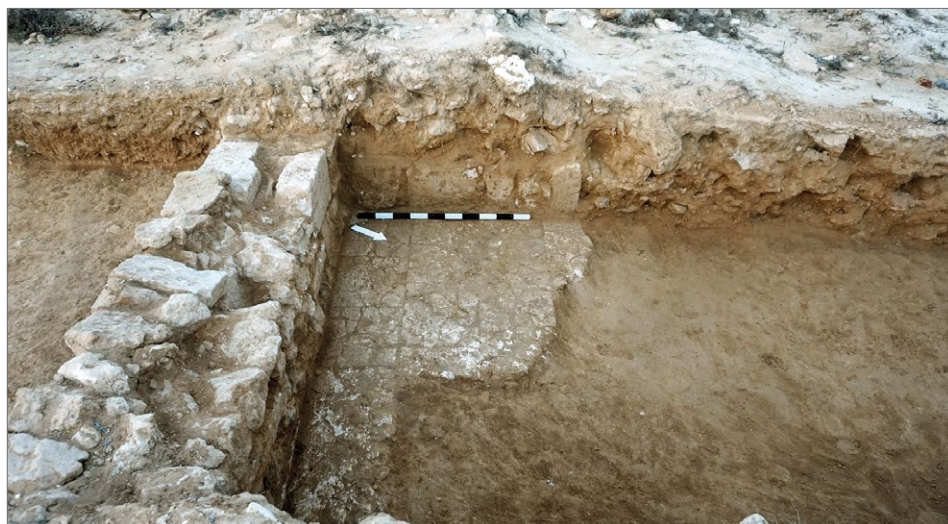
Fig. 42. Trench N1-8: corner of a room (University of Warsaw Marea Archaeological Project | photo M. Gwiazda)

two walls meeting at right angles represented the first phase of occupation in this part of the building [Fig. 42]. One of these walls and a large part of the floor were dismantled almost in their entirety during the last phase of use. An episode of stone rubble and silt deposition followed.

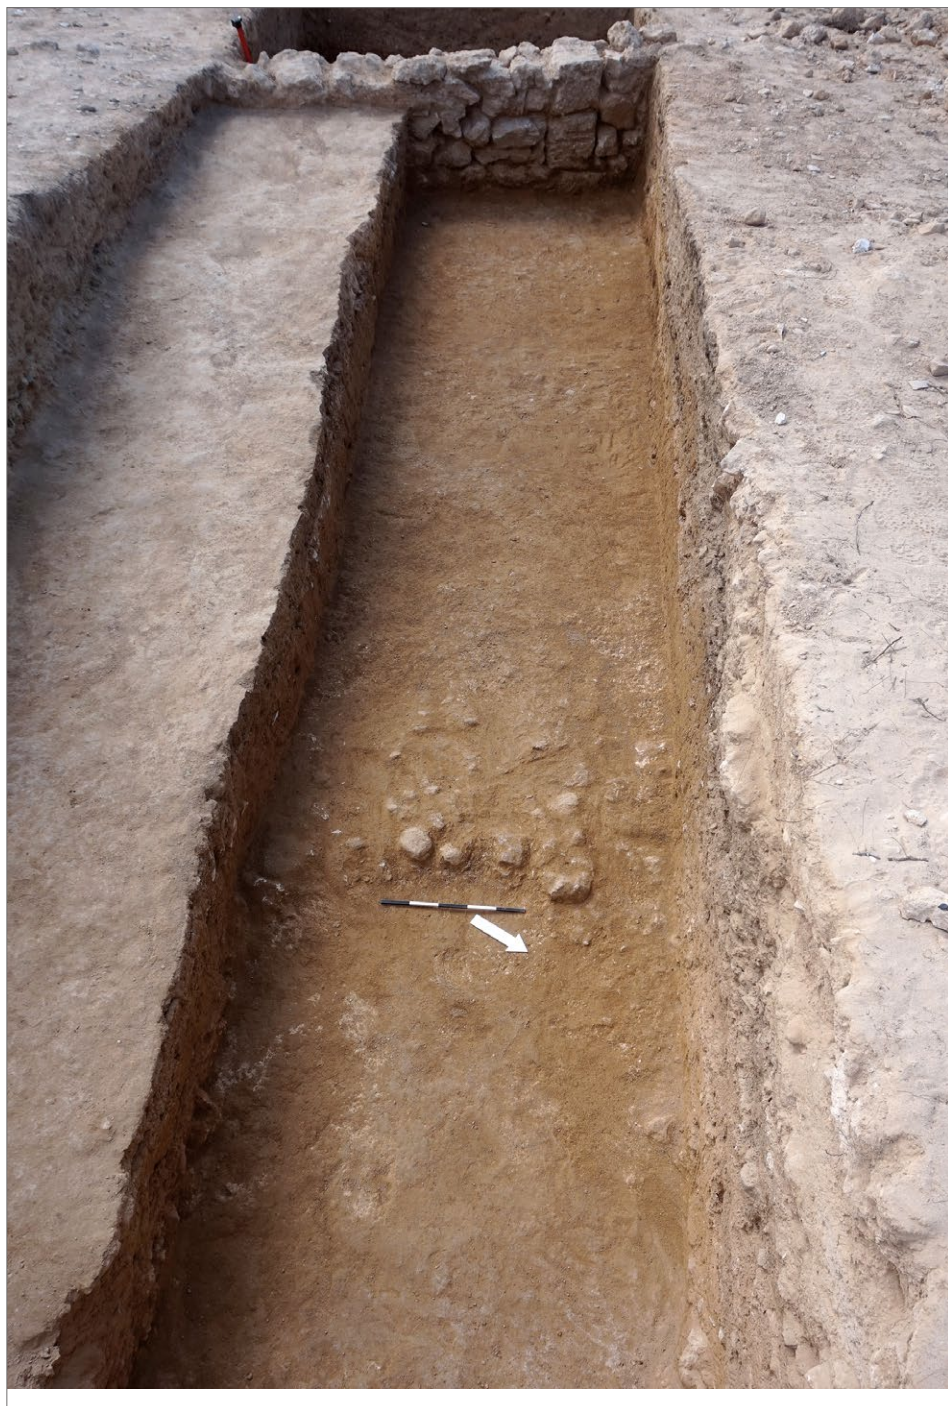
Fig. 43. Trench N1-2: triangular plaza (University of Warsaw Marea Archaeological Project | photo T. Barański)

the town [see Fig. 2]. Like the street in Trench N1-8, this plaza was later transformed into a rubbish dump. Mainly broken pottery vessels and numerous fragments of different-colored stone tiles [Fig. 30:N1-2], bricks, glass, animal bones and also fragments of mortar, plaster and floor slabs were deposited here. Concentrations of ash with charcoal were also encountered within this deposit. The dating of this dump based on the pottery places it in the early Islamic period (second half of the 7th–first half of the 8th century CE).

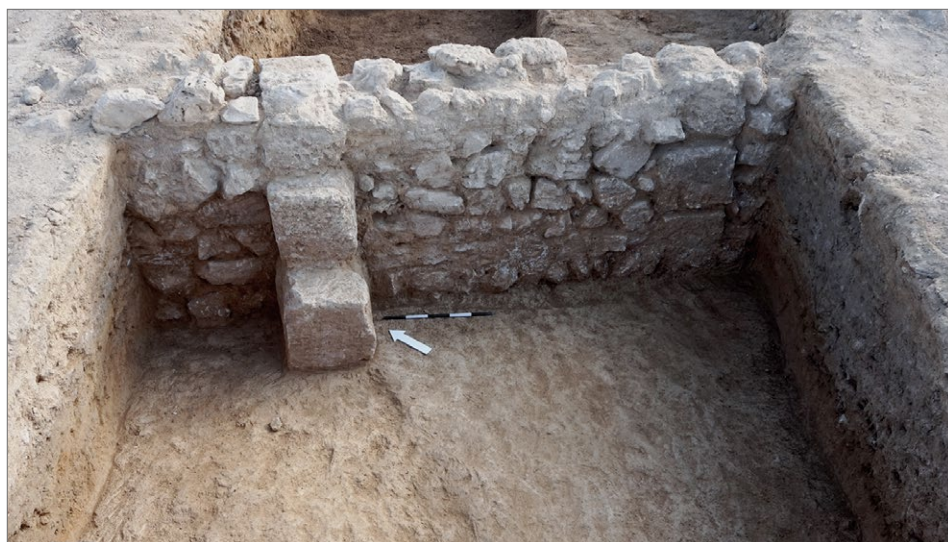
Fig. 44. Trench N1-3: retaining wall marking the boundary between the town and cultivated fields (University of Warsaw Marea Archaeological Project | photo T. Barański)

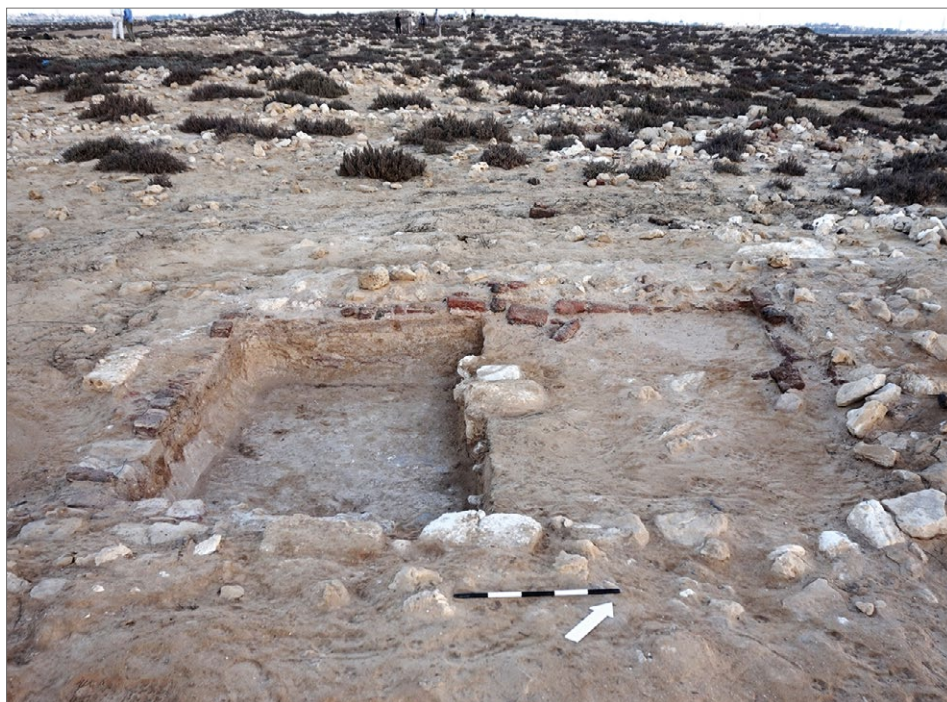
Fig. 46. Trench B1: water basin on the south side of the building explored in Trench N1 (University of Warsaw Marea Archaeological Project | photo T. Barański)

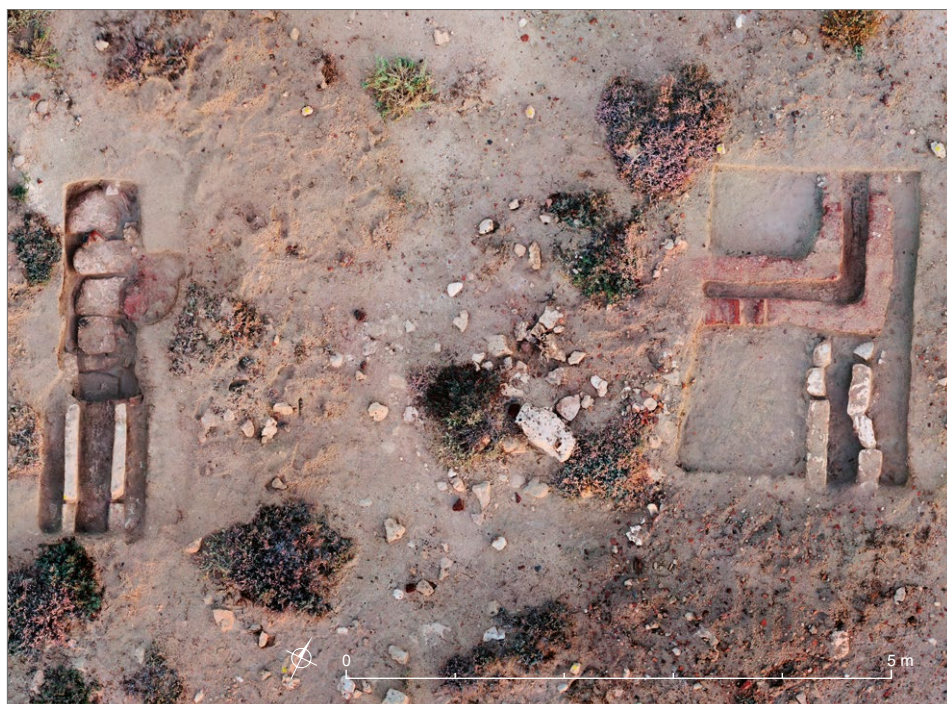
Fig. 47. Trench V5: irrigation channels on the southwestern outskirts of the town (University of Warsaw Marea Archaeological Project | orthophoto plan M. Gwiazda)

identified in the two trenches. The two channels in Trench V5 were parallel and had a northwest–southeast orientation. The foundations were of irregular limestone with a superstructure of limestone slabs bonded in hydraulic mortar [*Fig. 47*]. A section of this installation was made of baked bricks.

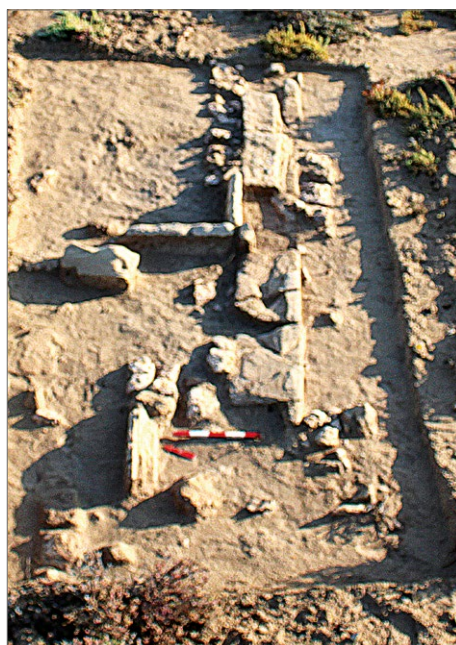
Fig. 48. Northeastern view of the irrigation channel in Trench V3 (University of Warsaw Marea Archaeological Project | photo M. Gwiazda)

Trench V3, located south of the previous one, contained an analogous structure with a northwest–southwest orientation. In this case, crushed limestone was used as a foundation, while the superstructure was made of limestone ashlars. The structure also had at least one branch draining off in a northwest direction [Fig. 48].

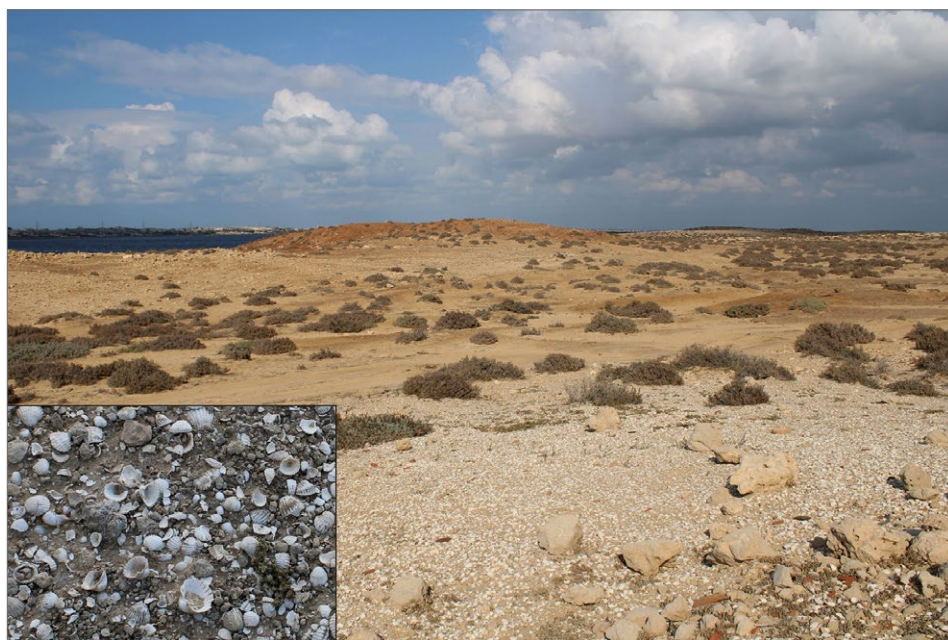
Fig. 49. Mounds covered with shells in the foreground; a mound of pottery at center back, at the site of amphora production on Mareotis Island (University of Warsaw Marea Archaeological Project | photo M. Gwiazda)

The concentration of cockle shells discovered in Trench A2-1 is analogous to that identified in 2019 in Trench A1-1 located 35 m further north (Derda et al. 2020: 556, Fig. 5). Unusual at first glance, these discoveries find some good parallels, helping to explain their presence right next to an amphora workshop. Similar concentrations come from a site 6 km to the southwest and discov-

ered during Lucy Blue's surface survey of the so-called Mareotis Island (Blue and Khalil 2011: 238–240, Site No. 124). A Roman workshop producing amphorae was located on that site. In its vicinity, mounds of pottery sherds mixed with cockle shells, as well as heaps containing only cockle shells, were noted [Fig. 49]. The mollusks must have been extracted together with the clay used to make pottery vessels. Refining the raw material to get rid of unwanted additions before embarking on the vessel-forming process had the side effect of shell heaps forming around the pottery workshops.
