Geological appraisal of the Theban cliff overhanging the Hatshepsut temple at Deir el-Bahari

Keywords: Theban Limestone cliff, Esna Shale, Temple of Hatshepsut, Deir el-Bahari, geological research, swelling rate

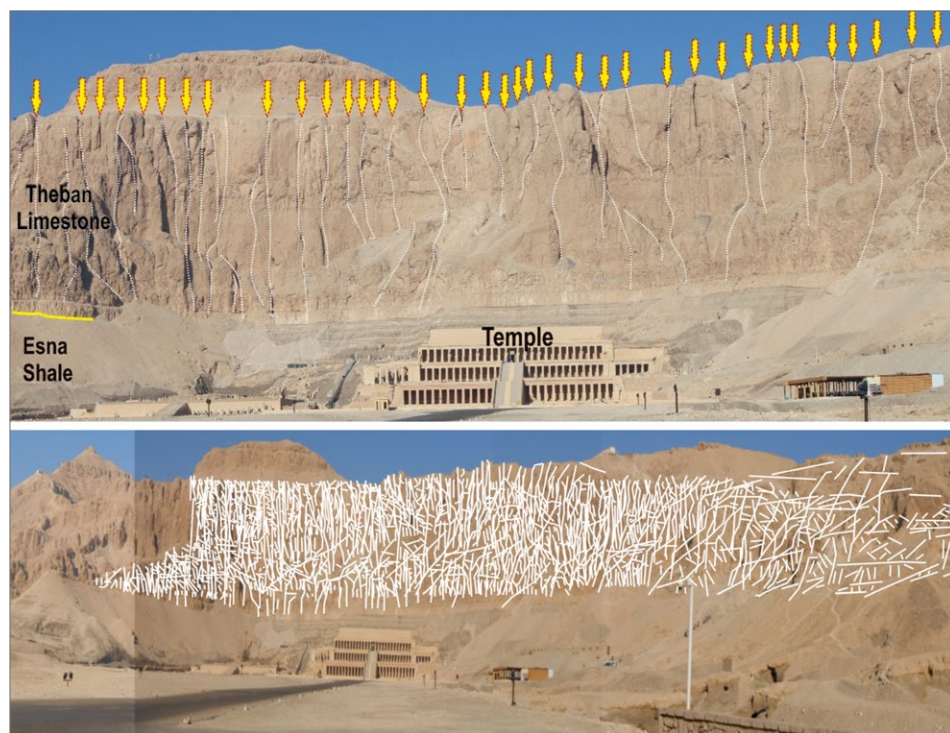
Fig. 4. General view of the dense fracturing of the cliff above the Temple (© Authors)

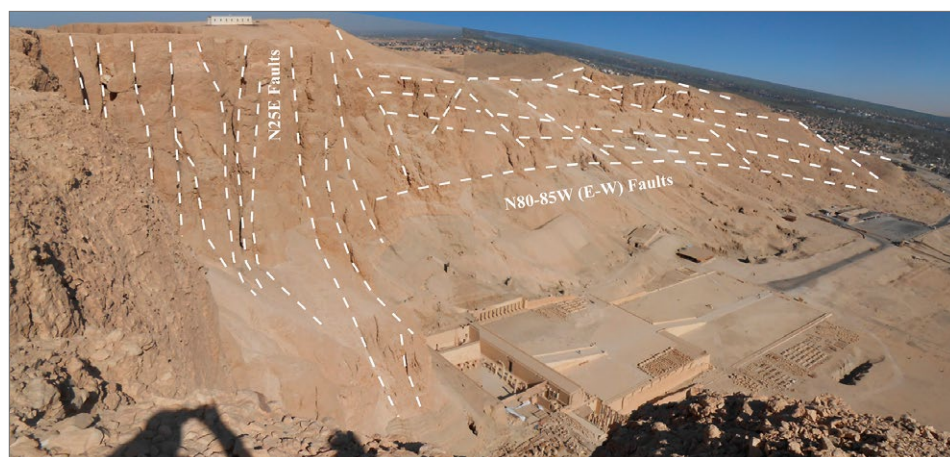
Fig. 6. The cliff around the bay of Deir el-Bahari: the marks reveal the nearly E-W trend parallel to the temple axis and the N25°E faults (© Authors)

The intersection of the major fault trends (E–W, N30°W, and N25°E) affecting the area [Fig. 6] led to the development of about 18 hanging limestone blocks on the cliff above the Temple, forming separated chimneys (1 to 2 m wide) that could threaten the Temple site in conse-

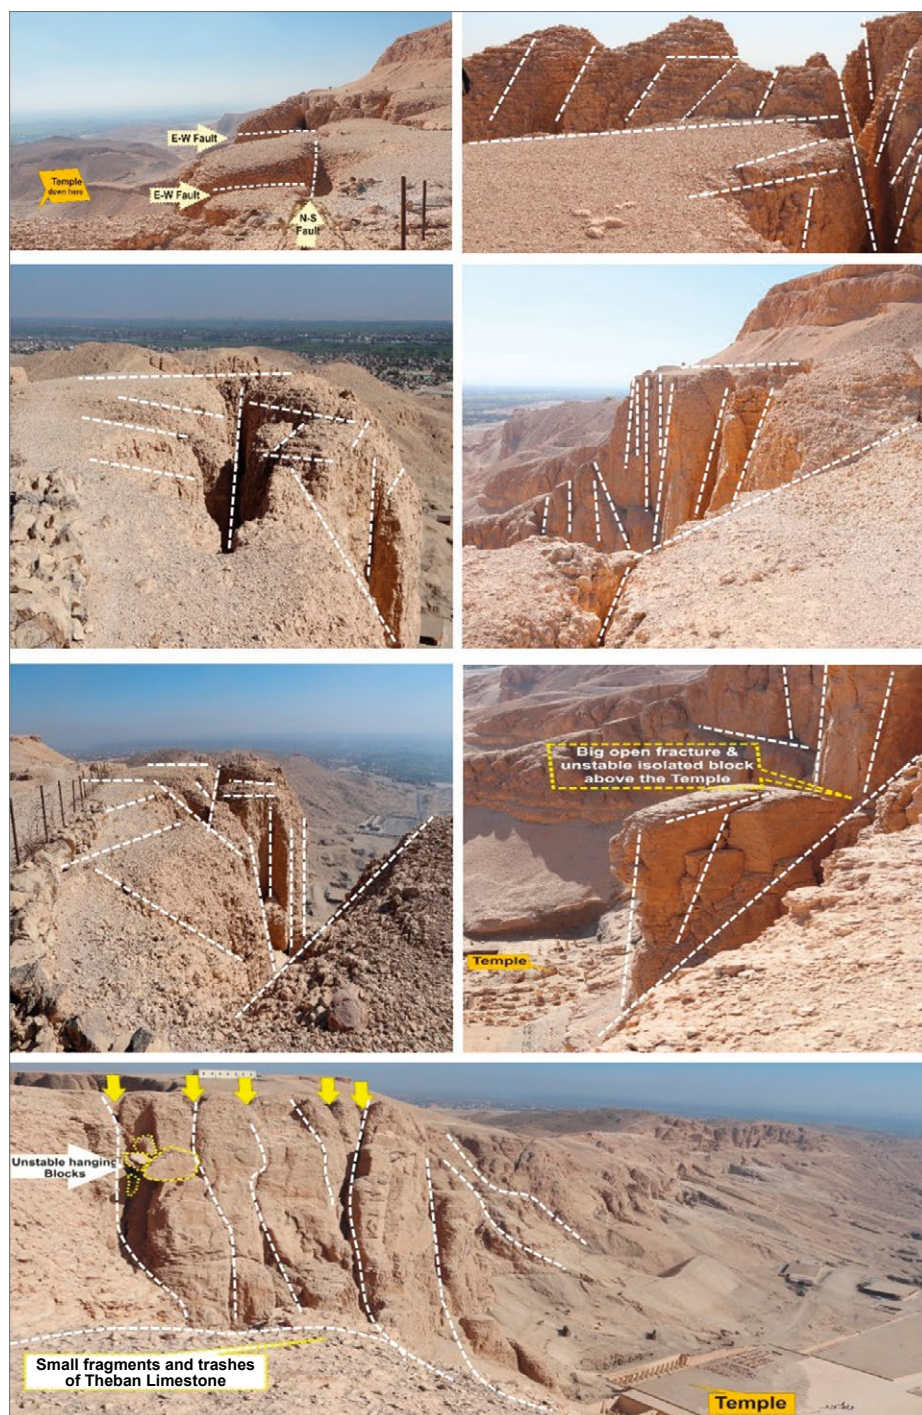
Fig. 7. Intersections between E-W and N25°E faults, causing hanging blocks, big open fractures and unstable isolated blocks above the Temple (© Authors)

quence of successive erosional and weathering action in the future [Fig. 7]. Two conjugate systems of joints (N30°W and N25°E) have been noted all over the site, cutting through the big, hanging rock masses. In many localities, the separation of these limestone blocks decreases downwards up to 20-to-50 cm, forming a V-shape [Fig. 8] filled with different-size

- About 18 hanging blocks and pillars (mainly isolated) were recorded. These could pose a hazard. Otherwise, there is no indication of a precise time for recent horizontal or vertical displacement of these hanging blocks.
- Small fragments and exfoliation, as well as limestone debris, were recorded scattered along the face of the limestone cliff and in between some of the pillars. These could be a lesser risk.

After monitoring all of the factors posing a threat to the limestone cliffs above the Temple, it has to be said that they continue to be dangerous. In order to propose effective solutions for the protection of the Temple, a detailed mapping of the area is essential to integrate the geological and environmental impact data, as well as to prepare a database for long-term static and dynamic monitoring of the separated blocks one by one.

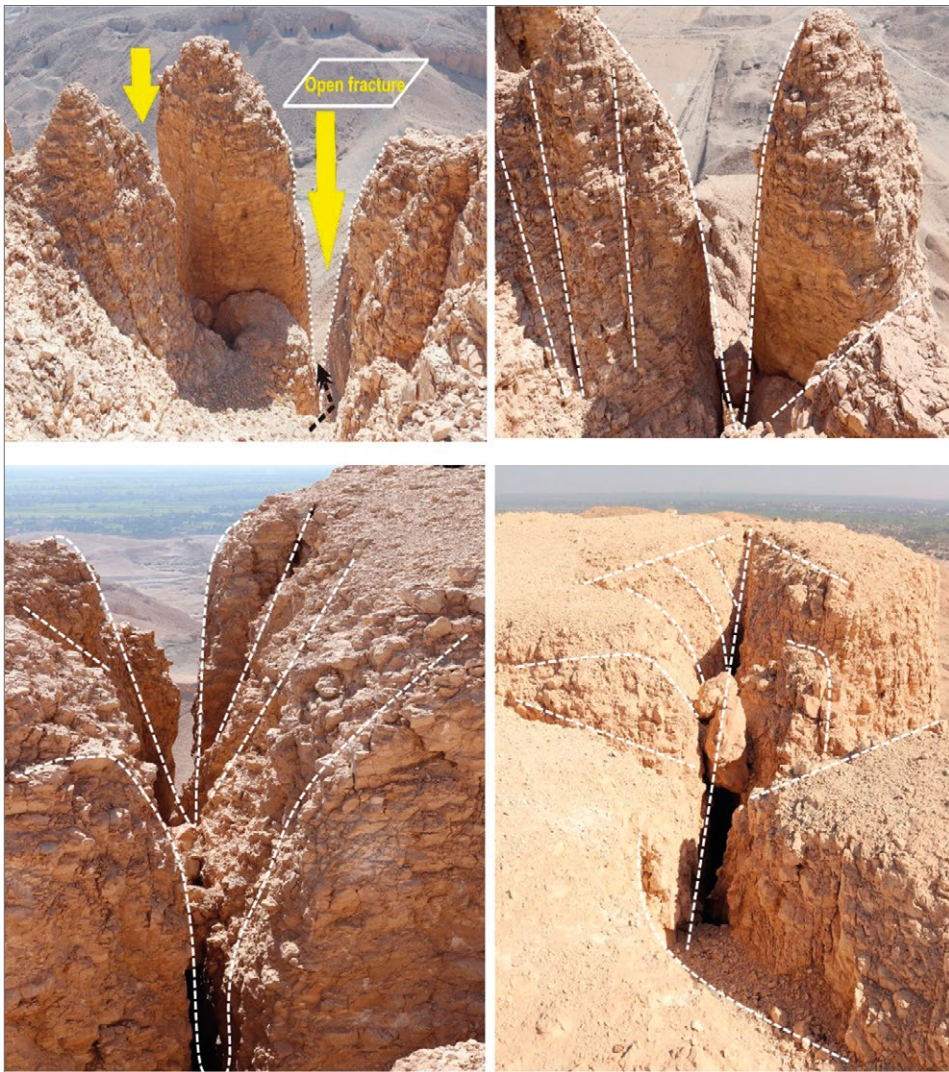
Fig. 8. Separated masses of limestone with V-shaped horizontal displacement (© Authors)

rock fragments at the top and padded with gypsum and calcite mineralization in the lower parts above the Esna Shale. The lack of mineralization along these joints at the top of the limestone hanging blocks implies that the joints could still be active under certain conditions, such as during heavily wet periods.

- Sets of faults and joints affect the Theban Cliff and threaten the Temple. A noticeable horizontal separation of the limestone rock masses ranged in width from 1 m to 2 m at the top, forming a V-shape that decreased downwards from 0.20 m to 0.50 m. Trends were recorded along some of the E–W, N30°W, and N25°E lines. Successive erosion and weathering could be the cause of the displacement of these masses.
- Although the exact age of these faults and joints is difficult to determine, still they may be younger than the Theban limestone unit and much older than the Quaternary rocks (about

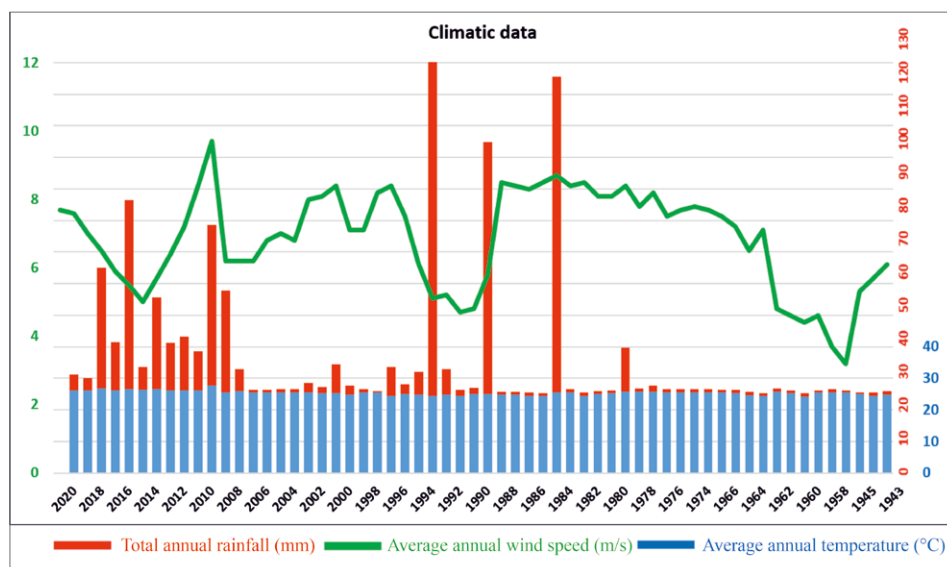
The climate of the Luxor region from 5000 BP until today has been drying successively, with several wetter episodes along the way (Zachos et al. 2001). The climatic data for the Deir el-Bahari region was collected for an interval between 1943 and 2020, showing the impact of climatic variability over 78 years. The intensity of such variability is likely to increase with the global warming, resulting in an increase in rainstorm intensity and consequently enhanced rock falls.

Fig. 10. Climatic data from the area around Luxor showing the parameters for the interval between 1943 and 2020 (© Authors)

The growing precipitation in the Deir el-Bahari area is the cause of an increased frequency of flash floods. For example, in 1994, a destructive flash flood in Upper Egypt (Deir el-Bahari, Luxor) reached maximum values of up to 123.7 mm (Strudwick 1995; Brock 1996). The precipitation variability chart shows periods of increase and decrease in rainfall [Fig. 10]. A marked decrease in rainfall (1.5 mm) is observed between 1943 and 1984, followed by a significant increase in rainfall (31.97 mm) between 1985 and 1994, with another significant decrease (12.89 mm) between 1995 and 2020.

near-surface conditions through mechanical weathering, causing the rock masses to be stressed and to deteriorate over time. Mean temperatures demonstrate a continuously growing trend: 1.0°C in the period in question, from 32.8°C to 33.8°C between 1943 and 2020. The annual mean of the minimum and maximum temperatures for Deir el-Bahari fluctuates between about 14.9°C and 35.7°C. Also, the average annual wind speed for the period between 1943 and 2020 is about 6.85 m/s. The maximum value is 9.7 m/s in 1965, the minimum value 3.2 m/s in 2017.

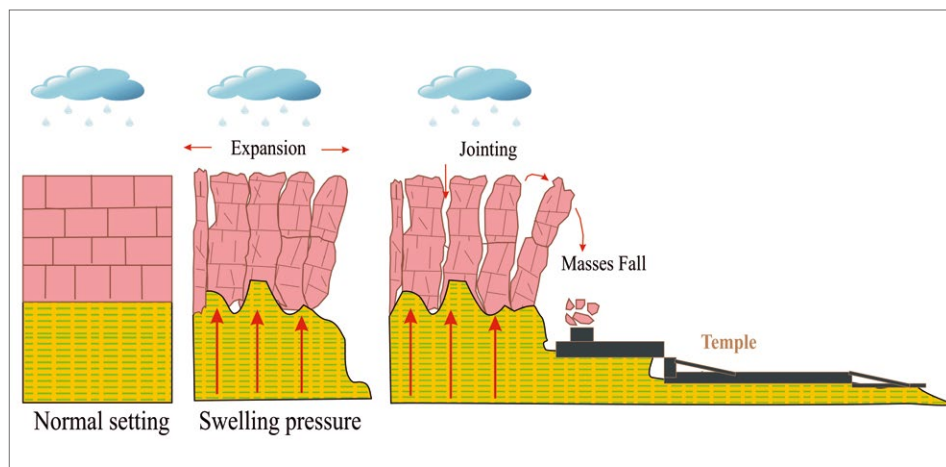
The discussion presented here served as the groundwork for developing a hypothetical impact model showing the probability of past, present and future scenarios of environmental and swelling threats endangering the temple site [Fig. 13]. Thus, water infiltrating through the fractured Theban Limestone during occasional rainfall, flooding, and then uneven drying up events, causes the swelling of the underlying Esna Shale, which, in the long run, weakens the rock masses forming the cliff above the Temple.

The contact zone between the Esna Shale and the overlying limestone cliff behind the Temple is generally sharp, especially in the area of the archaeological site, but close observation of the expected undulations over a large area requires more unrestricted field investigations to confirm the nature and current condition of the contact zone between the different rock units.

Fig. 13. A 2D hypothetical impact model illustrating the temporal changes of the cliff above the Temple site (© Authors)
