# Conservation of a commemorative monument to the Emperor Commodus in House H21c in Marina el-Alamein

**Abstract:** Current maintenance conservation work by the Polish–Egyptian Conservation Mission in Marina el-Alamein occasions a revisiting of the history of the archaeological discovery, interpretation and original conservation and anastylosis of a commemorative monument dedicated to the Roman Emperor Marcus Antoninus Commodus. The monument, a rectangular masonry structure with colonnaded front, was built inside a presumed dining or reception hall of building H21c near the harbor of the ancient Graeco-Roman town. The original project took place between 2000 and 2007 (Czerner and Medeksza 2010). Maintenance conservation after a decade created the opportunity for a more in-depth analysis of the dimensions of the monument and the individual architectural elements of which it was composed.

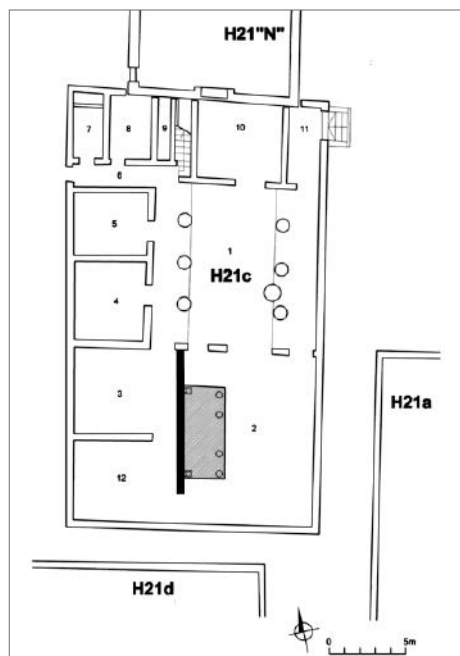
Fig. 1. Position of the Commodus monument inside House H21c (Polish–Egyptian Conservation Mission | drawing M. Krawczyk-Szczerbińska, S. Medeksza)

One of the most important architectural monuments from the site of Marina el-Alamein, an ancient Graeco-Roman harbor town on the Mediterranean coast of Egypt, is a commemorative monument dedicated to the Roman emperor Marcus Antoninus Commodus. It is a masonry-built structure located in what was most probably the main reception or dining hall (Room 2) of House H21c in the northern part of the ancient town, close to the harbor area [Fig. 1].

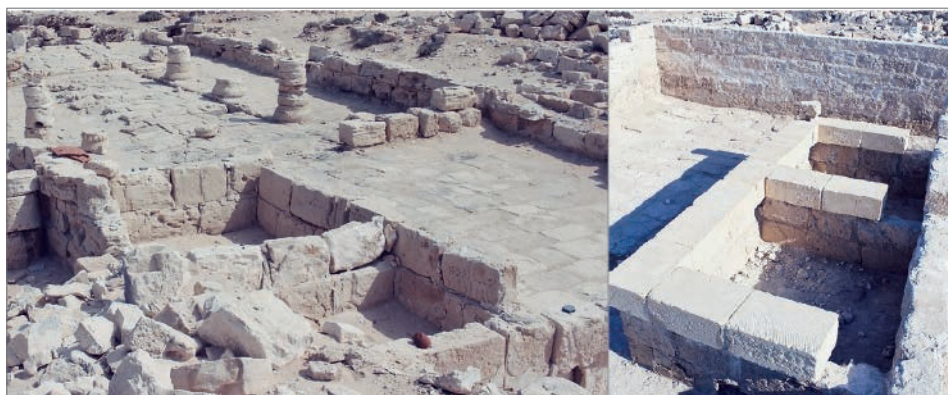
Fig. 2. Plinth of the monument after cleaning (left) and after finishing the walls with a capping at the edge (top level of the mensa +0.98 m) (Polish–Egyptian Conservation Mission | photos S. Medeksza)

The structure, which was first cleared in 2001, was not immediately recognized for what it was [Fig. 2]. Two square compart-

ments, 1.80 m to the side, were observed against the west wall of a large room that was indubitably the most important official hall in the house. It opened off a long courtyard with porticoes on either side. The compartments were constructed of two courses of vertical stone slabs (0.54–0.60 m long, 0.30 m wide, and 0.20–0.21 m thick), rising to a total height of 0.68 m. These walls were set directly on the paved stone floor, attached to the west wall of the room that rose behind them serving as a backdrop. The compartments appeared to serve no particular function.

parently filled solid with limestone rubble and sand (Czerner and Medeksza 2010: 98–99) [see *Fig. 2*]. Limestone slabs 21 cm wide were used for the walls and were capped with flat blocks typical of Marina (60 x 40 x 30 cm) forming a stone ledge around the perimeter. This base was subsequently decorated with the red marble slabs, arranged in a checkerboard pattern, the sides of individual slabs running presumably parallel and perpendicular to the diagonal of the *mensa* top.

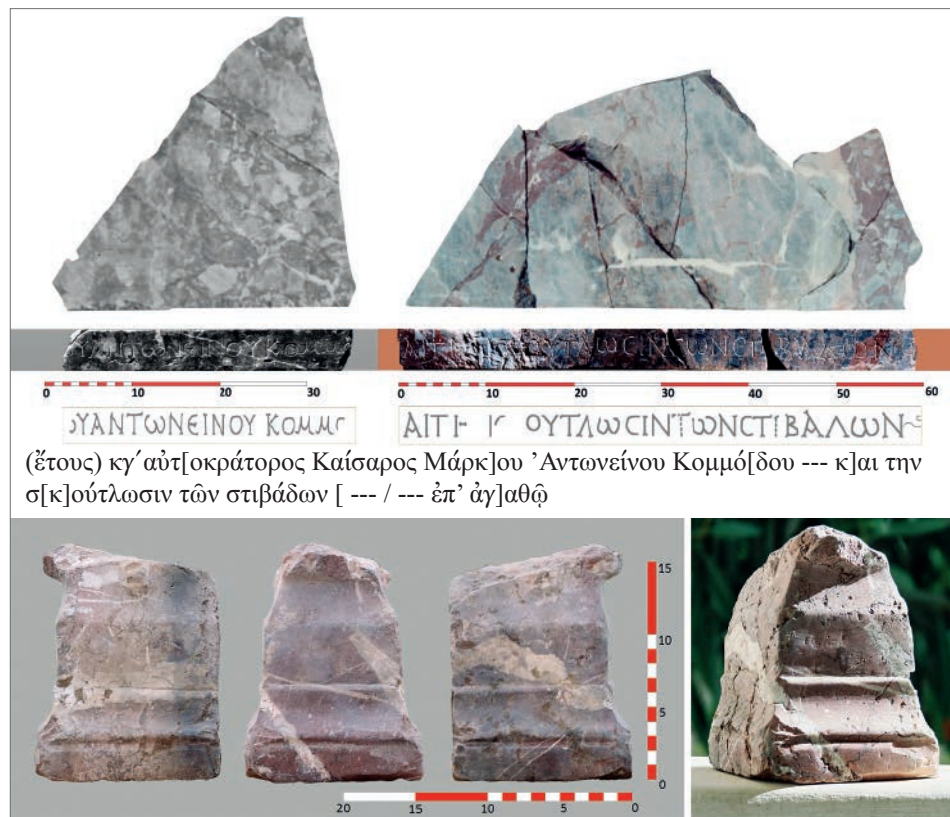
Fig. 3. Fragments of decoration: top, integrated *mensa* made of red marble with inscription around the edge; bottom, red marble decorative element (Polish–Egyptian Conservation Mission | photos A.B. Biernacki, W. Grzegorek; drawing and digitizing W. Grzegorek; reading A. Łajtar [2001; 2003])

Czerner and Medeksza 2010: 102) and reconstructed as a large rectangular marble *mensa*, 4.29 (4.34) m by 2.045 m. The slab was 4.3–4.8 cm thick and was furnished with a fragmentary inscription running around the edge, implying its horizontal position [Fig. 3 top]. It may have been set like a plinth covering the double-compartment structure. The inscription, consisting of letters 1.5–2.2 cm high, was cut in the middle of the height of the side of the slab. Read by Adam Łajtar (University of Warsaw), it contributed to the interpretation of the monument and its dating: "... Year 23

A small (12.5 x 12.5 x 16.3 cm) element, also made of red marble with light veins [Fig. 3 bottom], and a number of small, shapeless, flat chips from this marble (1–3 cm by 1–3 cm) came from the backfill of Room 2, but there is no certainty that they came from the monument.

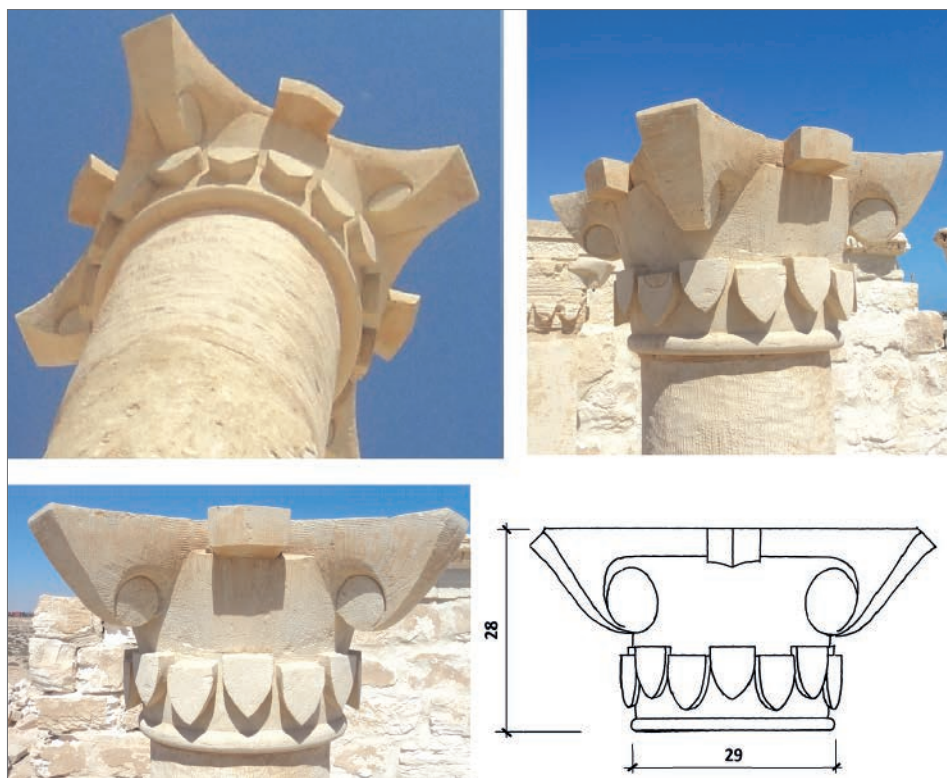
Fig. 4. Pseudo-Corinthian column capital classes as the so-called Marina type (Polish–Egyptian Conservation Mission | photos and drawing W. Grzegorek)

The architectural decoration included a pseudo-Corinthian capital (so-called Marina type) [Fig. 4] and a square pillar head also in the pseudo-Corinthian type. Fragments of red marble were recomposed into a two irregular pieces of a slab (34 x 34.5 cm and 29.5 x 60.5 cm; see Medeksza 2001: 73, 74;

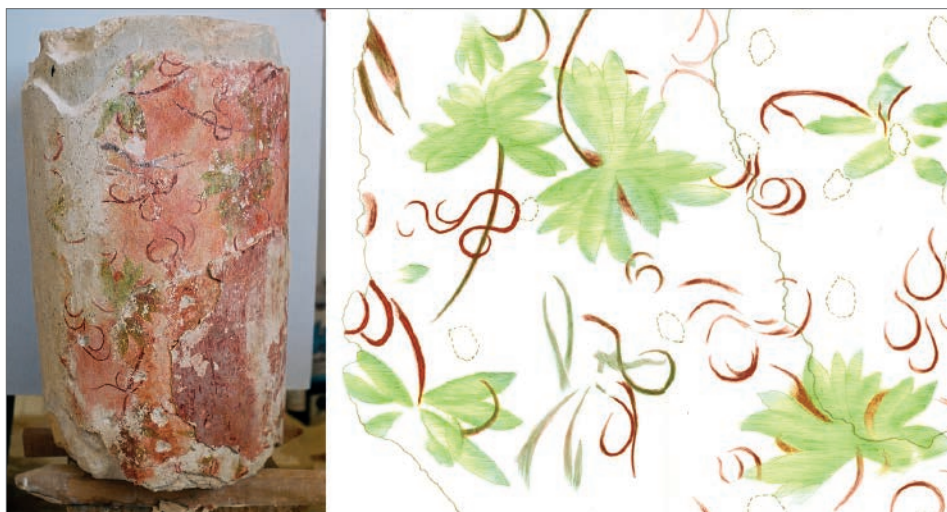
Fig. 5. Drum of a column with a plant ornament painted on the shaft (Polish–Egyptian Conservation Mission | photo W. Grzegorek, drawing W. Grzegorek and M. Ujma, digitizing M. Grzegorek)

Ujma in 2001–2002). The outer layer bearing a floral ornament in two colors (red tendrils with green leaves, Fig. 5) is 1 cm thick and made of more finely sifted aggregate, yielding a smoother surface as a ground for the wall painting.

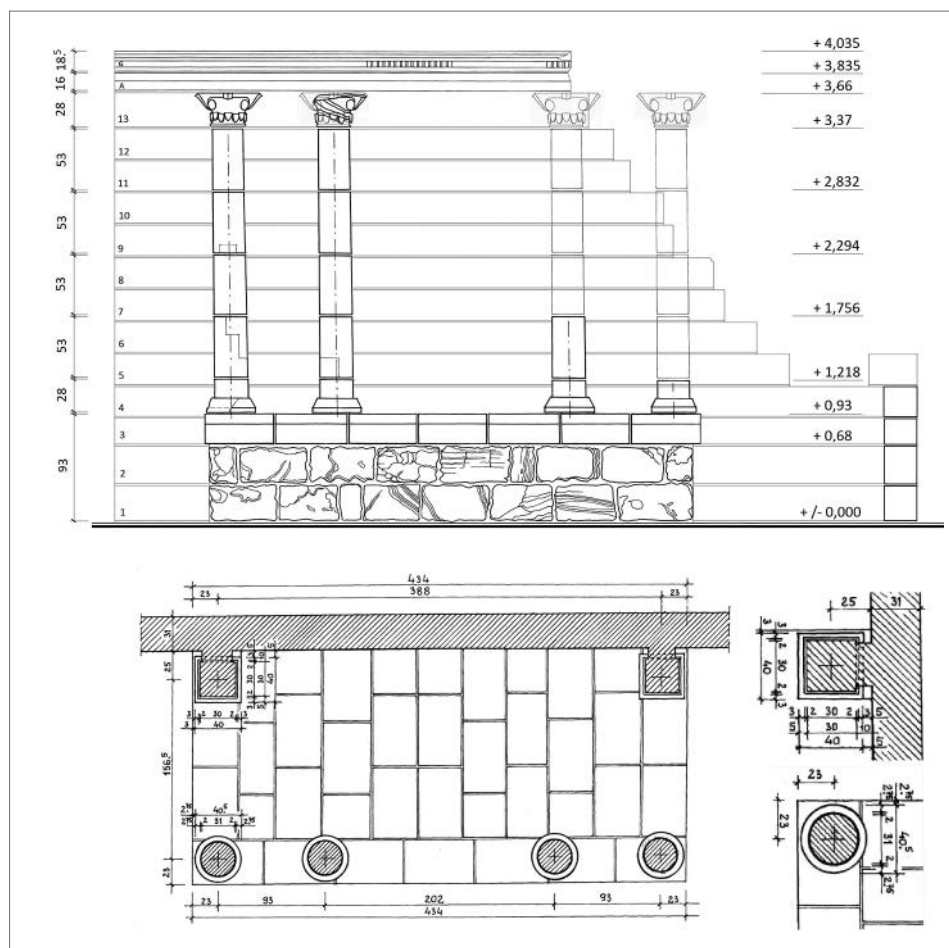
Fig. 6. Inventory drawings of the commemorative monument: front elevation elevation, plan and sections (state May 2018) (Polish–Egyptian Conservation Mission | inventory and drawing W. Grzegorek)

the house lent itself to the recreation of a two-row column portico on top of the base and with the west wall of the room as a backdrop. Originally, it consisted of four columns in front and two pillars or pilasters on the wall, standing 10 cm away from the wall, but connected to it by masonry. The distance between the axis of the column bases and the edges of the base is 0.23 m. The axis of the pillar/pilaster bases is 0.25 m from the wall. The spacing between the row of columns positioned at the edge of the plinth and the row of pillars by the wall is 1.565 m between the axes [Fig. 6].

The anastylosis took advantage of surviving architectural elements of the portico: two columns and one pillar of full height, as well as the outline of one drum on the base of the next column and the bases of the fourth, corner column and the second pillar by the wall (Czerner and Medeksza 2010: 109–112). The columns and pillars were mortared to the plinth slabs. The drums and capitals were joined with lime and cement mortar, using Egyptian-made white cement. The total height of the plinth, as well as of the columns and pillars, corresponds to the heights of the reconstructed columns of the portico belonging to the courtyard of House H21c, demonstrating the correctness of this hypothesis. For the sake of comparison, the lower diameter of the columns of the courtyard portico is 0.46 m, while that of the columns of the monument is only 0.315 m (Czerner and Medeksza 2010: 102; Grzegorek 2019: 285) [see Fig. 6].

top of the ledge to the top of the capitals is 2.73 m. The height from the top of the base to the top of the architrave is 2.905 m and to the top of the cornice 3.105 m [see Fig. 6]. The overhang of the cornice in relation to the wall facade is 0.19 m.

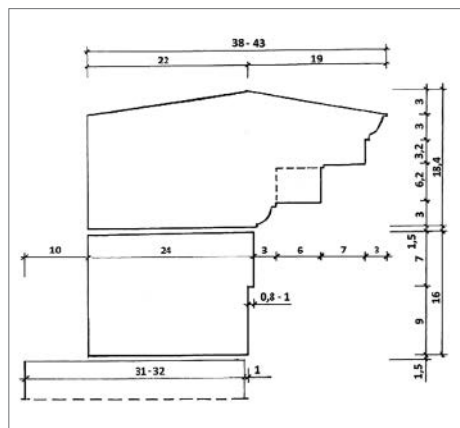
Fig. 7. Cornice with dentils (section drawing, 2018) (Polish-Egyptian Conservation Mission | inventory and drawing W. Grzegorek)

The west wall was reconstructed to a height of 10 courses above the top of the plinth surface, assembling the new blocks of the architrave higher with the preserved cornice mantle on top (Grzegorek 2019: 286) [Fig. 7].

The cornice block [see *Fig. 7*], inadvertently broken, was reintegrated on the floor by stone conservator Piotr Zambrzycki using stainless steel clamps and epoxy resin. After the resin had hardened, the block was settled on the top of the wall, bonded with mortar, completing the northern end section of the pinion cornice crowning the wall.

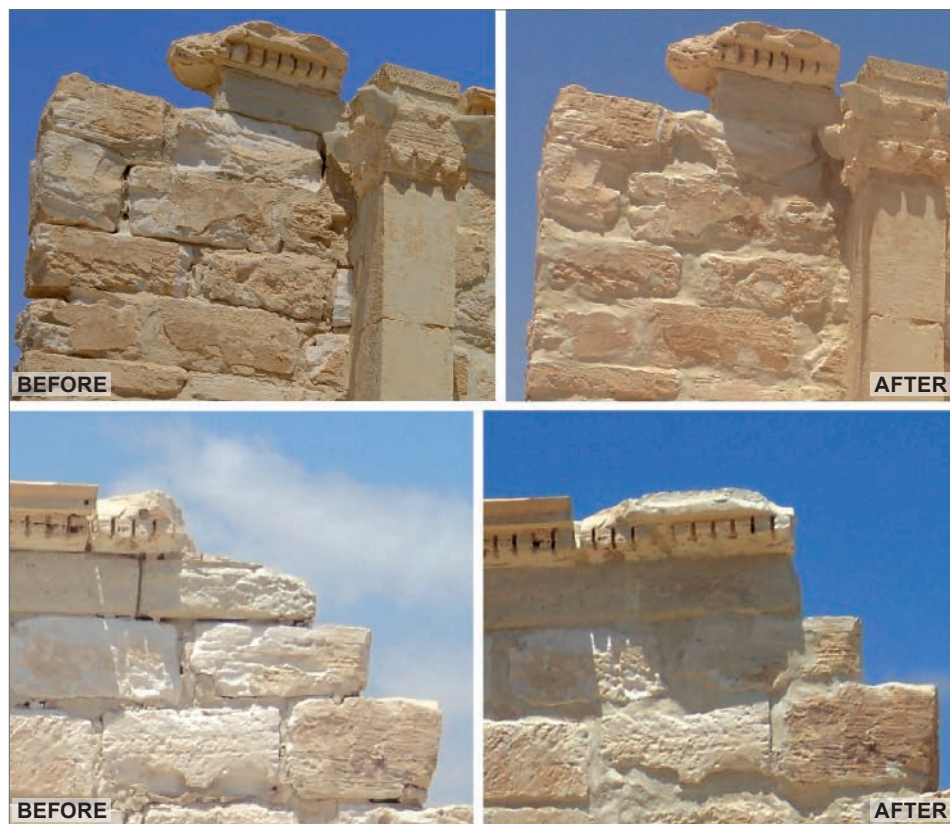
often carrying large amounts of fine abrasive sand. They are accompanied by aggressive atmospheric precipitation occurring in the coastal area. These processes are the cause of progressing degradation, evidenced by the loss of mortar from the joints and local erosion of limestone blocks in the walls.

Fig. 8A. Commemorative monument before and after completion of work in the 2018 season: details of the wall (Polish–Egyptian Conservation Mission | photos W. Grzegorek)

tion work was carried out by the author [Figs 8A–B]. Because of an urgent need to fill in the joints and larger stone losses in the wall located between Rooms 2, 12 and 3 of House H21c, the larger stone losses were filled on both sides and pointing work was conducted on the eastern face of the west wall of Room 2; local plastering of the surface of eroded stones was performed. This wall is structurally important

- cleaning the surface of stones and joints with a hard plastic brush and a wire brush,
- removal of loose fragments of mortar and stone,
- abundant moistening of cleaned joints or gaps between blocks after mortar depletion,
- filling the joints with mortar of dense plastic consistency and cleaning excessive mortar from the face of the stones,
- curing the binding mortar in the joints by sprinkling it frequently with water.

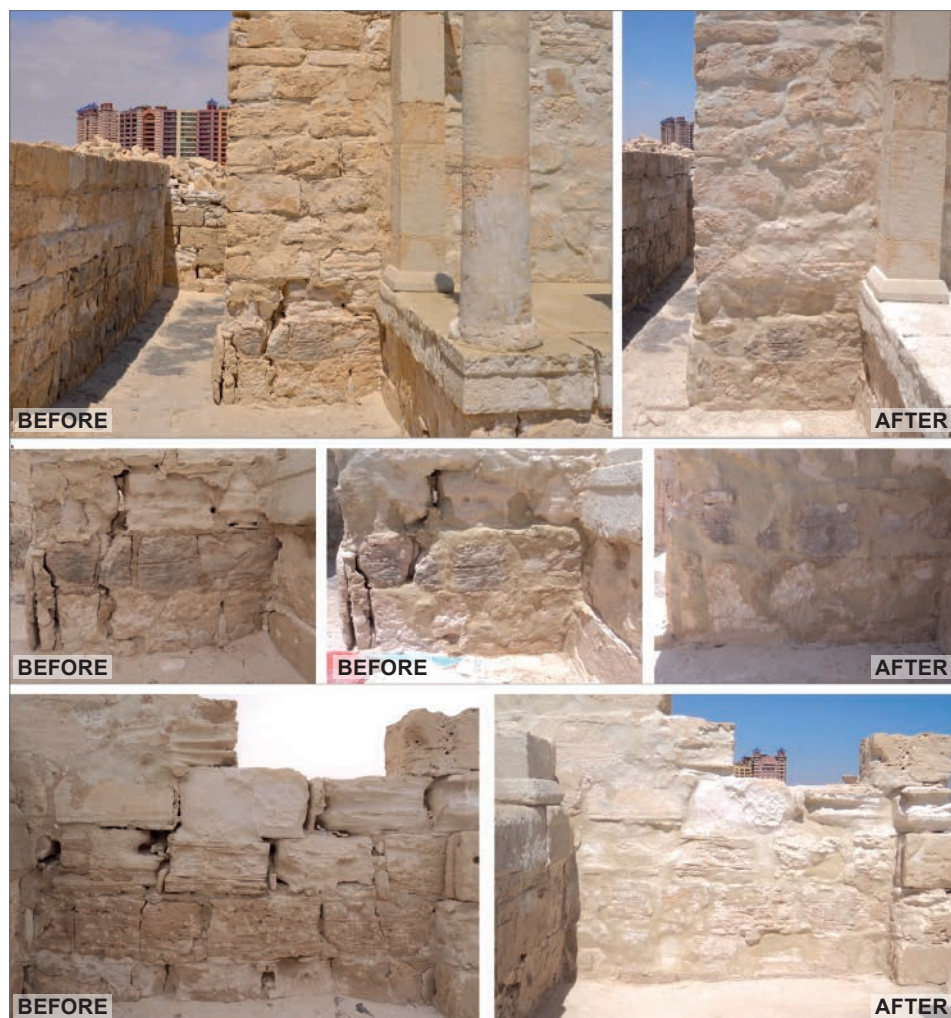
Fig. 8B. Commemorative monument before and after completion of work in the 2018 season: details of the wall, view from the the north and south (Polish–Egyptian Conservation Mission | photos W. Grzegorek)

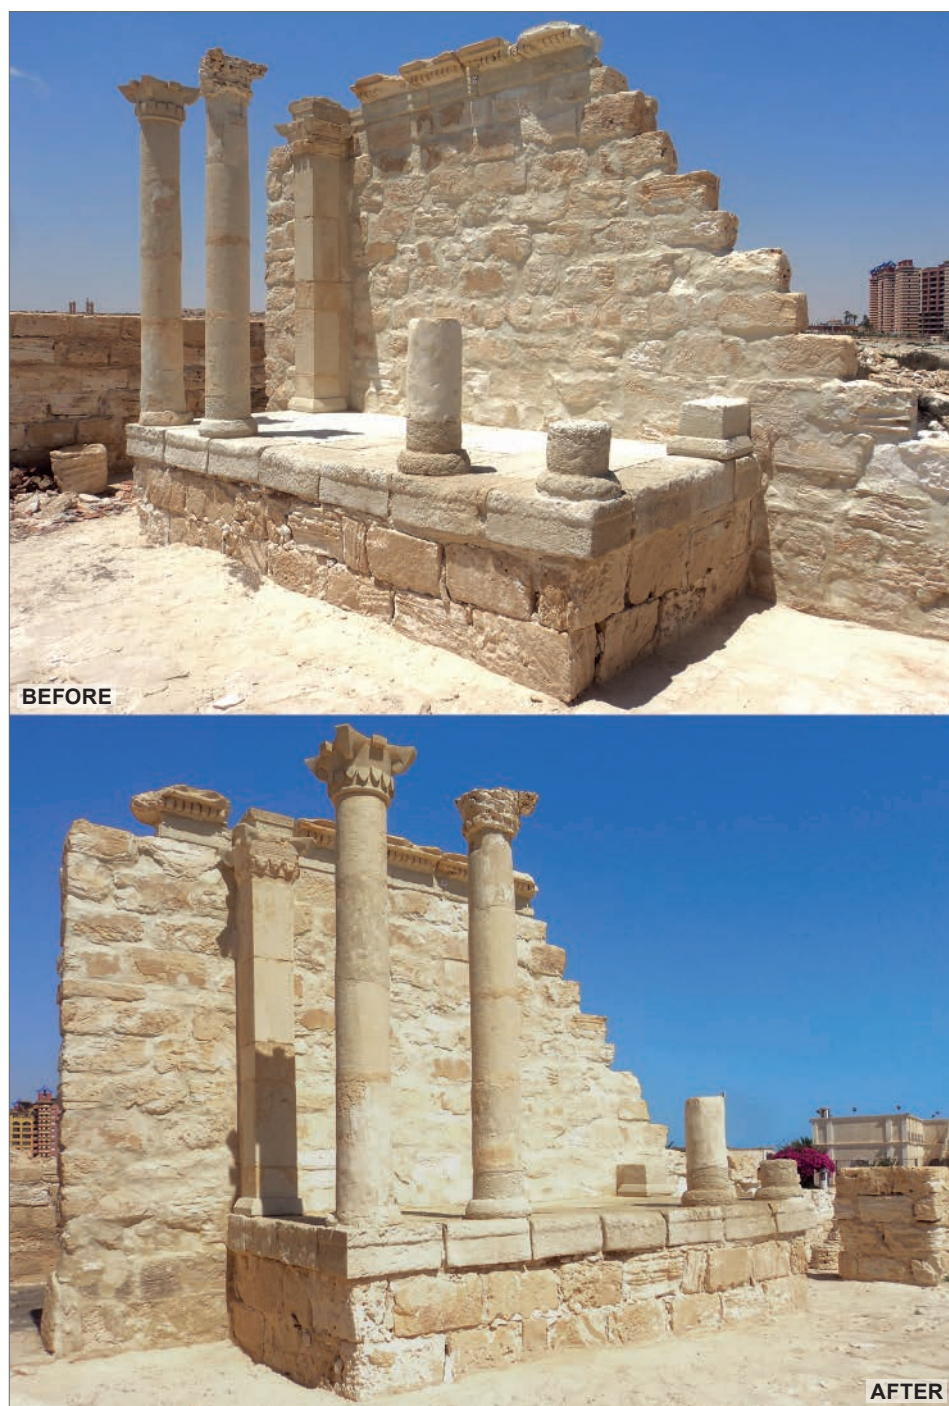
Fig. 9. Commemorative monument before and after completion of work in 2018 (Polish–Egyptian Conservation Mission | photos W. Grzegorek)

The current work was necessitated by the observed degradation of sections of the back wall on either side of the monument. Stone erosion and deterioration and loss of mortar from the joints threatened the collapse of parts of the structure. The case of the monument, requiring additional conservation barely a decade after the original
