Conservation work in Marina el-Alamein in 2018 (Polish–Egyptian Conservation Mission)

Abstract: The article presents the program and results of continuous monitoring and preservation of historic architectural structures after the winter period at the site of Marina el-Alamein in Egypt, carried out by the Polish-Egyptian Conservation Mission. The program embraced studies of ancient plaster, polychromy and execution techniques employed for producing elements of sculptural and architectural decoration, as well as conservation of archaeological artifacts.

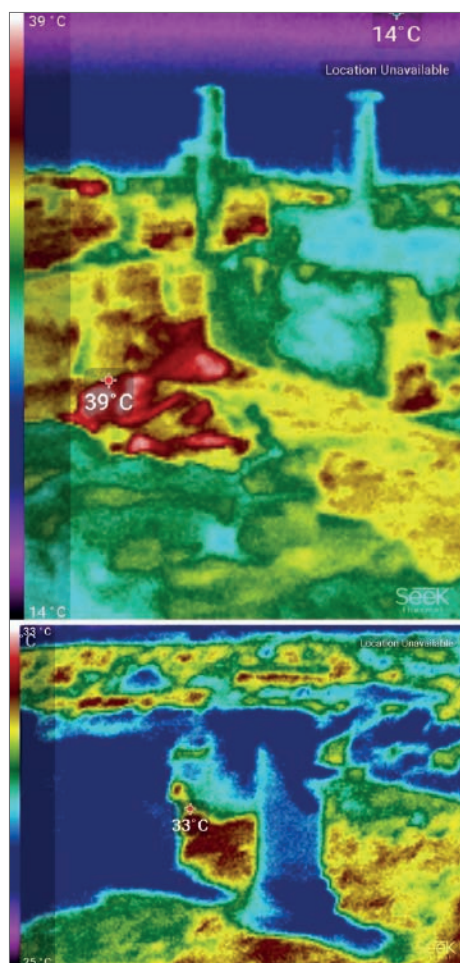
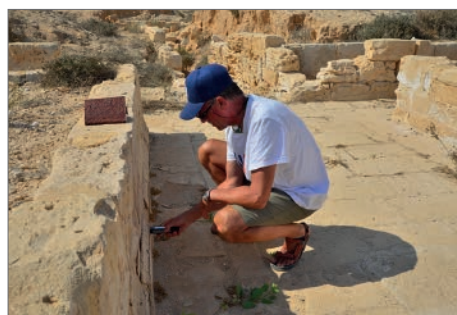
Fig. 1. Dampness study: left, thermovision measurements in the main square of the ancient town; right, wall humidity measurements being taken in Tomb T21 (Polish-Egyptian Conservation Mission | thermovision-image processing P. Zambrzycki, photo A. Selerowicz)

Thermal recordings and moisture distribution measurements were taken in mid-May, between 8 and 9 AM. High air humidity fluctuation and a dynamic increase of temperature can be observed in this part of the day. An electrical resistance Geo Fennel FHM 10 moisture meter and a Seek Thermal thermographic camera (range of 7000–14,000 nm) were used to conduct the tests.

Wall moisture distribution was measured using an electrical resistance device in vertical axes. The axes were marked from the eastern, northern (sea direction) and western sides. Measuring point spacing was set between 20 and 30 cm, depending on wall structure. The research goal was to establish dampness distribution, analysing the walls near the soil and up to a height of approximately 1 meter. The top parts of the walls were measured in addition.

Thermal recording has shown temperature distribution, which in the earlier part of the day matched the dampness distribution of the walls and surrounding terrain. This has also provided valuable information regarding the temperature

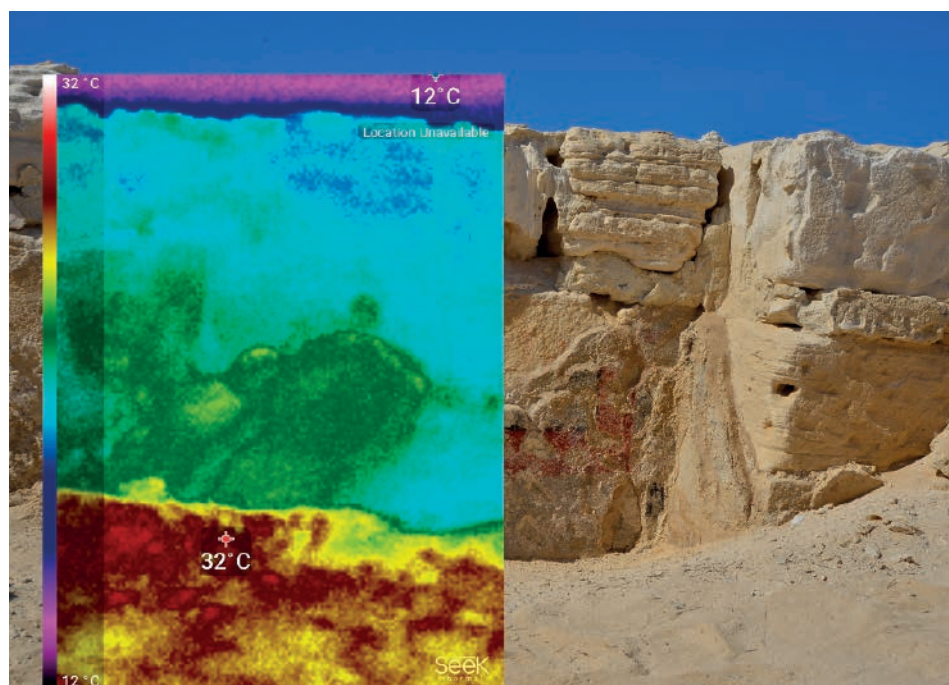
Fig. 2. Dampness study: thermovision measurement in the northeastern corner of Room 11 in the Roman baths with preserved relics of plaster (Polish–Egyptian Conservation Mission | photos P. Zambrzycki).

Instrumental analyses confirmed the higher dampness levels of house walls when compared with structures in the necropolis located on higher ground. In the lower part of the bath walls, dampness exceeded 2%. Significantly, plasters with preserved polychrome paintings reached values of 1.0–0.8% in comparable areas. This confirms that the major cause of dampness is capillary soaking from the soil, where periodic fluctuation of air humidity is a less important factor. Measurements taken at House H21 near the bay show a much higher

level of ground dampness. The readings fit within the 2% scale only above the height of 130 cm, which might be connected with high ground water levels and close proximity of the sea. Readings taken on the sunlit (eastern) and shadowed (western) sides of the walls differ only slightly. This further reinforces the belief that dampness is caused by capillary soaking from the soil. The situation is greatly improved in the area of the necropolis. The soaking effect is very limited there due to terrain, as the tombs are located on bedrock and far from the sea. In comparable areas the readings reached from 1.2% to 0.6%. [PZ]

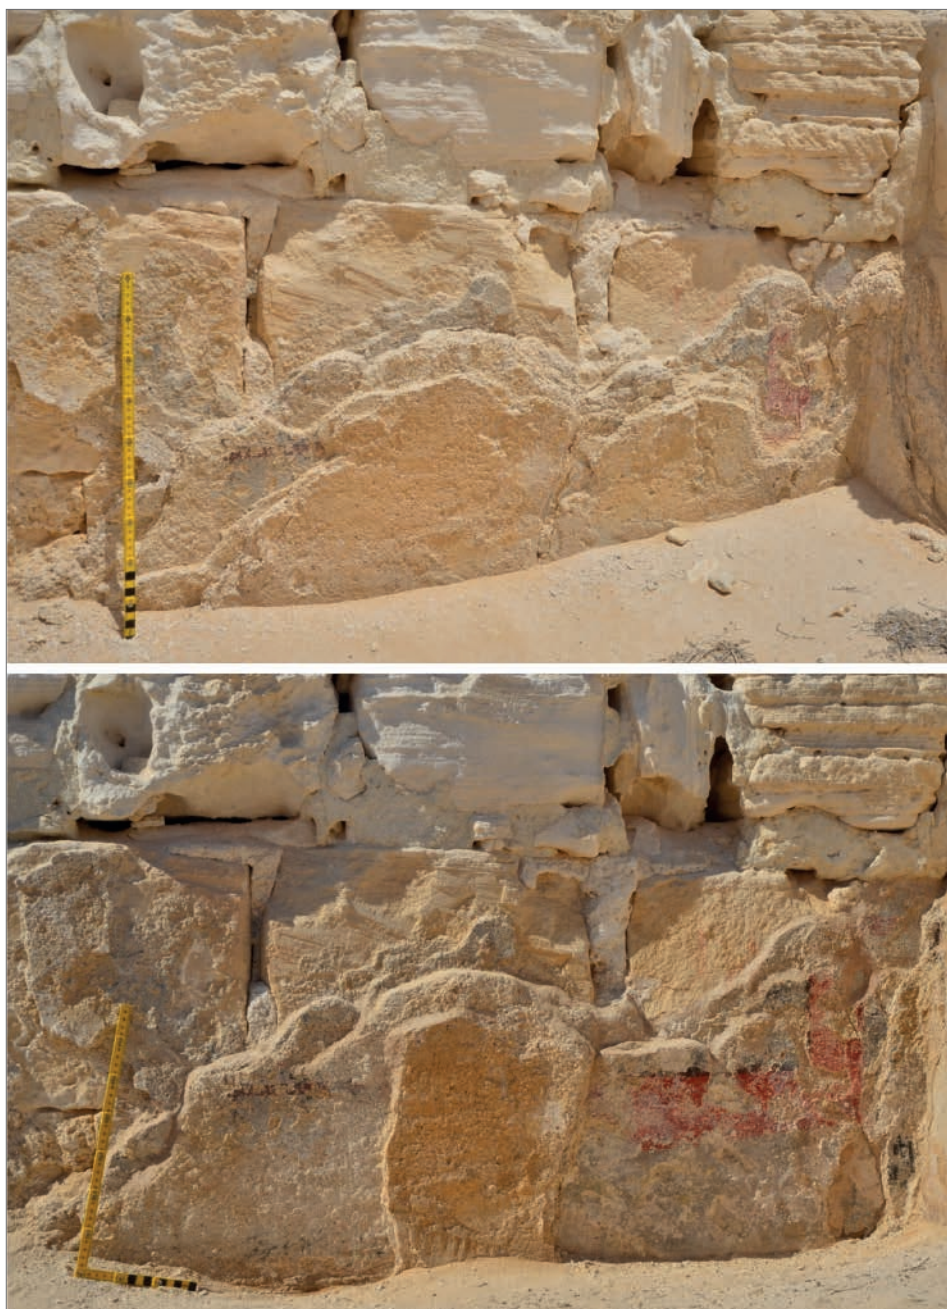
Several layers of decorated plaster of different degrees of cohesion are present on the lower walls of Corridor 11 of the Roman baths located south of the main town square in the central part of the site [Fig. 3]. The main threat to the integration of the layers are the unfavourable microclimatic conditions. Hence preventive action was undertaken aimed at reinforcing plaster adhesion to the substrate and protecting the surface of the polychromy.

Fig. 3. Northeastern corner of Room 11 in the Roman baths with preserved relics of plaster: top, before conservation; bottom, after conservation; note bands reinforcing the plaster edges (Polish–Egyptian Conservation Mission | photos P. Zambrzycki).

layers was established. The uncovered layers (in some places up to 10 layers were observed) were partly cleaned of depositions. Edges of losses were protected with bands of lime-cement mortar with sand and crushed brick filler, and a sprinkling of a 5% water solution of Primal AC33 as plasticizer. The polychromed plaster surface was reinforced with a 2% water solution of Primal AC33 (Jakubowski 2008: 130–131). The decorative layer is preserved in relatively good condition [Fig. 3 bottom]. Traces of cuts in this layer testify to ancient preparations for adding another plaster coating.

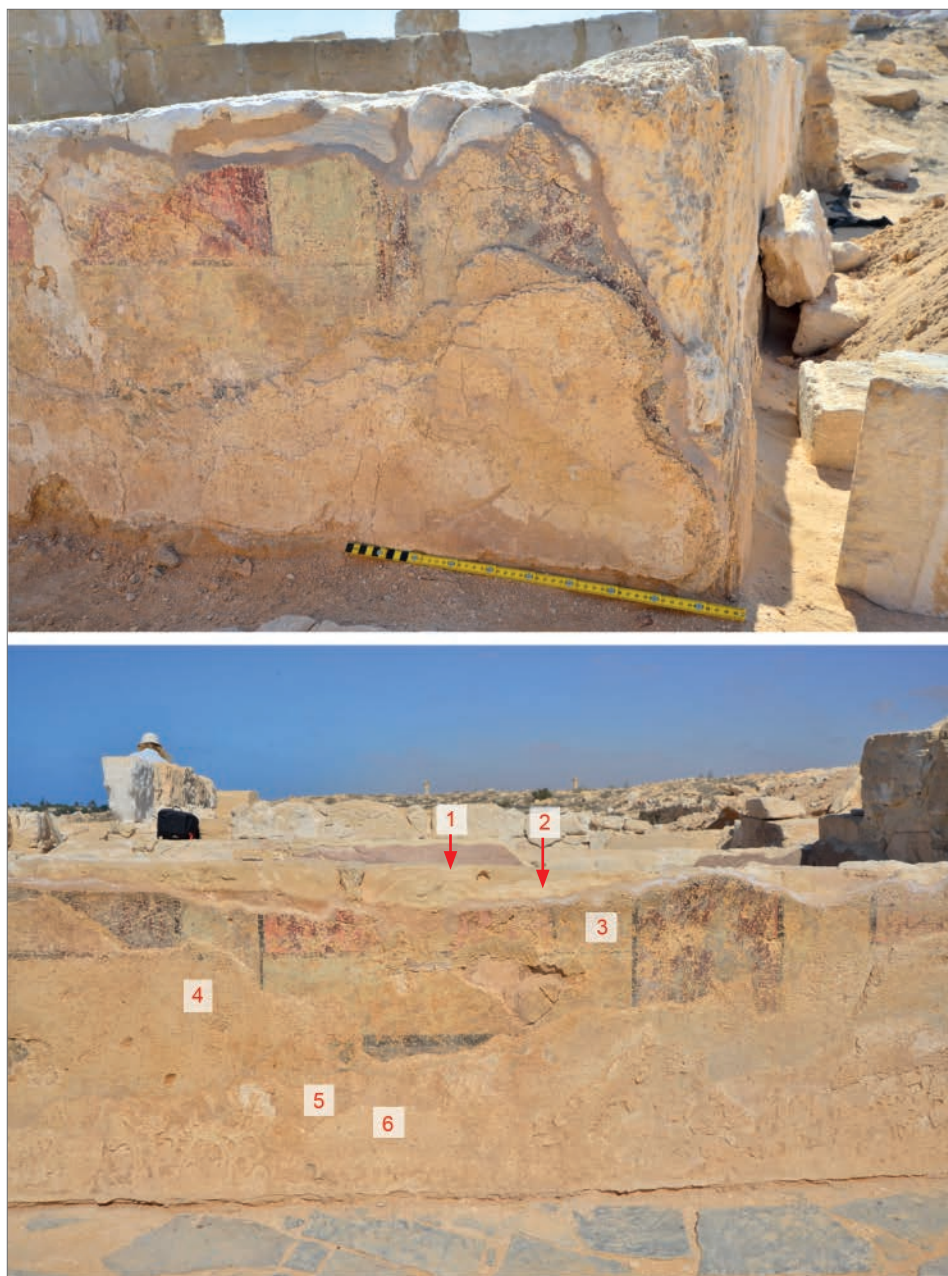
The nature of the decoration and its relatively good state of preservation called for a separate preservation program [Figs 4–5]. Examination of the plaster on the south, west and east walls, the latter divided in the middle by the entrance to the latrine, revealed six layers. The oldest two layers of plaster preserved a dado decoration

The painted decoration was on a lime mortar ground. The thickness of both dado paintings reaches around 2 cm. The one on the bottom, chronologically the earliest, is characterized by considerably higher artistry and is also much better preserved than the top one. Therefore it allows more accurate and detailed recognition of the composition and artistic skills of the painter. Probably due to severe damage, the paintings were covered later with simple coats of mortar with coarse-grained filler, the thickness of which does not exceed 5 mm.

Fig. 3. Polychrome plaster on the walls of Room 13 of the Roman baths: top, east face of west wall during the installation of bands protecting the plaster edges; bottom, south wall revealing the underlying decoration in the tests; 1 – wall; 2 – lime mortar; 3 – plaster with “dado” decoration, 1.5 cm thick; 4 – plaster with “dado” decoration, 2 cm thick; 5 – thin mortar with coarse-grained filler, 0.3 cm thick; 6 – thin mortar with coarse-grained filler, 0.5 cm thick) (Polish–Egyptian Conservation Mission | photos P. Zambrzycki)

Photographic documentation was made and samples taken for testing. There were no signs of salt efflorescence on the polychrome surface. The painting was cleaned of loose pieces of plaster and sand. Due to the high hardness of the plaster, it was decided not to deepen the cracks, as the vibrations induced during this procedure threatened to weaken the adhesion of the mortar to the substrate. The lime–sand mortar for the bands and filling in of cavities and bigger cracks was prepared with carefully chosen strength parameters. It was composed of lime, a fine-grained sand fraction, cement and a small amount of crushed brick (3:1:0.5:0.08 respectively). A 2% solution of Primal AC33 in water was added to increase mortar flexibility. Adding crushed brick served to enhance the hydrophobic properties (waterproof mortar) (Acharya, Archroy, and Gokhale 2017). Surfaces to be preserved were first moistened with water. As part of the research project, a 2% solution of Primal AC33 in water was applied for reinforcement, brushing it onto the surface with a soft brush.

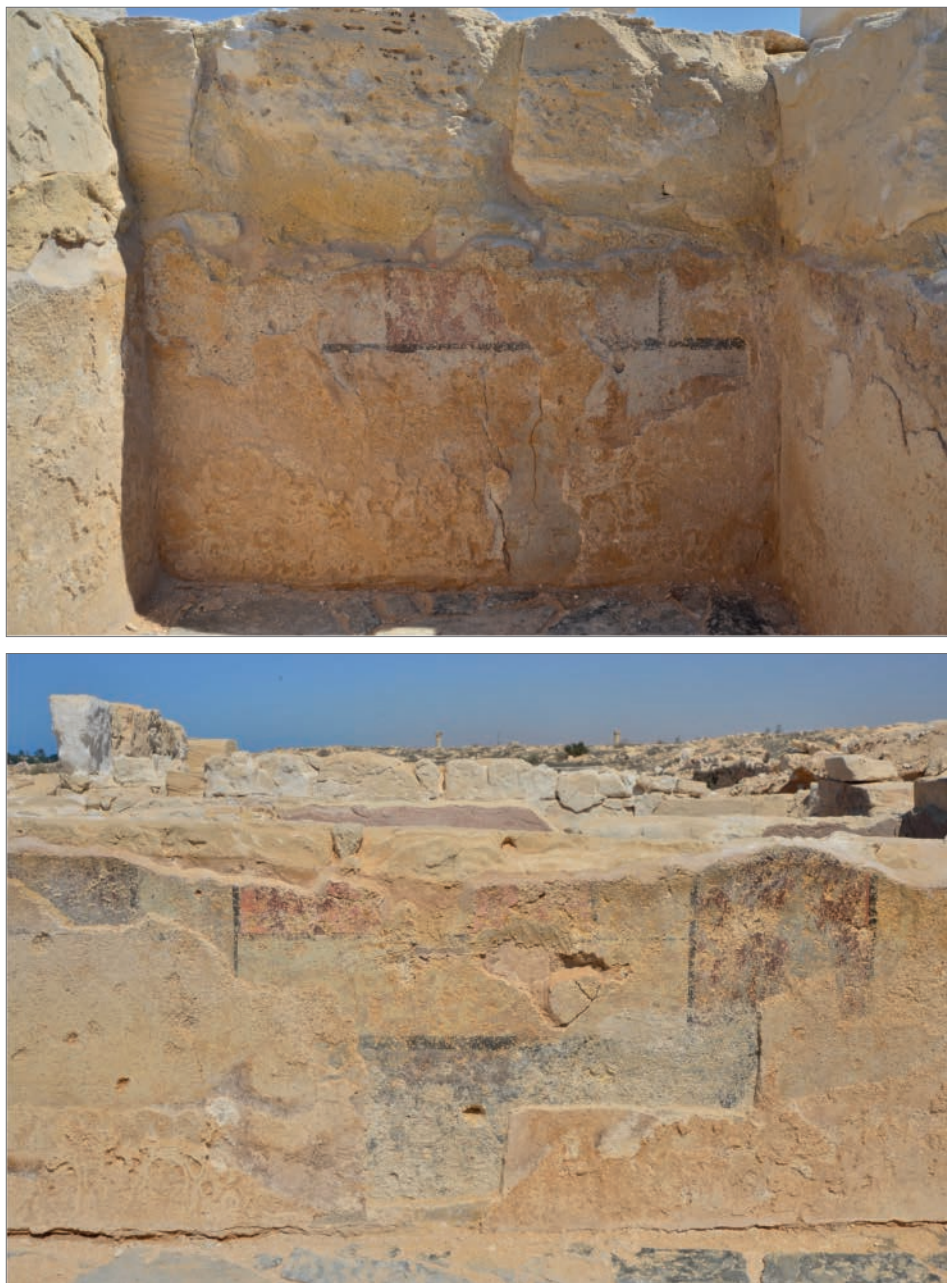
walls allowed for a theoretical reconstruction of the wall decoration in this interior. The lower part was a dado, a color frieze consisting usually of three colors. Above the dado was a series of geometric panels. One can see a black dado and shades of red in the panels above it. The decoration was painted on white mortar applied onto the stone substrate. The paint layer is characterised by good adhesion to plaster of high cohesion and hardness. The edges of the surviving plaster were weakened by harsh, unfavourable climatic conditions, and had become partly detached from the wall.

Fig. 5. Polychrome plaster on the east wall of Room 13 of the Roman baths: top, the first layer of plaster decorated with largely preserved polychrome decoration and successive technological layers preserved in poor condition, during conservation; bottom, original decoration visible in the tests (Polish–Egyptian Conservation Mission | photos P. Zambrzycki)
