Fieldwork in 2015/2016 in the Southern Dongola Reach and the Third Cataract Region

Bogdan Żurawski,¹ Aneta Cedro,² Mariusz Drzewiecki,³
and Roman Łopaciuk⁴

Abstract: The settlement remains surrounding the churches at the sites of Banganarti and Selib continued to be excavated in the 2015/2016 season by a team directed by Bogdan Żurawski. The research focused primarily on the living quarters around the churches and fortifications. An ethnographic survey carried out in Banganarti and Selib, and in the nearby villages documented traditional crafts, such as pottery making, basketry, baking and cooking using traditional techniques and recipes. Conservation and construction work were undertaken simultaneously with preparations for turning the Banganarti and Selib 1 sites into tourist attractions. Skeletal remains from earlier excavation were examined by a physical anthropologist.

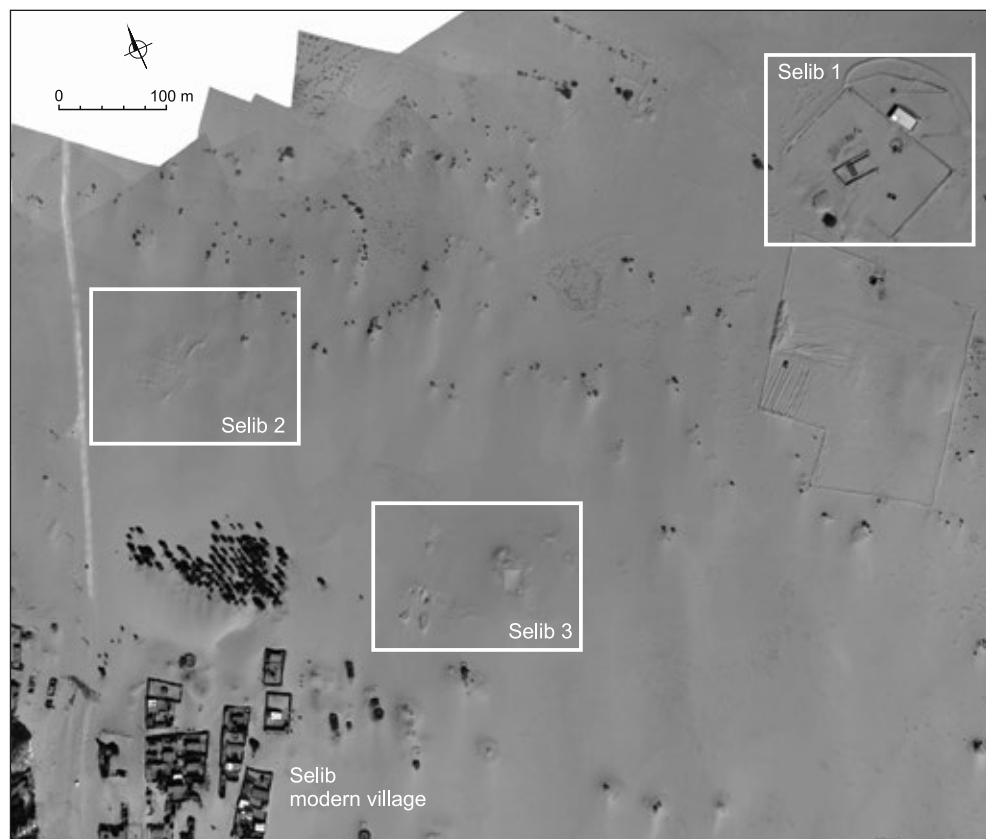
Fig. 2. Orthophoto of the Selib sites
(Photo and rendering B. Żurawski)

Selib 3 [Fig. 2]. The 2015/2016 season at Selib 1 was dedicated to the study of an area adjacent to the enclosure wall and to the wall itself. The research started with a narrow trench dug along the inner and

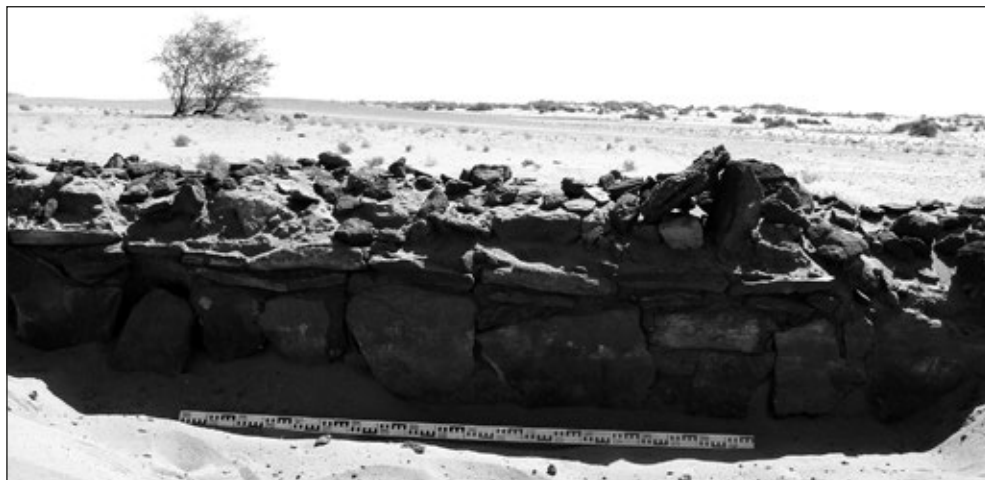
Fig. 4. Selib 1. Stones of the inner face of the bigger *peribolos* wall
(Photo M. Drzewiecki)

in width, unworked, closely-fitted stone blocks formed an even surface [Fig. 4]. A few stones in vertical position in one place suggest at least one episode of wall repair. A rectangular pit lined with red brick had been dug in the sand close to the northeastern corner of the wall [Fig. 5].

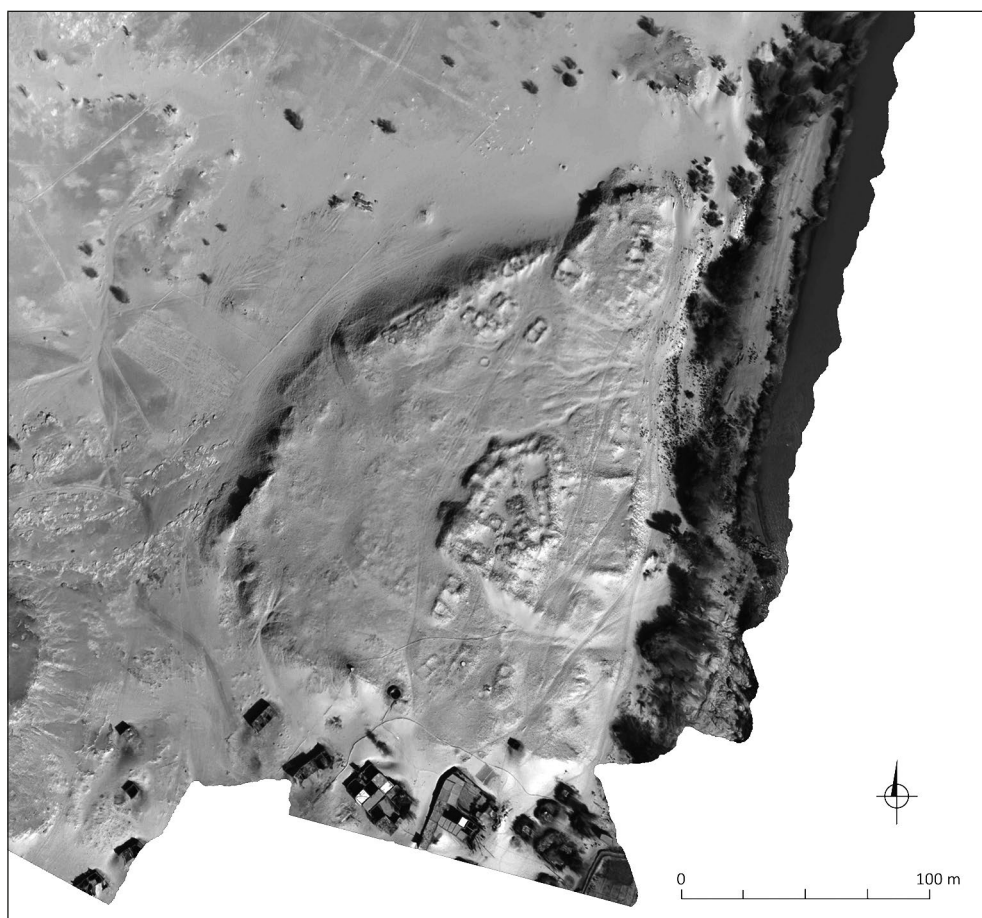
Fig. 8. *El-Diffar: orthophoto of the site made in 2016*
(Photo and rendering B. Żurawski, R. Łopaciuk, and P. Rurka)

Thorough documentation of selected fortified sites in the Southern Dongola Reach was carried out in the second half of the season. Two visits to the el-Diffar fortress permitted the geodesic and 3D photogrammetric documentation of the site to be completed (the initial research was conducted in 1998–2000 and in 2002). The first attempt at composing an airborne image of el-Diffar, unfortunately incomplete, was made in 1998 during the Southern Dongola Reach Survey using a camera suspended from a box kite (Żurawski 2003: 295, Fig. 5). In 2016, this task was accomplished. The ensuing 3D orthophotographic model of the site shows the modern village encroaching gradually into the archaeological zone [Fig. 8]. This poses a serious hazard as the site has never

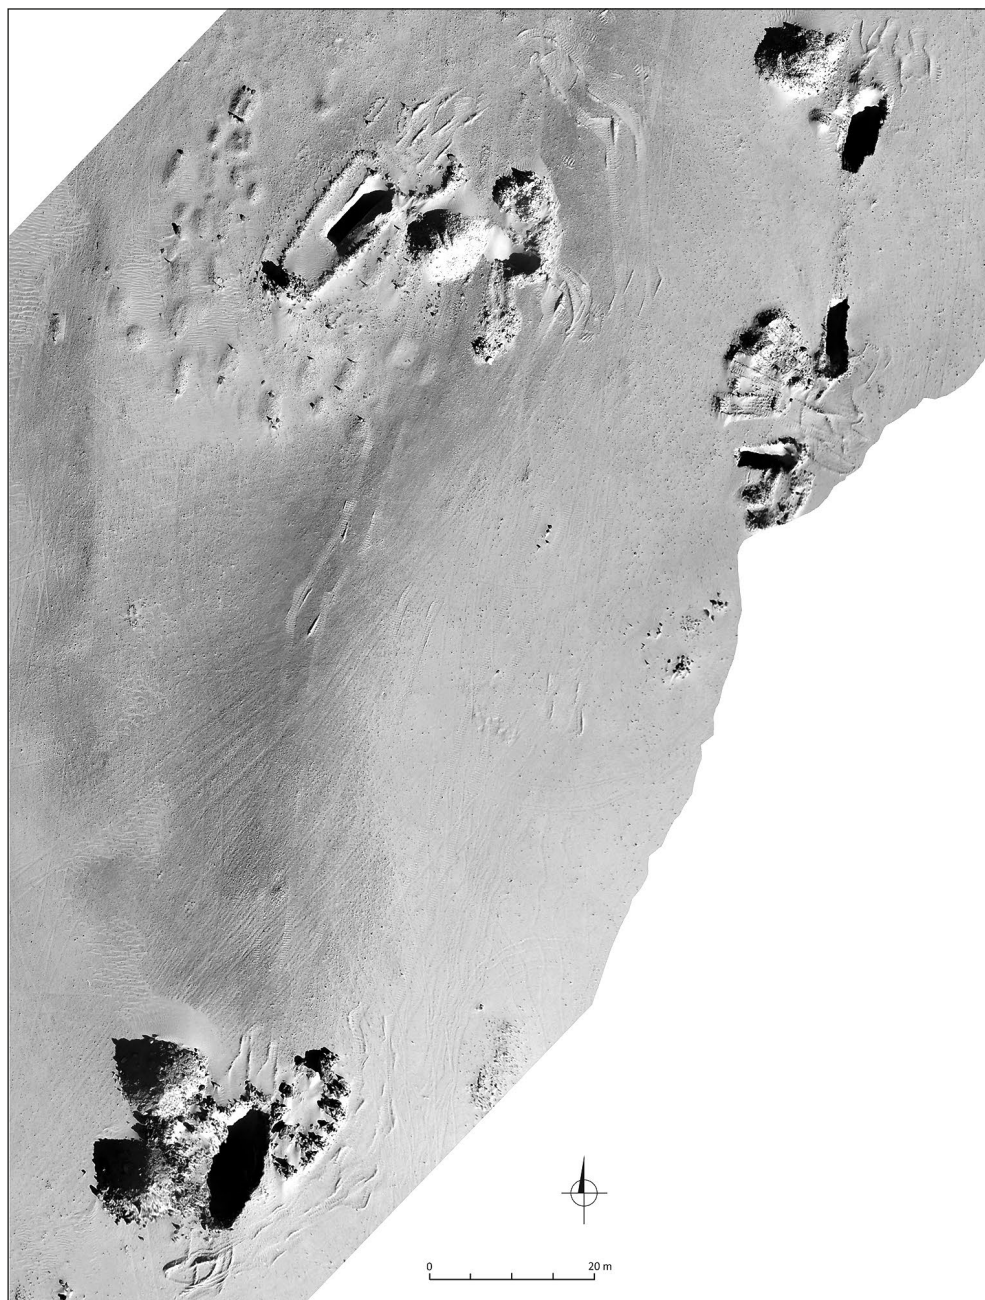
*Fig. 9. Bani Israil: orthophoto of the site
(Photo and rendering B. Żurawski, R. Łopaciuk, and P. Rurka)*

The team undertook salvage work outside the concession area at the endangered site called Bani Israil [Fig. 9]. Located in the desert about 1.50 km northeast of the modern village of Banganarti, this place is well known among local residents as the site of the ‘tombs of giants’. A few grand elongated superstructures, overlaid with stones, were constructed there, amidst graves of a standard size and uncertain date. The archaeological inspection was induced by recent acts of robbery that had led to a partial destruction of the site.

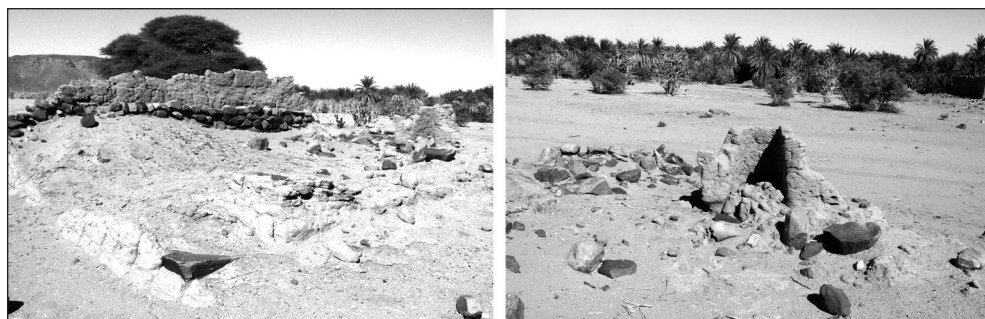
Fig. 12. *Kissenfarki West: left, stone building identified as a mosque; right, niche in the east wall of the building (Photos M. Drzewiecki)*

There was also a small rectangular building northwest of the fort. It was erected of stone in the lower section and layered mud (Arab. *jalous*) in the upper section. It had an entrance from the south, close to the southwestern corner, and a stone threshold. A niche in the middle of the east wall indicated that it was a mosque [*Fig. 12*].

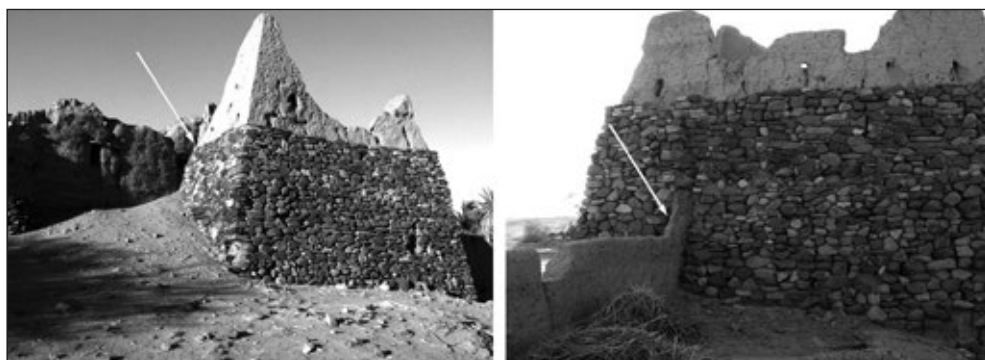
Fig. 13. *Kissenfarki East: fortifications of a post-medieval fort; arrows indicate construction phases (Photos M. Drzewiecki)*

Kissenfarki East is a small but very well preserved site, interpreted as a post-medieval fort [*Fig. 10* bottom]. The fortifications (there) bear traces of many reconstructions. Mud-brick, stone and *jalous* were used to erect and renovate the walls. Surprisingly, the walls in the corner sections were not bonded. Even more surprisingly, walls raised in the *jalous* technique were not the youngest

addition to the fort. Based on this preliminary study one may conclude that the youngest elements of this complex are the rectangular towers built in the northeastern and southeastern corners [Fig. 13]. It seems that they were built over the older ones. Concluding, the oldest fort was most probably of mud brick with later *jalous* additions, in the last phase reinforced with stone towers.

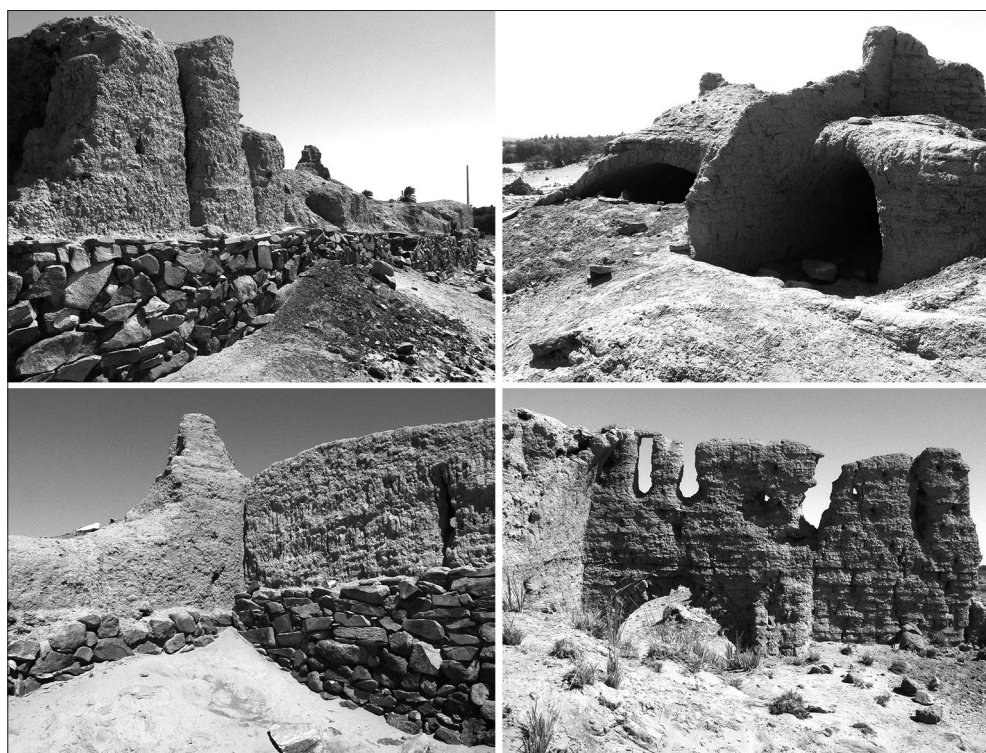
Fig. 15. *Fagirinfenti, Site 1: top row, Building A, details of construction; bottom left, Building A and ramp/aqueduct; bottom right, Building C (Photos M. Drzewiecki)*

consisted of raising mud-brick walls on a stone substructure. This technique was used for Building A and the ramp/aqueduct [Fig. 15 bottom left]. The stone substructure, finished with flat slabs, was a maximum 1.50 m high. It made for a very stable base for the mud-brick walls.

despite being built in the same technique [Fig. 15 bottom left]. The ramp/aqueduct reached the building directly at the entrance. There were remains of a mud-brick arch at this end of the aqueduct. This unique structure extended towards the river, taking a 90° turn to the west just before a modern road. It seems that the other end of the ramp/aqueduct was at a well located not far, to the south of Building C.
