# More remarks on the enlarged doorway in the Djeser-akhet temple of Tuthmosis III at Deir el-Bahari

Janina Wiercińska

**Abstract:** The issue of the enlargement of the entrance to the Bark Hall of the Djeser-akhet temple of Tuthmosis III at Deir el-Bahari was a major focus for the Polish restoration mission from the start. The widening of the passage was noted early on in the research and new data was forthcoming with every successive field season as the decoration of the entrance wall on either side of the Hypostyle Hall and of the Bark Hall was reconstructed. More detailed information continued to add to the recreation of the process of how and when these changes were introduced, as discussed by the author in earlier articles. Further fragments of relief decoration identified in recent years as originating from the cut sections of the walls have offered new data to supplement the author's view, being at the same time a significant source of information on the original decoration predating the destruction phase in the Amarna period.

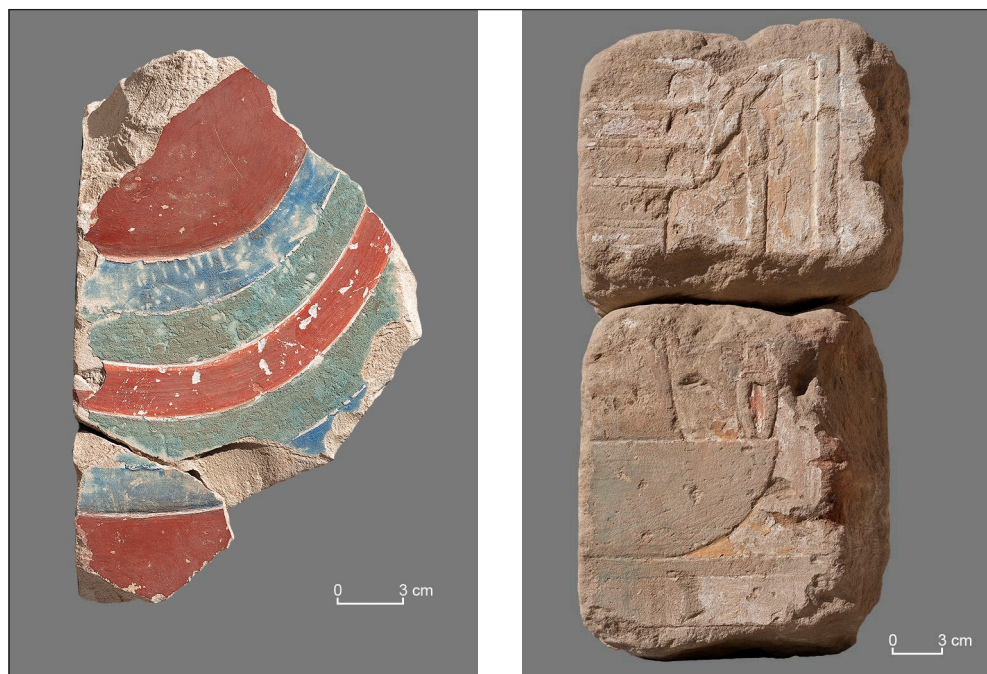
Fig. 2. *(and opposite page) Undamaged fragments of the torso, throne base and throne of Amun from the cut part of the west wall of the Hypostyle Hall, south of the granite doorway (PCMA Tuthmosis III Temple Project/photos Z. Doliński)*

In the case of the decoration of the Hypostyle Hall, nearly all the fragments identified in recent seasons originate from the part of the wall located to the south of the granite doorway [Fig. 3]. They are fragmented blocks of limestone (the crown and necklace of Amun) and sandstone (the god's throne and its base). Masonry combining blocks of these two materials is hardly rare in the temple of Djoser-akhet. Of note is an inscription located in the original scene behind the enthroned Amun; its upper part is particularly well preserved on nine granite fragments, which had been part of the lintel above the doorway as determined already in the past (Wiercińska 2010: 222 and Fig. 5). This part of the granite doorway is not preserved. Like the south jamb, it must have been made with too long a block a part of which was then cut flush with the face of the wall. After the entrance had been widened, the vertical inscription behind Amun on the wall that was part of the south jamb was concealed under a coat of white paint (hence its legibility even today). Texts on the wall part of the lintel, namely the beginning of the inscription and the horizontal text reaching as far as the figure of the vulture goddess Nekhbet, as well as the border of the architrave extending into the wall, were cut away. Their discovery on the temple platform seems puzzling, especially since no other fragments attributable to the same lintel were recovered. The lintel dimensions: height about 1.35 m, width about 3.11–3.13 m, can be determined with relative precision thanks to the reconstructed decoration of the west wall of the Hypostyle Hall and the known width and height of the jambs in the doorway, as well as the dimensions of the threshold and architraves mounted

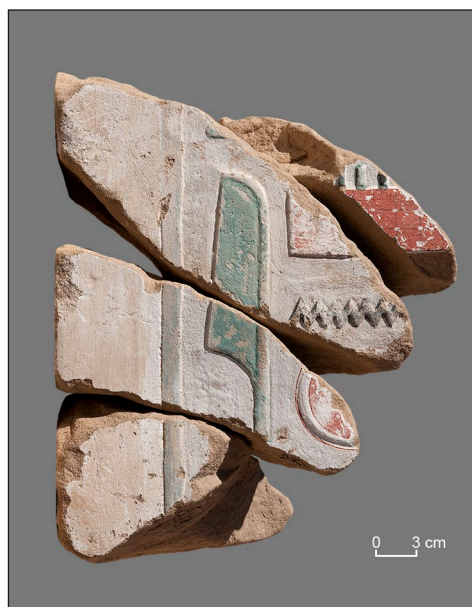
Fig. 7. Undamaged name of Amun on fragments of the cut doorframe in the Bark Hall (PCMA Tuthmosis III Temple Project/ photos Z. Doliński)
