Research and conservation in Marina el-Alamein in 2016 (Polish–Egyptian Conservation Mission)

Abstract: Activities undertaken by the Polish–Egyptian Conservation Mission to Marina el-Alamein in 2016 included research and conservation in the public district of the ancient town as well as in private houses. Work focused foremost on research, conservation and exhibition of monuments in the central town square, especially the remains of a peristyle adjacent from the east, and the southern portico of the square itself. Research and conservation continued also in the area north of the central square, concentrating on the remains of public baths dating from the Hellenistic period and, on the south, on the remnants of Roman baths in use from the 2nd to the 3rd century AD. Maintenance conservation was carried out in private houses, in both baths complexes and in the eastern and southern area of the central square.

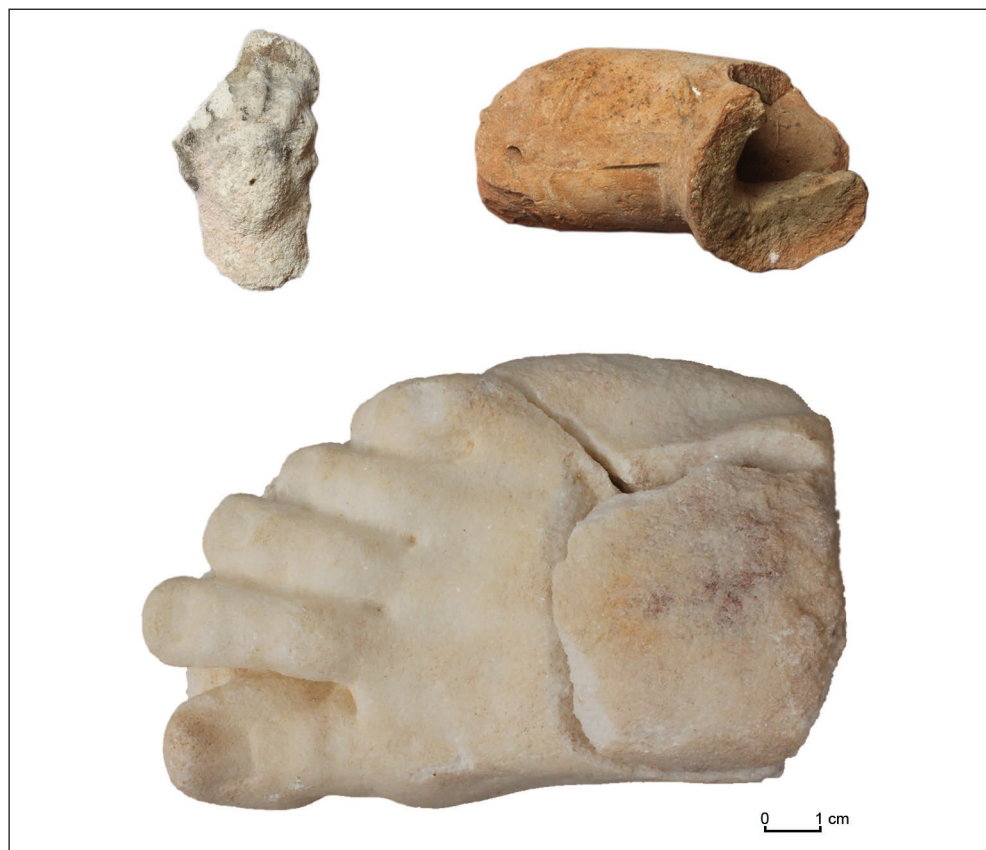
Fig. 4. Finds from room 17 of the Southern Baths: top left, a man's sandalled foot in terracotta; top right, fragmentary statuette of mortar representing a female head; bottom, fragment of a foot from a marble statuette (PCMA Marina el-Alamein Conservation Mission/photos R. Czerner)

survived. In the southwestern corner, level with the preserved wall tops, part of a marble sculpture was found in a firmly packed rubble pile. It was a fragment of a right foot broken into three pieces [Fig. 4 bottom], set on a plinth. Only its anterior portion without the ankle is preserved (12.3 cm long, 5.7 cm high and 8.1 cm wide). The foot is slender, presumably female, and is neatly carved. The second toe is longer than the big toe. The total length of the foot is estimated

at about 0.22 m. The statue to which it belongs must have been almost lifesize. A small oval hole and remains of an iron dowel inside the foot are visible, indicating that two parts of the foot may have once been connected or that the sculpture had undergone repairs in antiquity (on sculpting techniques, see more: Grossman 2003: 59). Not much can be said based on just this fragment, but naked or seminaked, and hence barefoot representations commonly depicted Aphrodite either entering or leaving the sea.

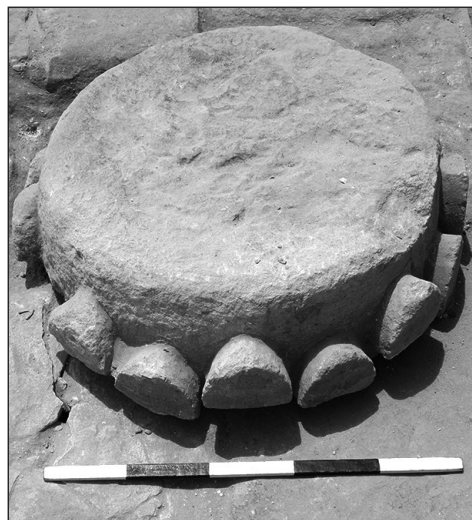
Fig. 6. Part of a pseudo-Corinthian capital from the eastern peristyle of the forum (PCMA Marina el-Alamein Conservation Mission/photo R. Czerner)

The hearth (0.40 m by 0.90 m) discovered in its vicinity was surrounded with stones; the lower part of a pseudo-Corinthian capital (see above) lay stuck in the slabbing to the east of the hearth [see Fig. 6]. The fill of the hearth yielded fragments of ceramics and animal bones, pieces of bronze and iron nails. The faunal assemblage was identified by Urszula Iwaszczuk (PCMA UW) as representing sheep/goat, cattle, fish and birds.

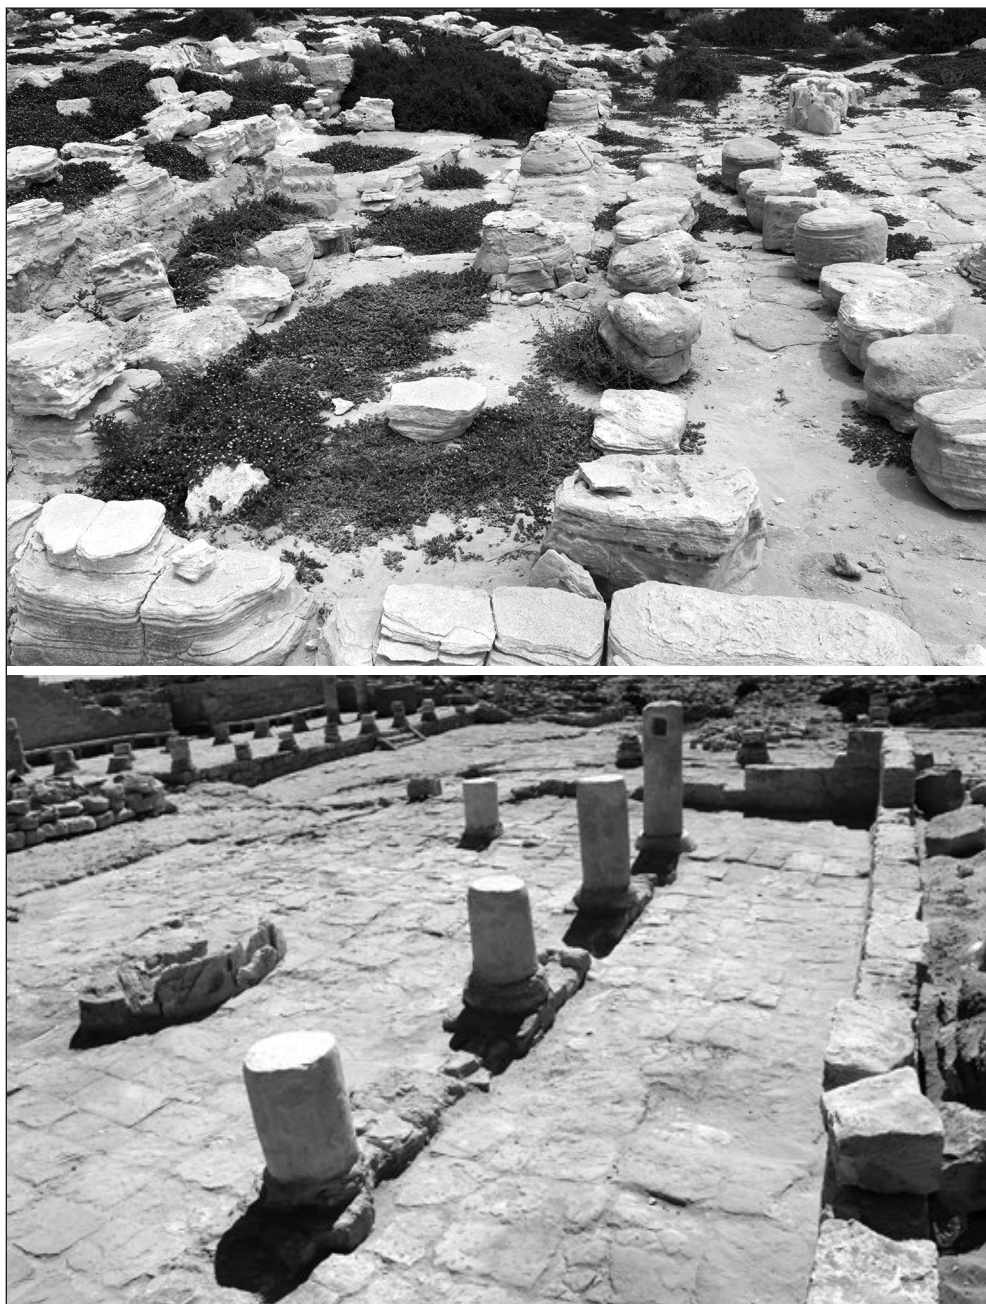
Fig. 7. Eastern peristyle of the forum: top, before and bottom, after restoration in 2016 (PCMA Marina el-Alamein Conservation Mission/photos R. Czerner)

The peristyle area was particularly affected by weather conditions [*Fig. 7 top*]. To protect the relics, but also to provide appropriate exposition, the preserved north and west walls were also restored along with partial anastylosis of five columns and protection work on them. The most weathered blocks from the walls were replaced, 1–3 layers were added to the wall tops using original blocks from the site. The maximum height of the wall after restoration is 0.76 m (four courses) at the western corner. The wall undulates due to uneven ground subsidence.

Column drums were eroded and some had large losses, but their condition was satisfactory for conservation work to be carried out. To protect them, they were replaced in position on bases surviving *in situ*, after which they were plastered. The height of the columns after anastylosis is, in the northern row, counting from west to east: 1.52 m (six drums), 1.06 m (four drums), 0.77 m (three drums), 0.57 m (two drums), 0.23 m (only the base); the column in the west portico is 0.47 m (two drums). Lime-and-white cement mortar was used. Restoration of the eastern peristyle has enhanced the attractiveness of the area [*Fig. 7 bottom*].

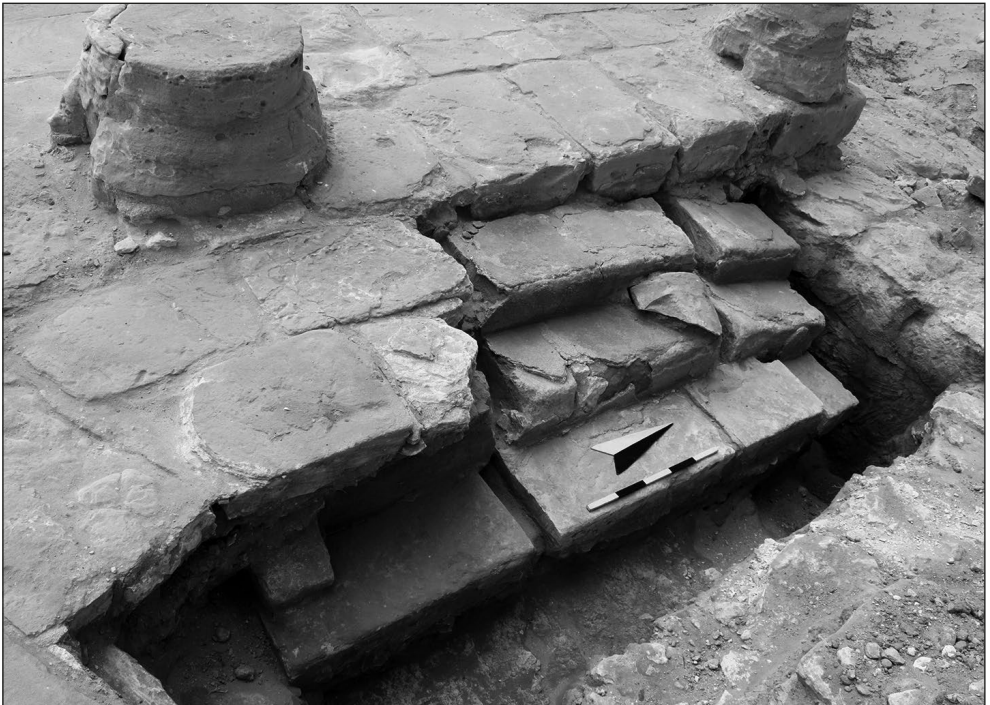
Fig. 9. Steps from an earlier phase leading to the northern aisle of the southern portico in the main square (PCMA Marina el-Alamein Conservation Mission/photo R. Czerner)

After documenting the excavated steps, the damaged flooring was reconstructed following the original scheme. The lower parts of some columns in the two-aisled southern portico were restored by filling in the joints between the drums.

While repairing the slabbing in the northern portico, the peristyle, and the eastern portico in the forum, three test trenches were dug. The fill yielded small fragments of ceramics, mostly non-diagnostic. Steps from an earlier phase were uncovered in the probe in the southeastern corner of the forum, under the slabbing east of the double portico, by its eastern stylobate. There were three steps (2.00 m long, each 0.14 m high), all damaged and slipping to the north. Waterproof plaster has survived on them in some places. A bedding layer for the slabbing (about 0.10 m) was noted, another one about 0.25 m below the slabbing. Traces of a street surface were observed at a depth of about 0.42–0.45 m. Glass and pottery sherds were found in the fill, along with small pieces of plaster. On the second step, there was a fragment of a column drum. The pottery will continue to be studied in the coming season, but it is already clear from this investigation that the redevelopment of this part of the forum took place in the beginning of the 2nd century AD.

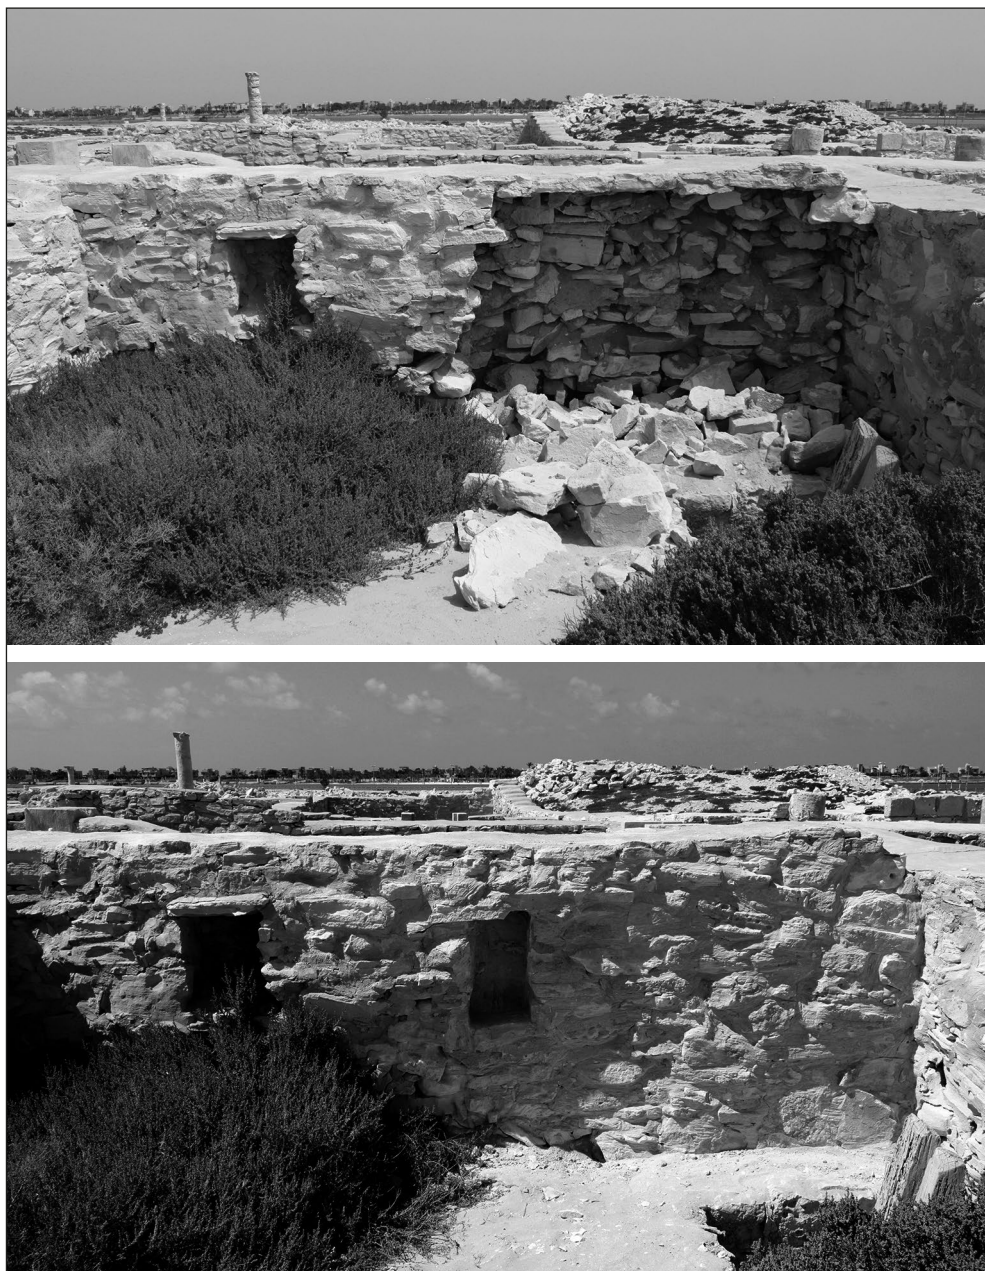
Fig. 10. Conservation maintenance in House H9: top, a wall in collapsed condition after the winter rains; bottom, after reconstruction in 2016 (PCMA Marina el-Alamein Conservation Mission/photos R. Czerner)

Heavy rainfall in the winter of 2015/2016 resulted in a partial inundation of the area of the ancient town, fostering plant growth in the ruins in effect. Rainwater flowing from the direction of the modern asphalt road wore away the mortar from house wall joints, causing the collapse of large sections of walls in several places, except for upper parts that had previously been consolidated with mortar [Fig. 10

top]. The walls in question, about 0.50–0.75 m thick, were built of crushed rock rubble and bonded externally with lime mortar and internally with clay mortar. Repairwork involved using crushed rock rubble and mineral mortar (6 parts sand, 3 parts lime, 1 part white cement) [Fig. 10 bottom]. The following areas of house H9 were thus treated: south wall of room 9, north wall of room 10 (a recess was reconstructed in it), south and west walls of the tavern.

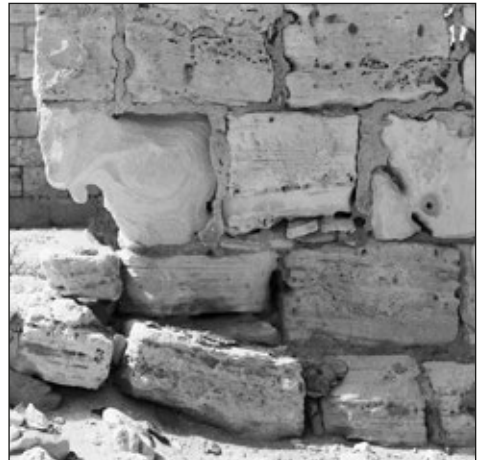
Fig. 11. House H21N: losses of stone blocks in the wall next to the passages (PCMA Marina el-Alamein Conservation Mission/photo P. Zambrzycki)

– loss of stone blocks (degradation increased around the house entrances). The most damaged blocks were located in the passages and on the southern side of the walls [*Fig. 11*].

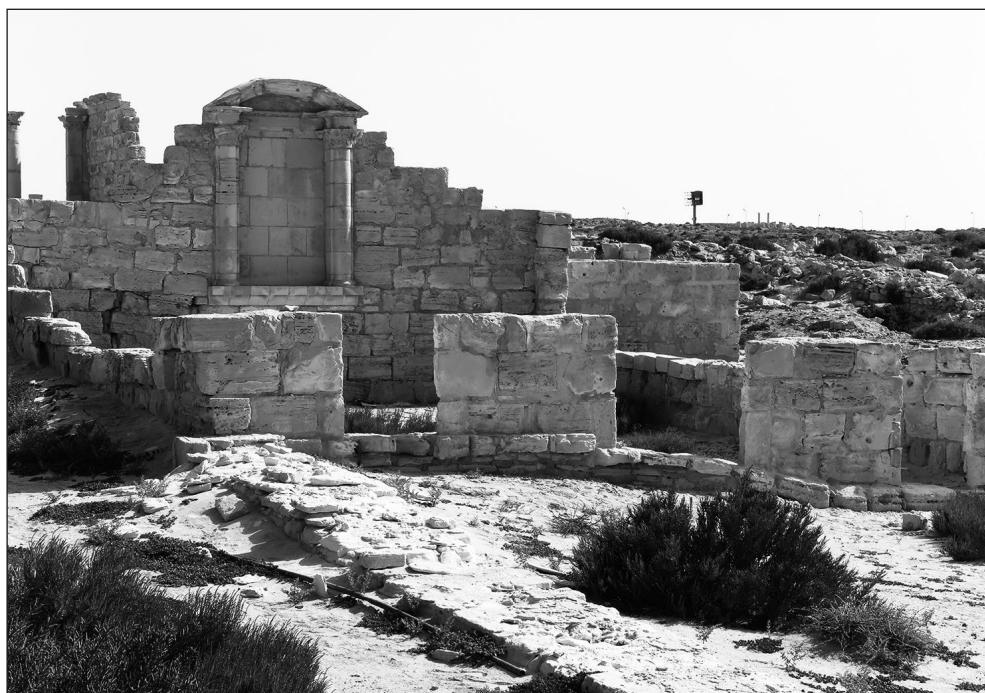
Fig. 12. House H21N after the conservation of walls in 2016
(PCMA Marina el-Alamein Conservation Mission/photo P. Zambrzycki)

mortar (6 parts sand, 3 parts lime, 1 part white cement). Around the entrance openings damaged parts of blocks were removed and replaced with original ancient stones collected at the site. The joints were filled with mortar [*Fig. 12*].
