The medieval fortifications at Banganarti after the 2016 season

Mariusz Drzewiecki

Institute of Mediterranean and Oriental Cultures, Polish Academy of Sciences

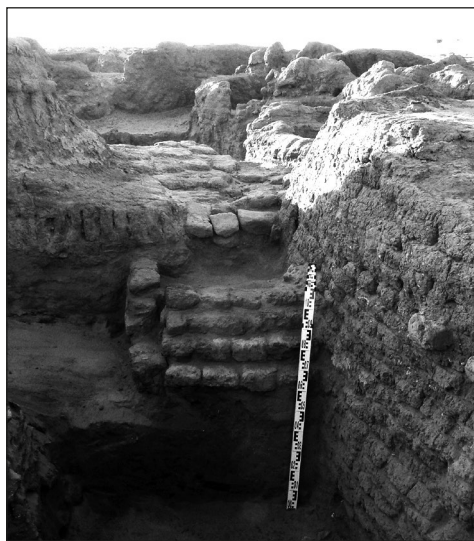
Fig. 2. Staircase and the passage on top of the fortifications (Banganarti Mission/photo M. Drzewiecki)

faunal remains (Osypińska 2015). This was most probably rubbish discarded regularly by the residents of the enclosure. Layers below the foundation of the fortifications, reaching a thickness of 0.80–0.90 m, yielded, among others, evidence of two events of intensive fires: charcoal, ashes and dark brown burnt soil. A trench in 2013 uncovered a red-brick staircase where a rectangular courtyard met with the outer face of the curtain wall [Fig. 2]. This

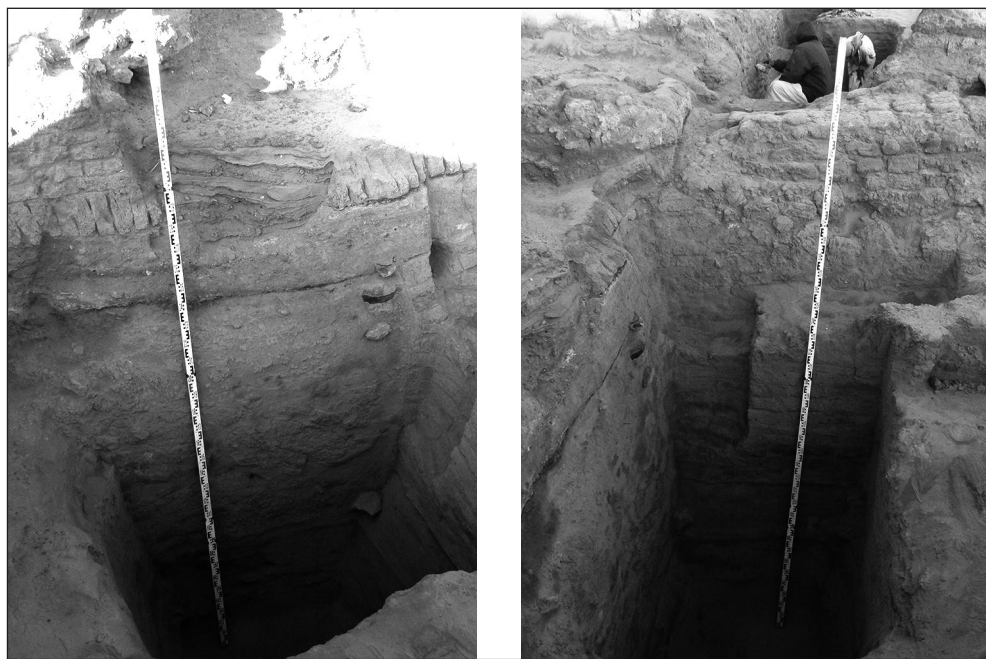
Fig. 4. Trench 12/2016: left, view from the northeast; right, inner face of the curtain wall (phase 1) (Banganarti Mission/photos M. Drzewiecki)

A similar layer of compressed mud, the brick outlines visible in the trench section, was recorded in the same trench (12/2016), above and next to the first phase of the fortifications [see *Fig. 3:9; 4 left*]. The layer was hard and unified, indicating that mud brick and mortar had dissolved into a homogenous mass up to

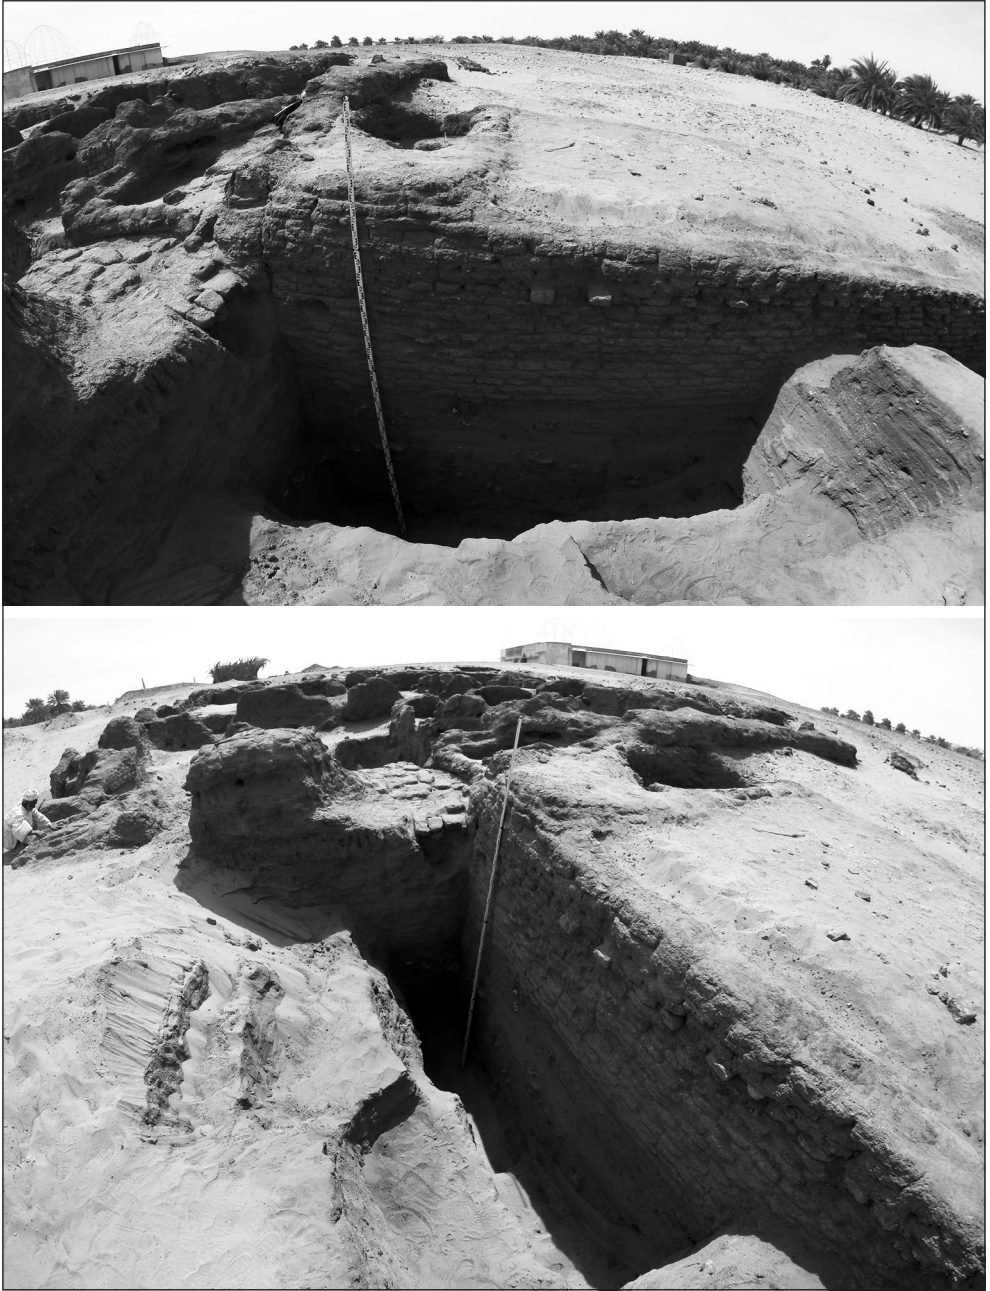
Fig. 5. Trench A/2016: top, view from northeast; bottom, view from the north (Banganarti Mission/photos M. Drzewiecki)
