# ALEXANDRIA KOM EL-DIKKA. SEASONS 2014–2015

Grzegorz Majcherek<sup>1</sup>

**Abstract:** The Polish–Egyptian mission at Kom el-Dikka, ran by the Polish Centre of Mediterranean Archaeology, University of Warsaw, stepped up the already advanced preservation processes aimed at establishing an Archaeological Park at the site. Conservation work was carried out in the theater portico, the bath complex and the residential quarter of late Roman date in the eastern part of the excavation area. In turn, the western part was the focus of archaeological research centered on the exploration of some late Roman structures located underneath. The early medieval/Islamic cemetery overlying these remains was explored first. A detailed report from this work is appended to this article. The human skeletal remains from the cemetery were examined by anthropologists. The western gate to the bath complex, leading from the theater portico, was fully exposed. Finds from present and earlier work at the site continued to be studied: glass vessels, pottery, lamps, bone objects, painted wall plaster, and a vast collection of coins.

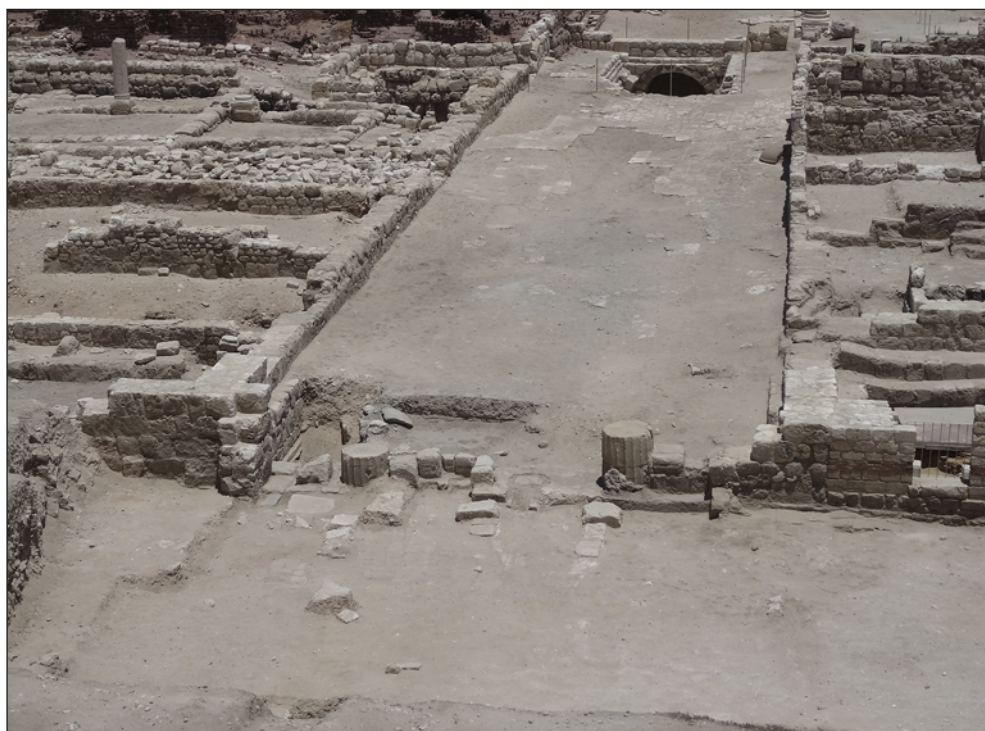
Fig. 5. Western gate of the baths  
(Photo G. Majcherek)

The area under excavation was located next to the western gate of the bath complex where a trench measuring 12 m by 10 m was set out. Investigations in this area started back in the 1997–1998 campaign, when a fragment of necropolis was explored and a trial pit was dug, revealing a section of the gate leading to the bath complex (Majcherek 1999: 30–34). The monumental entrance now explored in its entirety was flanked by two Doric columns (approximately 0.85 m in diameter) standing 3.50 m apart. The southern one (two drums high) was preserved to a level of approximately 1.10 m above the foundation wall, while of the northern one only a single drum has been preserved [Fig. 5].

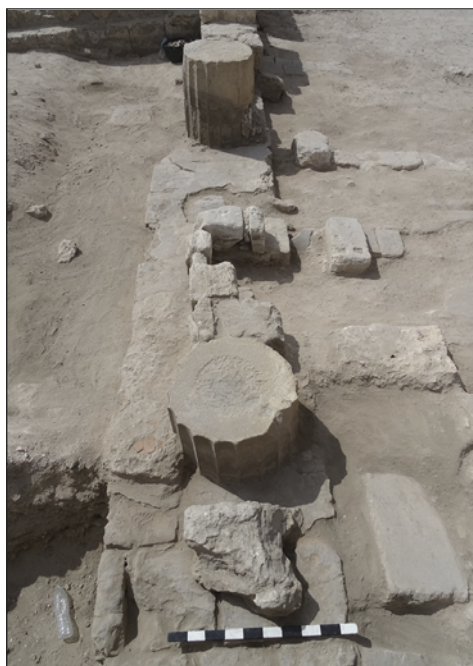
Fig. 6. Remains of steps in front of the western gate (Photo G. Majcherek)

only several isolated pavers have survived. But even in this state of preservation it was obvious that the flagging was laid on a markedly higher level (approximately 0.55–0.60 m) than the original pavement of the portico. Stairs were certainly needed to manage the difference in levels. Indeed, several blocks, apparently leftovers of steps, were cleared in front of the gate [Fig. 6]. Contrary to other structures, they were made of hard nummulithic limestone, their heavily worn upper surfaces pointing to prolonged use. The dimensions of isolated surviving fragments of the lowermost steps and their location with regard to the threshold suggested the presence of at least two steps. A fragment of walling

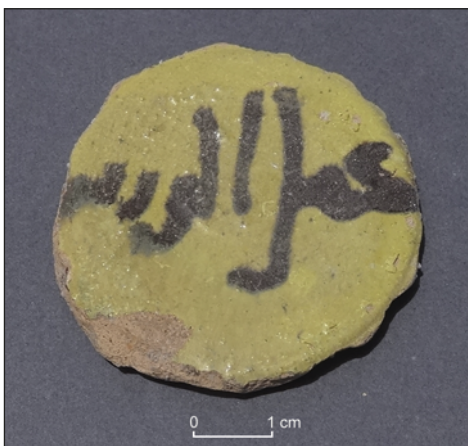
*Fig. 7. Inscribed fragment, cut from a bowl of Early Islamic Lead Glazed ware (Photo G. Majcherek)*

glaze over a creamish slip and bearing an Arabic inscription painted in manganese [Fig. 7].

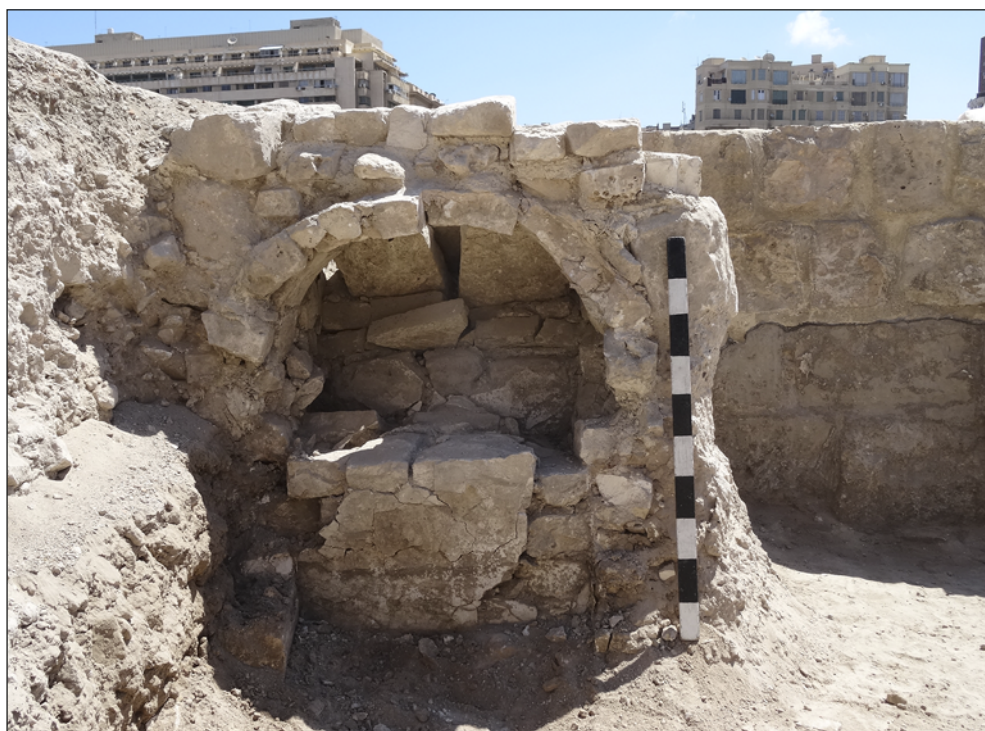
*Fig. 8. Tomb CV 161. Vaulted burial chamber (Photo G. Majcherek)*

Similar enclosures, encompassing several graves, were recorded in the past also in other areas of the early Islamic cemetery on Kom el-Dikka (Promińska 1972: Pl. II; Majcherek 1999: 34; 2008: 31). However, two of the latest tombs stand apart (CV 161 and CV 163, see below, appendix, page 62), presenting fairly unusual architectural features. Both were apparently intended for multiple burials, hence their special design. They were equipped with vertical, rectangular shafts opening at ground level and giving easy access to the burial chambers. Both chambers were covered with stone-made barrel vaults built of small regular limestone blocks [Fig. 8].

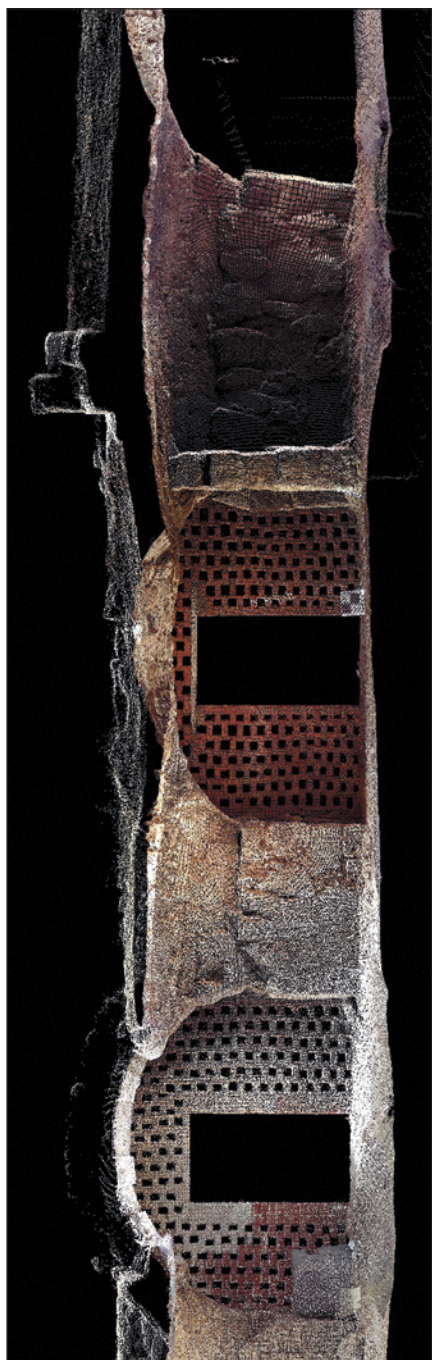
*Fig. 9. Photogrammetric scan of the underground vaulted structure, western wing  
(Processing W. Terlikowski, P. Bartosiak)*

In the 2015 season, the underground vaulted complex of the baths was an object of thorough examination and documentation in view of planned conservation work. The complex excavated back in the 1960s, and then provisionally protected, is now in dire need of professional intervention. In many cases, especially in the western wing, vaults and side walls have lost their structural integrity. Many blocks are severely damaged. To mitigate the effect of almost fifty years of exposure to sun and weather and to preserve the historic fabric for the future, prompt and extensive conservation is required. As a prerequisite for future work, a team of specialists (Wojciech Terlikowski and Piotr Bartosiak) from the Warsaw University of Technology surveyed and examined the structure. The western corridor of the complex was scanned with a photogrammetric laser scanner Faro Focus X 33 LLS [Fig. 9]. The high precision scans are prerequisite for preparing

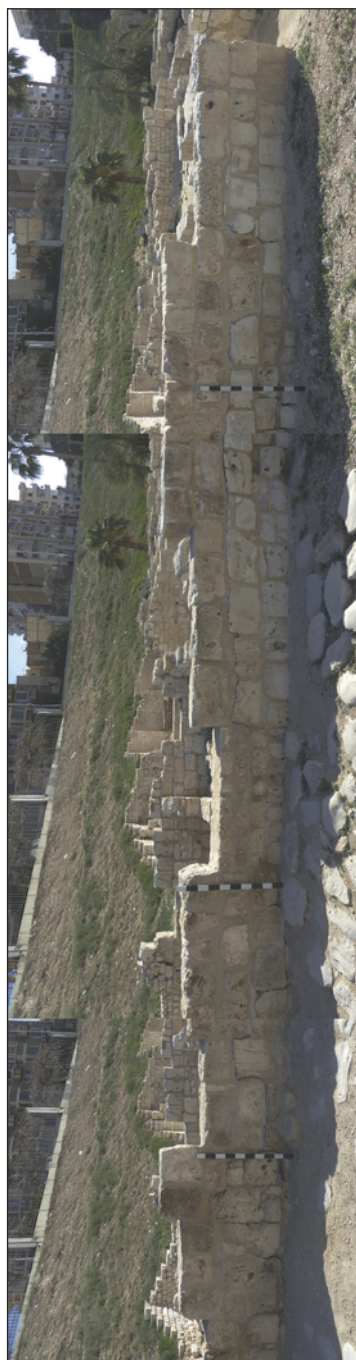
*Fig. 10. House H4 western elevation following conservation  
(Photo M. Polak)*

articulating its historical importance in the planned site presentation. It also introduced a physical barrier that secured safe passage for visitors in the future. The same idea stands behind the blocking of the original doors leading from street R4; the small-stone masonry used for the purpose visually differentiated these sections from the original wall fabric.

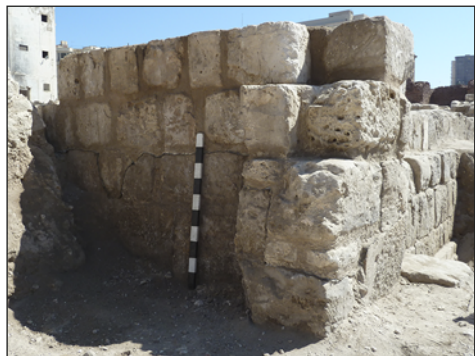
*Fig. 11. Western gate of the baths, restored northern flank (Photo M. Polak)*

The gate leading from the portico to the bath complex was also scheduled for conservation. Both the massive pilasters flanking the entrance had been damaged seriously by medieval burials and partly dismantled. They were now consolidated, and to a certain extent restored. The northern one was restored to a height of 1.55 m above the level of the gate threshold, with three courses of masonry added to the existing structure [Fig. 11]. Adjoining

however, was limited to adding only two courses of masonry, making two sections, not exceeding 2.50 m in length. All newly added blocks were separated from the original wall fabric by a layer of bitumen tar felt.

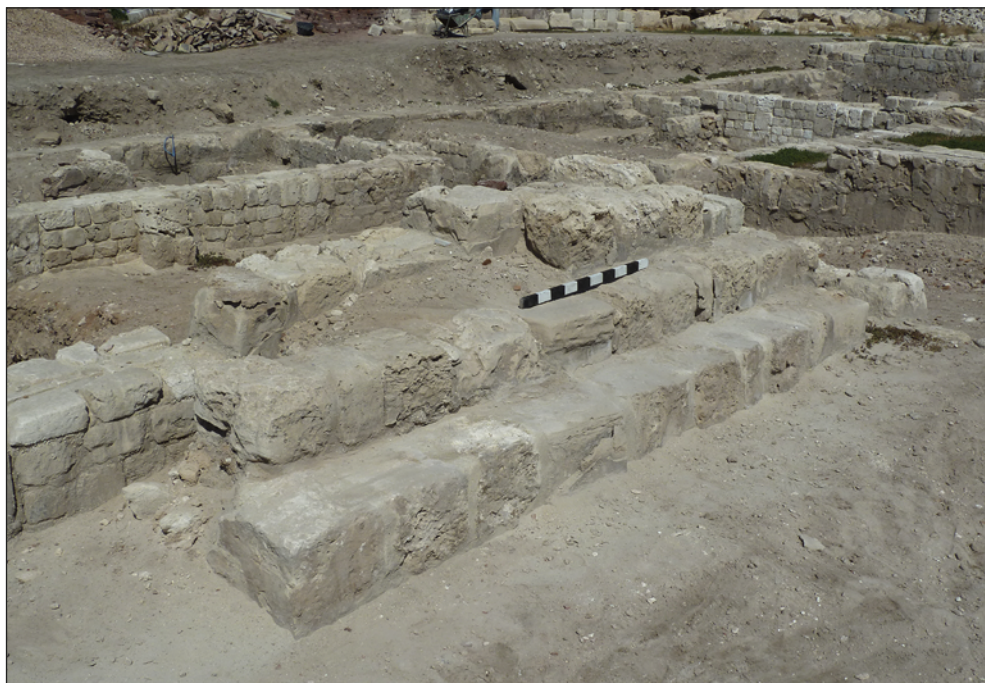
*Fig. 12. Restored western wing of seats in auditorium W (Photo M. Polak)*

In auditorium W, cleared in the 2005 season (Majcherek 2008: 33–34), conservation work focused on restoration of stone benches, placed along the west wall. The benches are in fairly good condition, but their structural integrity is endangered by missing blocks and mortar joints. A section of the lowermost bench, approximately 5 m long, was restored almost entirely, using limestone blocks retrieved from the excavations in the auditorium. The northern segment of the topmost bench was likewise restored, while seriously deteriorated or missing blocks were replaced with new ones [Fig. 12]. The entire structure was consolidated: empty joints refilled with new mortar and extant patches of plaster reinforced.

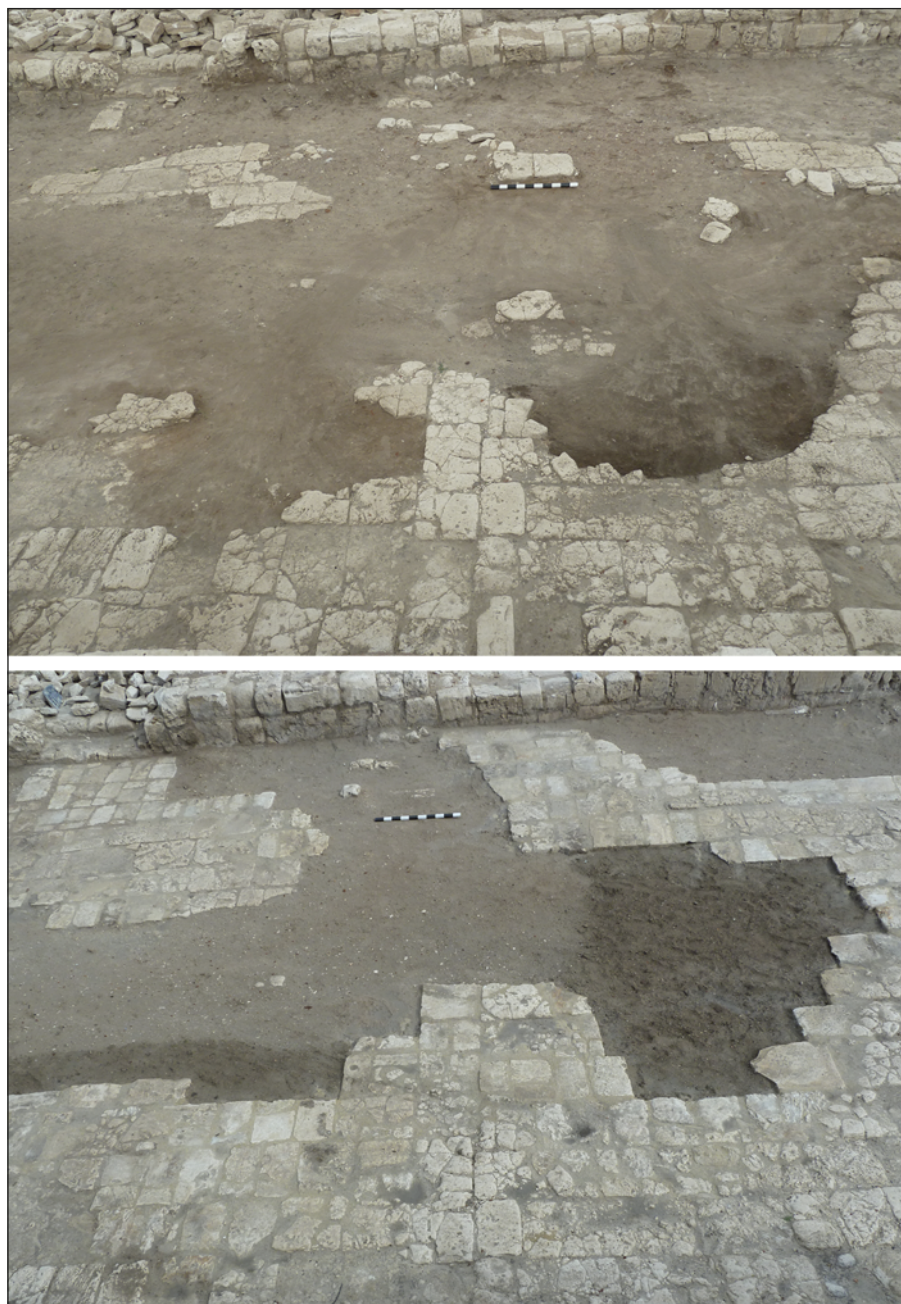
*Fig. 13. Pavement in the southern passage of the bath: top, before restoration, and bottom, after restoration (Photos M. Polak)*

eastern part. The pavement made of regular limestone pavers of varied dimensions was now found to be in need of conservation. Some of the pavers were seriously affected both by natural agents and human factors: eroded, broken or disintegrated.

In accordance with general principles of conservation observed at the site (Petzet 2009), the intervention was limited to only the most necessary operations. The applied measures included consolidation of damaged pavers or exchange of the most deteriorated ones (work supervised by Marcin Polak). Original pavers found during the excavations nearby were used for this purpose. To minimize further deterioration of extant sections of original pavement, a single row of new pavers was added around the most endangered patches, creating thus a sort of protective edge. As a result of this procedures some minor gaps in the pavement were now totally repaved [Fig. 13].

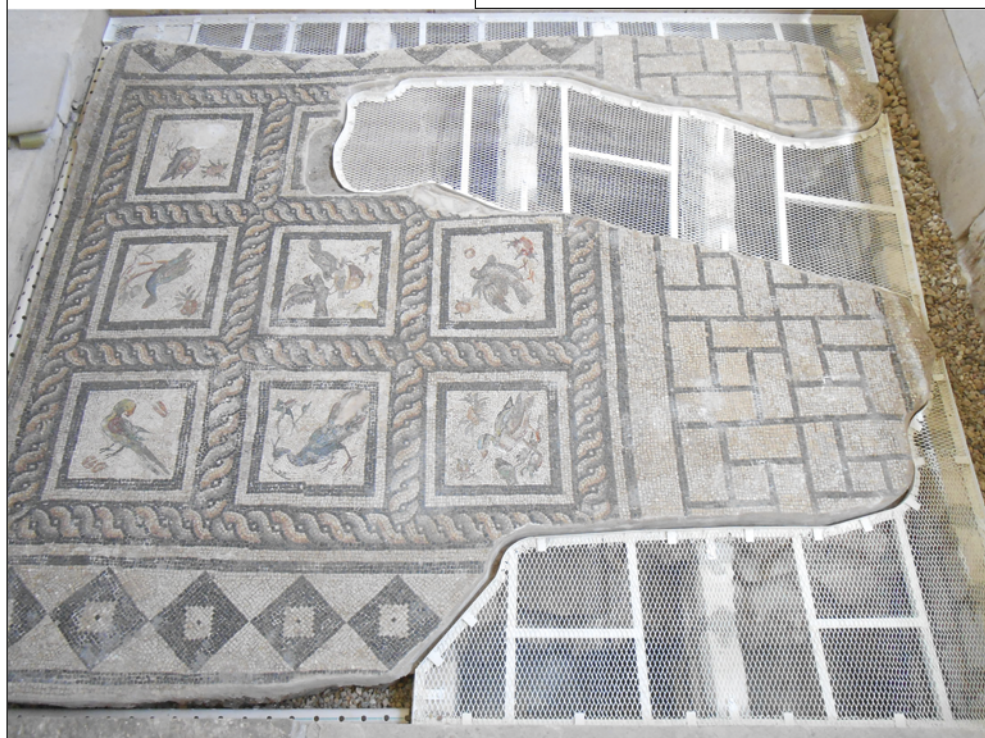
*Fig. 14. Mosaic shelter: top, ventilation pipes around mosaic  $\alpha$ -2; bottom, ventilation grille around mosaic  $\alpha$ -5 (Photos G. Majcherek)*

Along the western and southwestern edges of the mosaic, where there was not enough room for installing frames, perforated polypropylene ventilation pipes (Diam. 50 mm) were introduced.

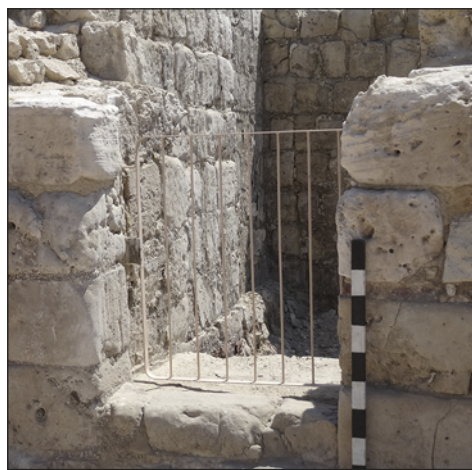
*Fig. 15. New railing in the entrance to auditorium L (Photo G. Majcherek)*

The entrances to the auditoria were closed with movable iron railings. They were shaped as large rectangular frames made of iron bars filled with welded vertical bars. The railings rest on legs made of sections of C-bars [Fig. 15].

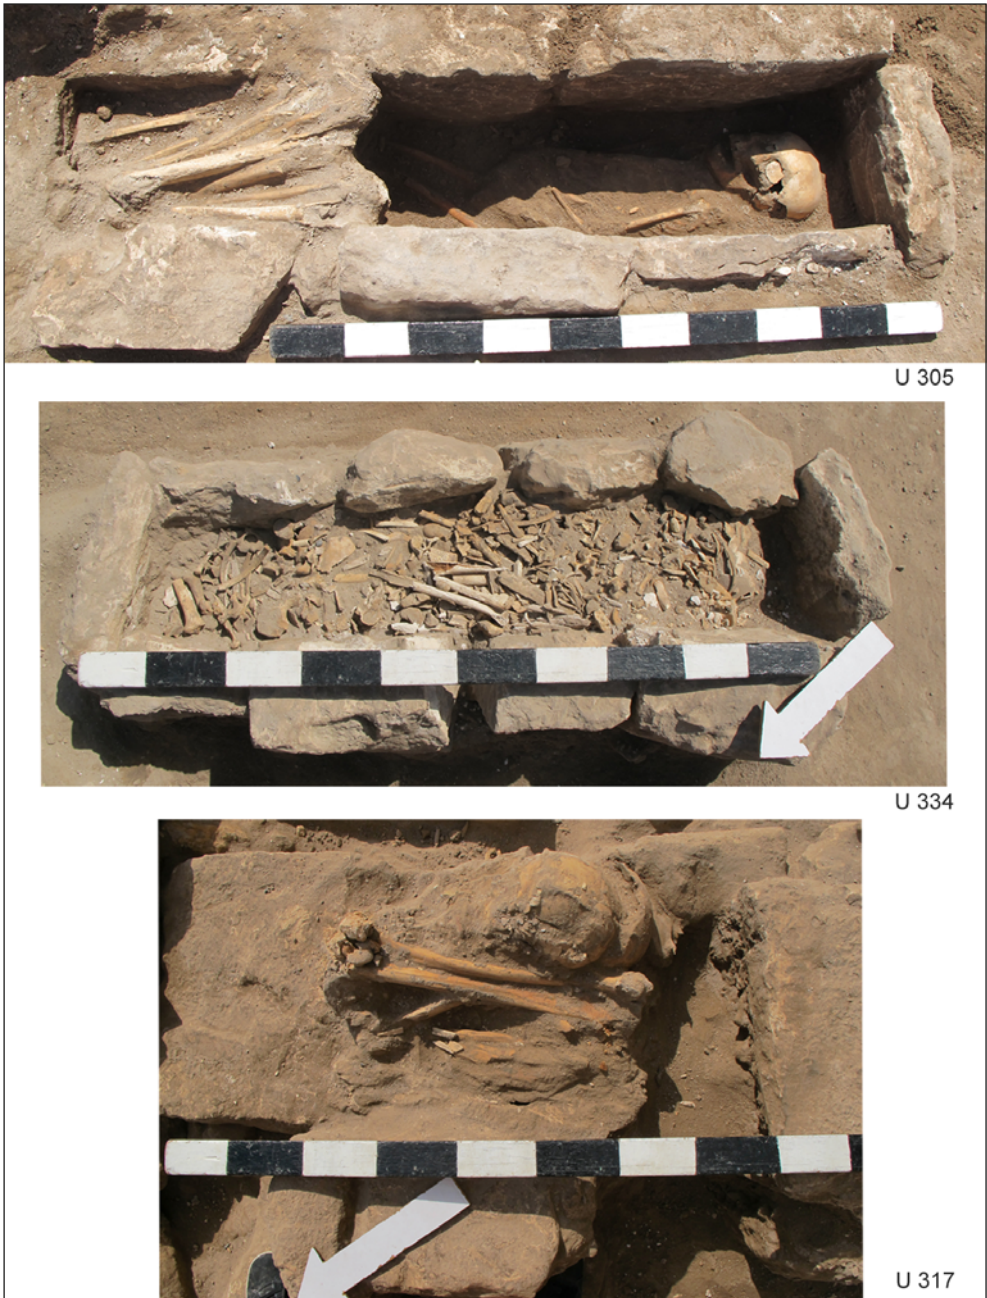
Fig. 18. Top view of burials from area U: U 305 (on the left, remains of a secondary burial in the upper layer); U 334, mixed bones of several individuals; U 317, reburied bones (Photos E. Kulicka)

Some graves were different compared to graves known from sections of the Lower Necropolis investigated in earlier seasons (Kulicka 2015: 63–65 with further references). In these four instances, groups of bones appear to have been moved from earlier graves. Grave U 305 contained a later burial [*Fig. 18 top*]. Grave U 334 yielded a skeleton in anatomical position; however, the fill inside the stone box contained mixed human bones [*Fig. 19 center*]. Grave U 317 was located under two

diagonally set stones, on top of a group of earlier graves. Bones apparently collected from other graves — arm and leg bones and the remains of two skulls — were reburied here [*Fig. 18 bottom*]. A similar grave (UD 25) was found in area U during excavations in 1982 (unpublished). It, too, was not a primary burial and contained four skulls which had been collected and reburied. One possible explanation for this violation of Muslim tradition of not exhuming corpses is the building or extension of a mosque or mausoleum in the neighborhood, necessitating the moving of collected human remains.

Altogether 60 graves were excavated in area U which is situated in the northwestern corner of the site [*Figs 17, 18*]. The burials belonged to the so-called Lower Necropolis, the elevation of the graves falling in the range between 7.30 and 8.35 m a.s.l.

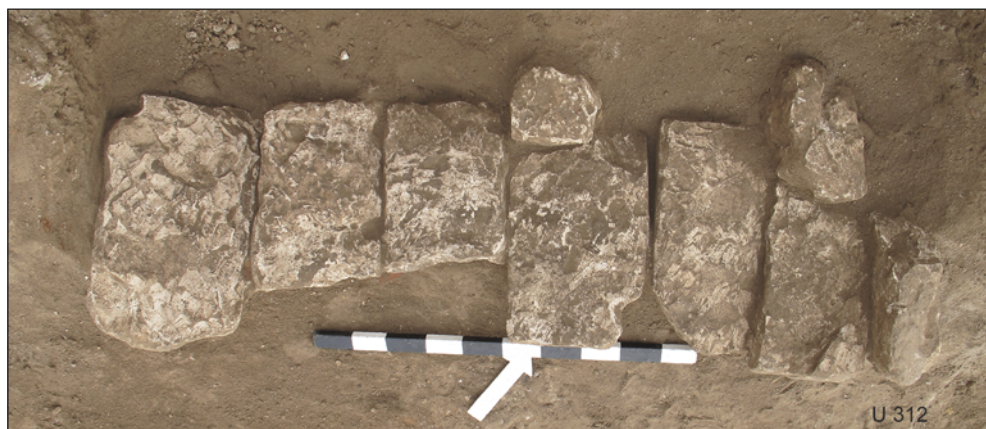
*Fig. 19. Slab covering of burial U 312 in area U (Photo E. Kulicka)*

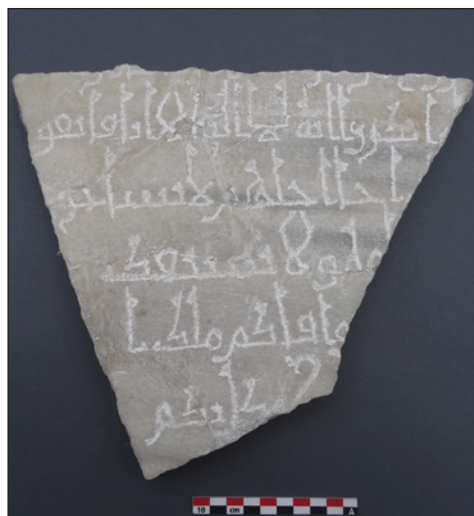
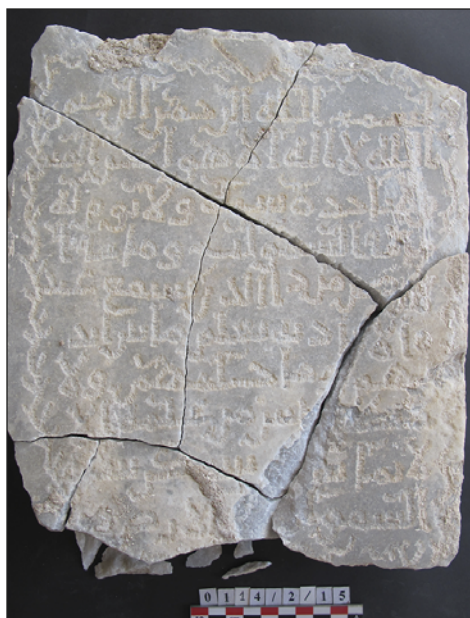
Fig. 21. Funerary stelae, Reg. Nos 5270 (left)  
and 5271 (Photos E. Kulicka)

Secondary evidence suggests that at least some superstructures were furnished with stelae, customarily made of marble, inscribed with Qu'ranic verses and the name and date of death of the deceased. Two fragments of stelae, damaged presumably during the salvage of building material for other purposes, were recorded (see also above, page 41) [Fig. 21].

Graves CV 201–CV 209, usually ascribed to the 9th–10th century AD (Middle Necropolis phase), were cleared in the western part of the trench [see below, appendix, Fig. 20]. Two broken and fragmentarily preserved inscribed funerary stelae were found next to grave CV 207 [see below, appendix, Fig. 21]. Both featured Quranic verses, engraved in Kufic script. No date was preserved. Both the crushed

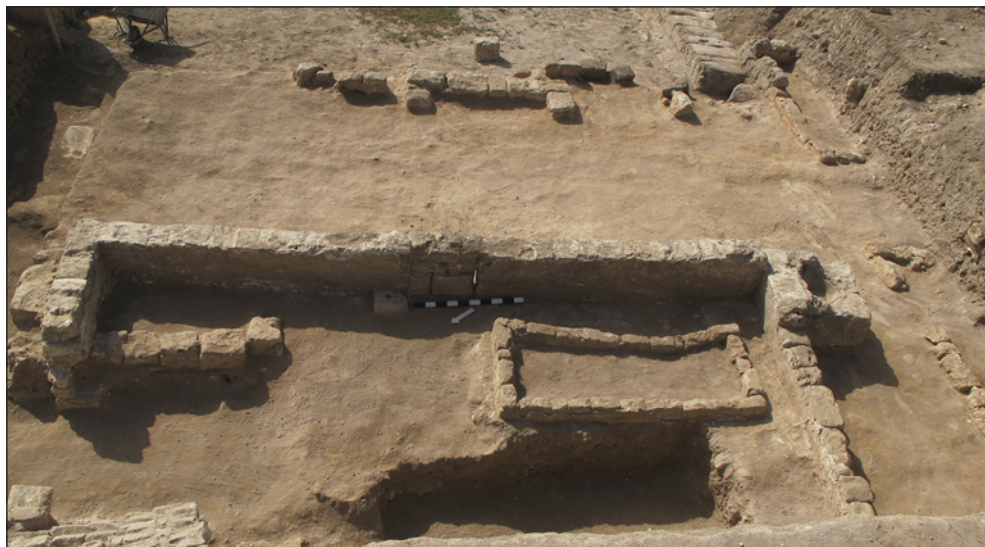
Fig. 22. Enclosure around tomb CV 173; note door post inside the blocked door in the enclosure wall (Photo E. Kulicka)

the burial boxes and the burials themselves did not survive. A walking level was preserved around the headstone of CV 173 [Fig. 22], which was undoubtedly constructed contemporaneously with the enclosure wall, surviving in its southern section together with stubs of the east and

west walls (destroyed by later tomb construction). An entrance, which existed in the south wall, was blocked and there was a stone door post just inside it, on the left. Attached to the corner of the enclosure wall at the southwestern corner on the outside was a square installation with a built-in

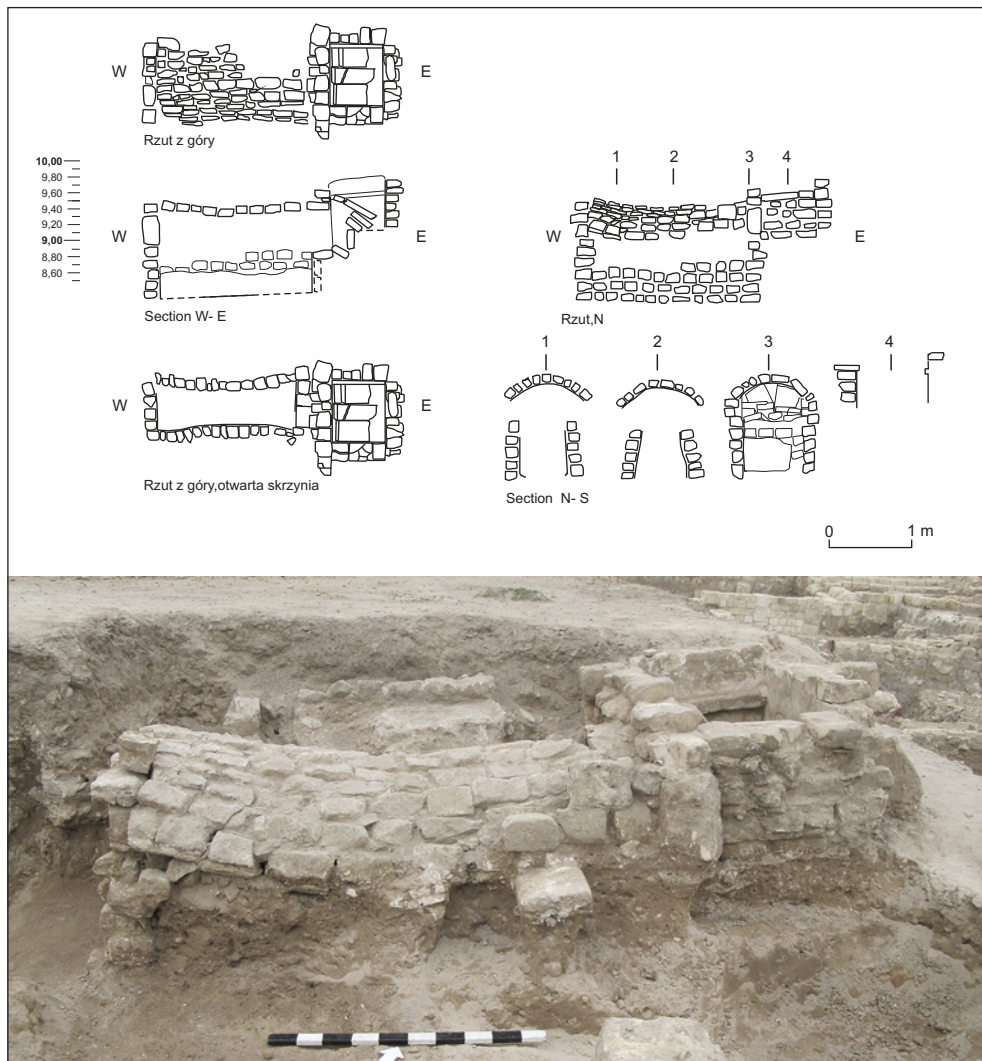
Fig. 24. Tomb CV 163 in area CV (west)  
(Drawing and photo E. Kulicka)
