PRELIMINARY RESULTS OF A STRATIGRAPHIC ANALYSIS OF LATE ROMAN AND EARLY BYZANTINE ARCHITECTURE IN THE RESIDENTIAL QUARTER OF JIYEH

Michał Dzik

Institute of Archaeology, University of Rzeszów

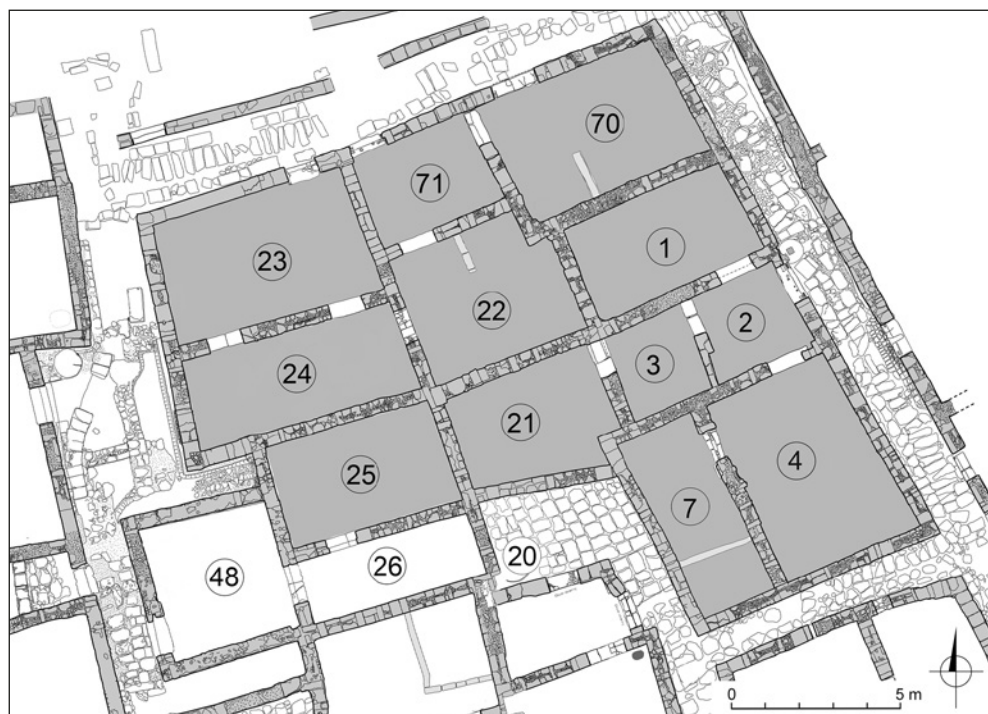
Fig. 1. Residential quarter in the northeastern part of sector D; highlighted in grey, elements included in the stratigraphic analysis of the architecture conducted in 2013 (Prepared by M. Dzik, original plan by M. Puzkarski)

The research began in the northeastern part of sector D, cleared for the first time during Roger Saidah's excavations in 1975 (Saidah 1977). Fourteen rooms, identified as 1–4, 7, 21–26, 48, 70 and 71, were located in this area, forming a separate building complex, surrounded by streets save for the southwestern side [Fig. 1]. Initial studies of this fragment of the quarter have dated the architecture to the late Roman and early Byzantine periods; the area remained in use in all likelihood through the mid-7th century. It could have encompassed a house consisting of at least nine rooms (Nos 1–4,

Ten areas (1, 2, 3, 21, 22, 23, 24, 25, 70 and 71) were documented in the first stage of fieldwork. Part of the documentation for rooms 4 and 7 was also prepared. The architecture within the quarter presents a fairly diversified state of preservation. The southern part, in which some

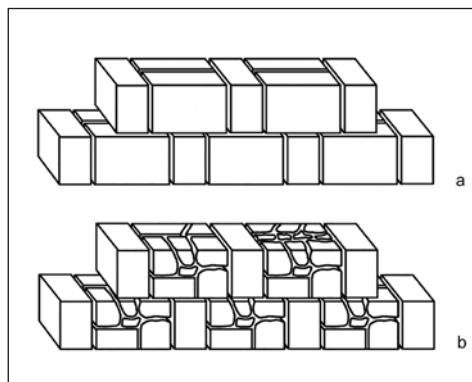
Fig. 3. Wall bonds most frequently encountered in the complex (Drawing M. Dzik)

phases in settlement development. Almost a third of the walls were constructed on new foundations, without any links to the earlier buildings. For a significant part of the walls it could not be determined at the present stage of research whether they were a continuation of earlier structures or not. The field of observation was very restricted owing to the presence of early Byzantine occupational levels. Almost all the wall segments were raised with the use of lime-ash or lime mortars (the only exception is one of the phases between areas 21 and 25 constructed without the use of mortar). Sand conglomerates (*ramleh*) were a common building material. Limestone ashlar were also used sporadically in the walls. The presence of more or less numerous reused stone blocks was evidenced for all of the walls from this period. They originated most frequently from dismantled structures, as indicated by the remains of plasterwork, visible on the internal surfaces of the blocks. These also included stones taken from other structures, such as an oil press, for example, elements of which were noted in the north wall of areas 4 and 7. The thickness of bearing walls from this period ranged between 0.38 m and 0.48 m, most often 0.40 m to 0.44 m. Values below 0.41 m were ascertained only for partition walls. Wall thickness higher than the standard in some cases seems to have been a consequence of these walls being adapted to the size of reused blocks originating from older dismantled structures. In the case of almost all the walls enclosing the examined rooms, the bond consisted of single bull header ashlar tying the wall transversely, separated by segments made of bull stretcher blocks or, much more often, irregularly laid stones [Figs 3, 4]. The described bond

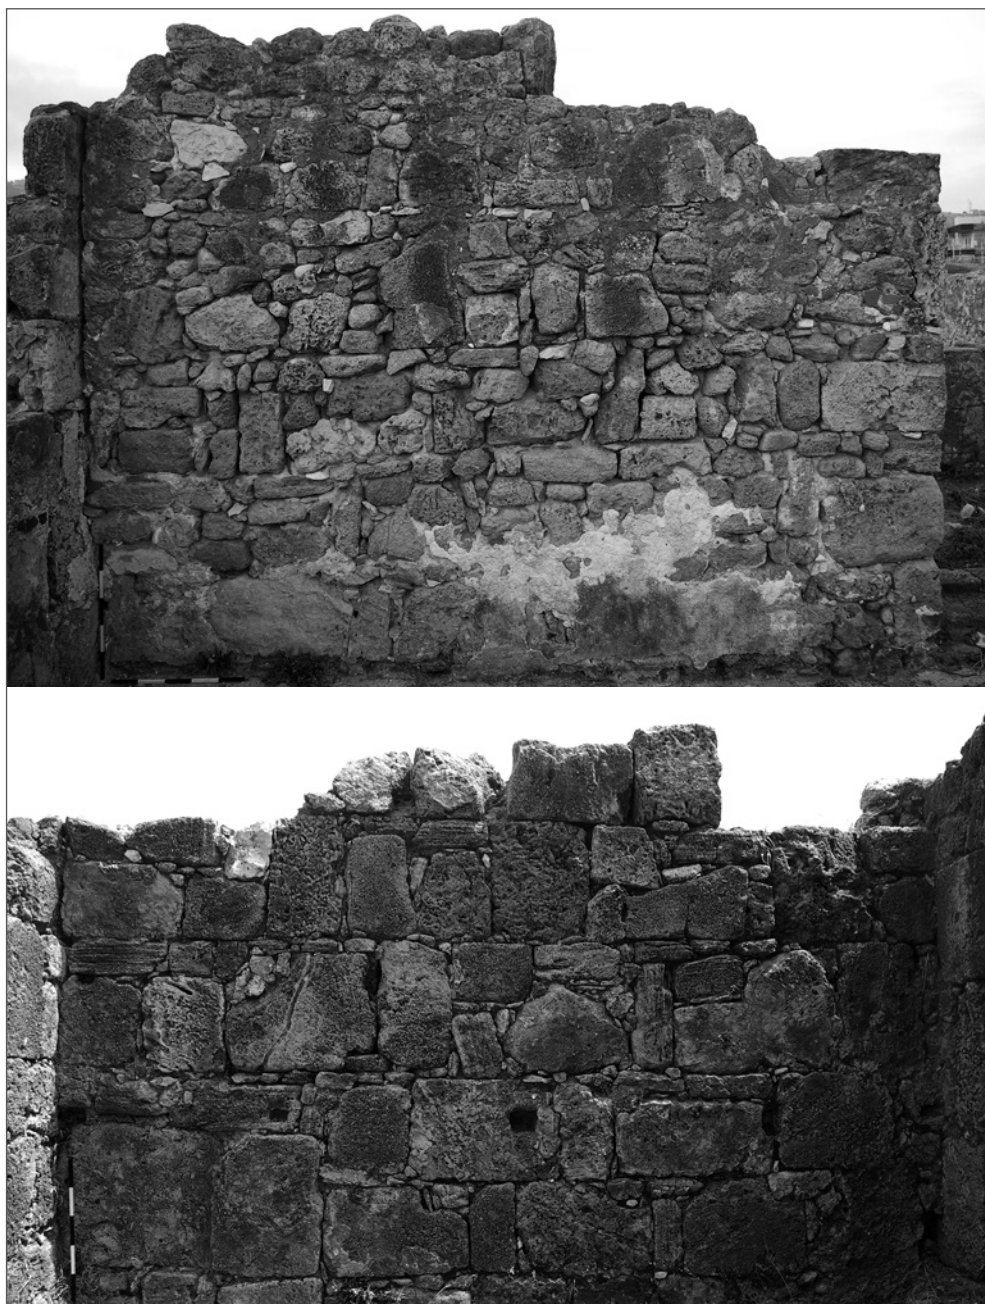
*Fig. 4. Examples of wall bonds: top, south wall of area 25; bottom, east wall of area 22
(Photos M. Dzik)*

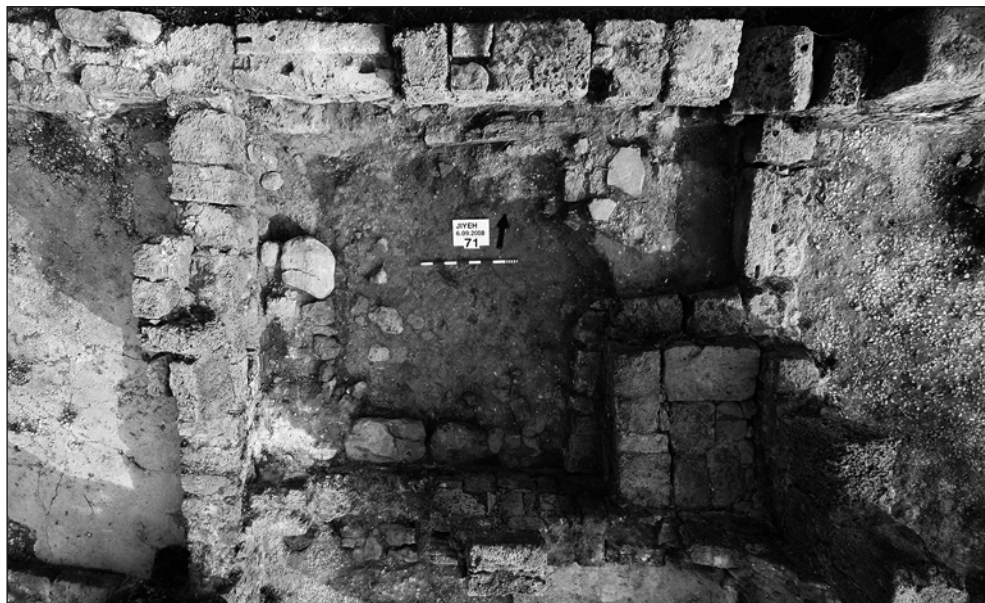
Fig. 7. Area 71 in 2008: top view with a stone platform, part of the staircase, in the bottom right corner (Photo M. Bogacki)

During the second phase a stone platform was erected in room 71 [Figs 7, 8].¹ It was part of a staircase leading to a higher level in room 22, most probably onto a wooden gallery. This structural element has been reconstructed from the layout of recesses and corbels of stone and mortar, found in walls enclosing room 22 on the east and south. This structure was located at a height of about 1.85 m above the youngest floor. It can be presumed that there was a passageway (or passageways) from the gallery to a higher utility level, to the east or south of area 22. Yet another wooden structure was located in the southeastern part of area 21. The observed layout of the recesses suggests the presence of wooden joists for a raised platform situated at a height of about 1.60 m above the youngest floor. It is uncertain in the present stage of research whether it performed the role of a connecting passageway. There are some circumstances to indicate that up until the overbuilding of the south wall of room 21, it might have led into area 20.

¹ The object was documented photographically in 2008. In 2010, it was destroyed as a result of illicit digging and pillaging. The dimensions, stratigraphic relations and function of the platform were reconstructed in 2013 based on archival documentation, preserved fragments of the base and layout of the plasterwork and mortar on adjacent walls in area 71. The conclusions reached became the basis for determining the function of corresponding platforms, located in a few other rooms on site.

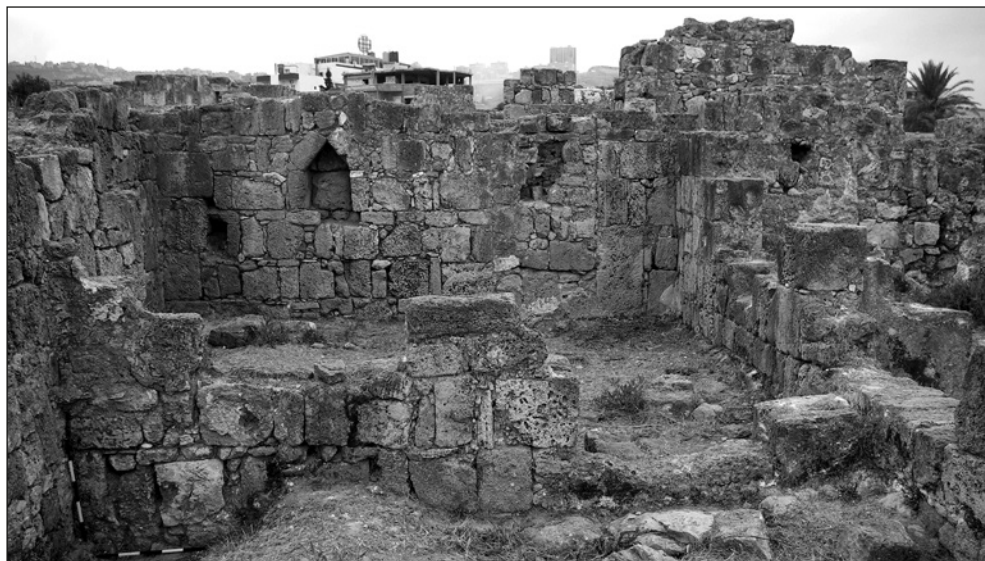
Fig. 8. View from area 71 southward in 2013: at bottom left, space left by a stone platform destroyed in 2010; in the background, the south wall of area 22 with a pentagonal niche (Photo M. Dzik)

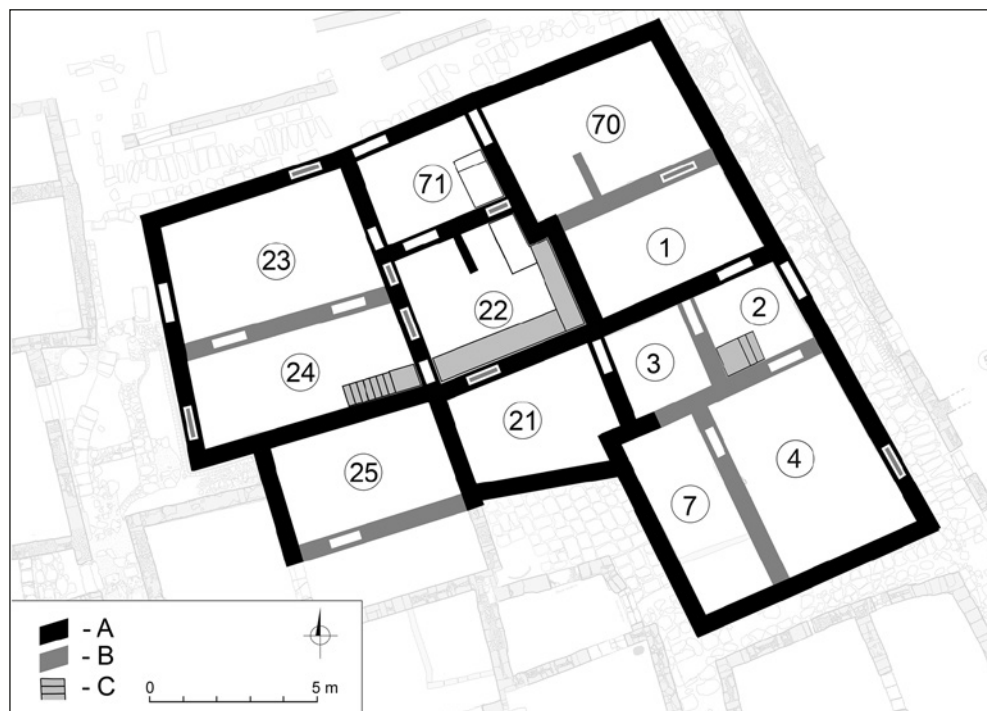
Fig. 9. *Third-phase buildings: A – walls erected at the beginning of the third phase and older walls; B – walls constructed during the third phase; C – staircase and gallery*
(Prepared by M. Dzik, original drawing M. Puzkarski)

The beginning of the third phase of the building, of which rooms 22 and 71 constituted the axis, was marked by a large investment project involving the reconstruction and at points, construction from the foundation up, of a wall establishing the external limits of the building complex [Fig. 9]. Simultaneously, walls were raised enclosing areas 1 and 24 from the south. It is worth noting that the
